Display message "Coolant temperature too high" appears in multifunction display

Topic number	LI54.15-P-067157
Version	2
Function group	54.15 Fuse and relay box
Date	10-25-2017
Validity	Model 205, 213 and 253 with engine 274
Reason for change	Formulation adjusted
Reason for block

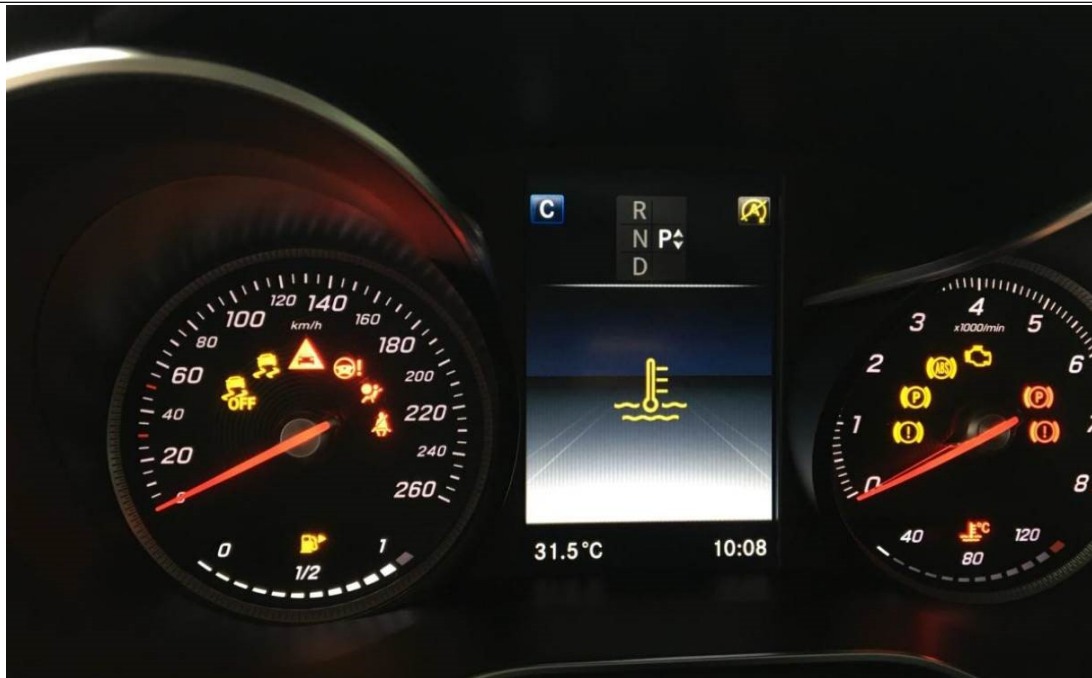
Display message.jpg:

Display message "Coolant temperature too high" appears in multifunction display.

Attachments	
File	Description
Display message.jpg	Coolant temperature display message

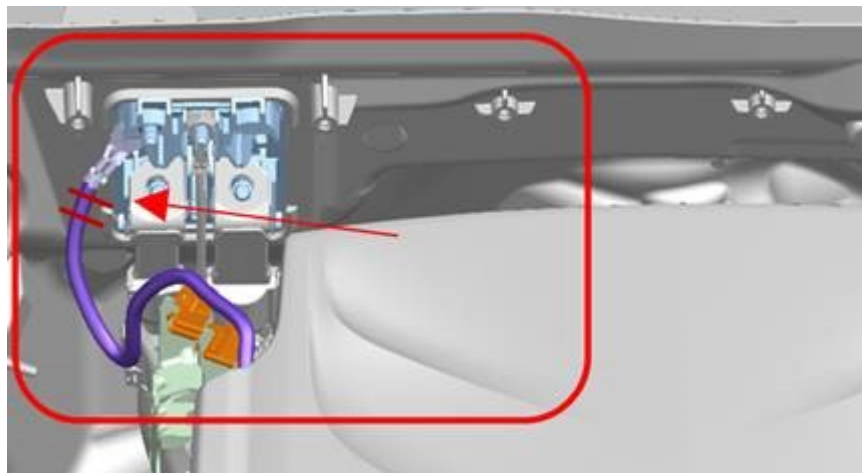
X244_Photo1.jpg:

1. Feed line from K40/8 connector S3 to X244/14
2. Feed line from X244/16 to M75/11
 - Check the circuit 30 line at the busbar X244 (see photos "X244_Photo1.jpg" and "X244_Photo2.jpg") for damage after carefully removing the heat-shrinkable tube (for example, the copper strands could be broken).
 - This point must then be closed again with fabric tape.
3. Feed line to ground point W46/1.
4. Check threaded connection of ground point W46/1 (see photo "W46.1.jpg").

Attachments	
File	Description
X244_Photo1.jpg	Busbar, photo 1
X244_Photo2.jpg	Busbar, photo 2
W46.1.jpg	Electric coolant pump ground point

All assembly parts/components can be replaced depending on the scope of the damage, see parts table (below).
Please do not dispose of any parts pending guidance given within PTSS.
