# Service Campaign Bulletin

Campaign No. 2017080007, October 2017

SUBJECT: **Model 217 Model Year 2017**  
**Apply Preservation Agent to Underbody**

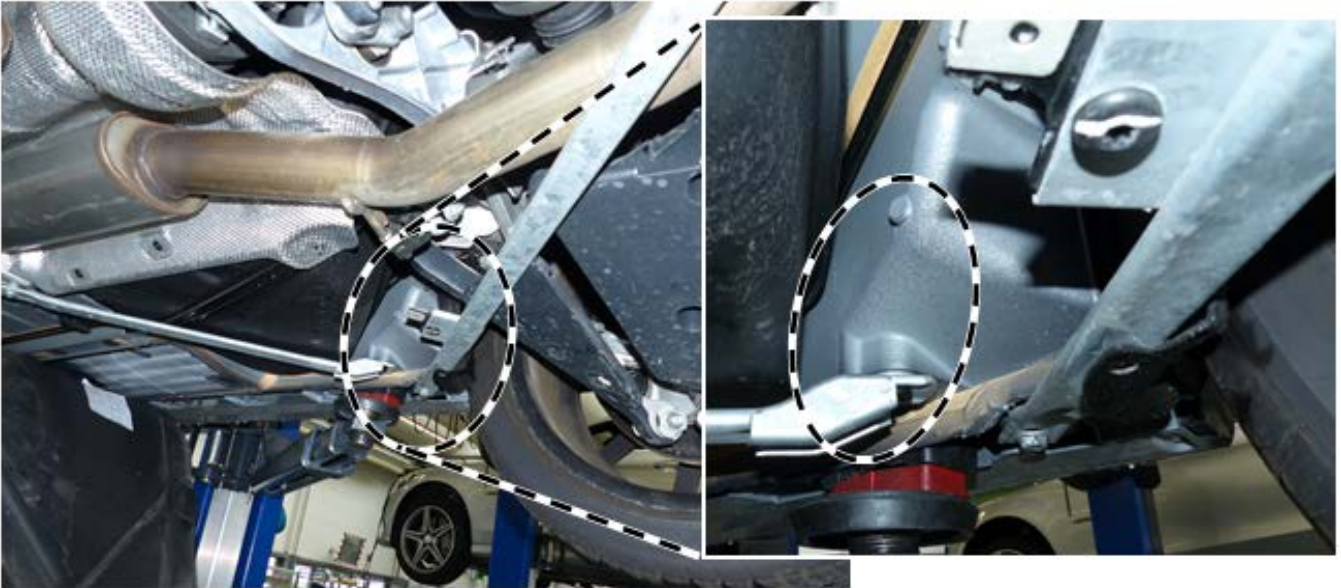
Figure 1 Shown on right rear

Remove left and right rear underbody paneling on the sides.
2. Apply preservation agent to mounting consoles on left and right rear underbody (Figure 1).

Daimler AG ('DAG'), the manufacturer of Mercedes-Benz vehicles, has determined that on certain S-Class Coupe (217 platform) vehicles the mounting console for the underbody paneling does not correspond to the current production configuration. The surface of the mounting console may have been damaged as a result of a process malfunction. An authorized Mercedes-Benz dealer will apply preservation agent to the left and right rear underbody paneling on the affected vehicles.
