Service Update

17197 Malfunction Indicator Lamp

Reference Number: N172085030

Condition	Some 2016-2017 model year Chevrolet Volt vehicles may have contact between an evaporative emission pipe and air conditioning (A/C) hose. Over time, such contact may wear a hole into the pipe causing a malfunction indicator lamp (MIL) to illuminate and diagnostic trouble code (DTC) P0442 may set.
Correction	Inspect the pipe for wear, install a bumper on the pipe; and if necessary, replace the purge pipe.

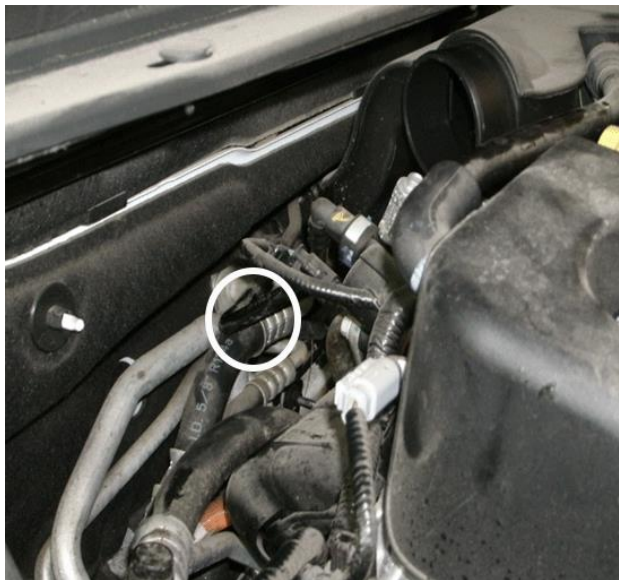
4806941

2. Remove the positive crankcase ventilation (PCV) tube (3). Refer to *Plastic Collar Quick Connect Fitting Service* in SI.
3. Remove the air cleaner outlet tube (4) from the air cleaner outlet duct assembly by loosening the clamps (1, 2).

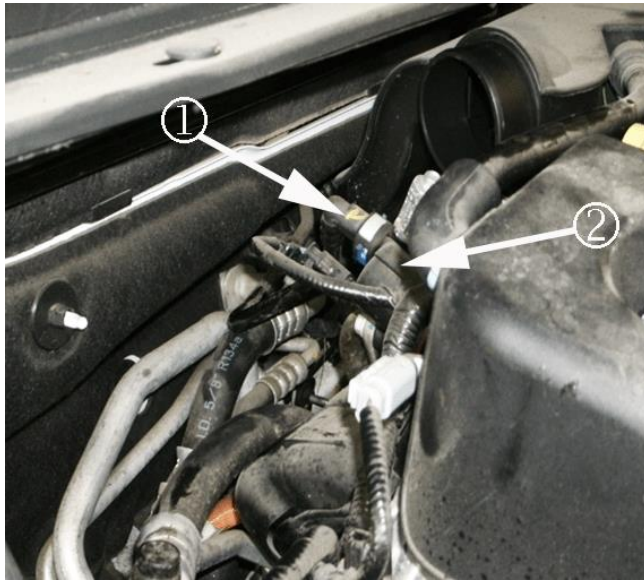
4806957

4. Locate the area in question on the evaporative emission pipe.

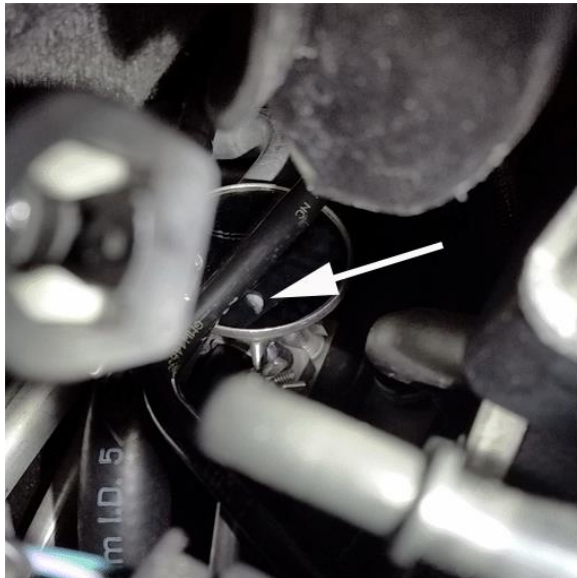
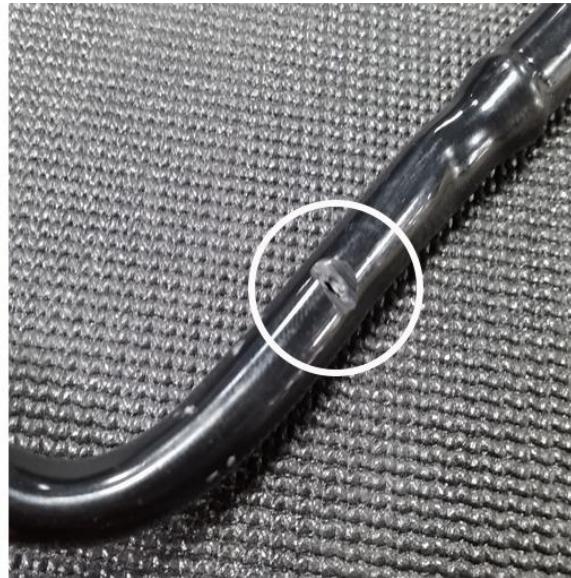
4806962

5. Disconnect the evaporative emission pipe (1) from the evaporative emission canister purge solenoid valve (2). Refer to *Plastic Collar Quick Connect Fitting Service* in SI.

6. Using an inspection mirror, inspect the underside of the evaporative emission pipe for evidence of damage.
 - If the evaporative emission pipe does NOT show any signs of damage, proceed to the next step.
 - If the evaporative emission pipe shows signs of damage, replace the evaporative emission pipe. Refer to *Evaporative Emission Pipe Replacement* in SI.

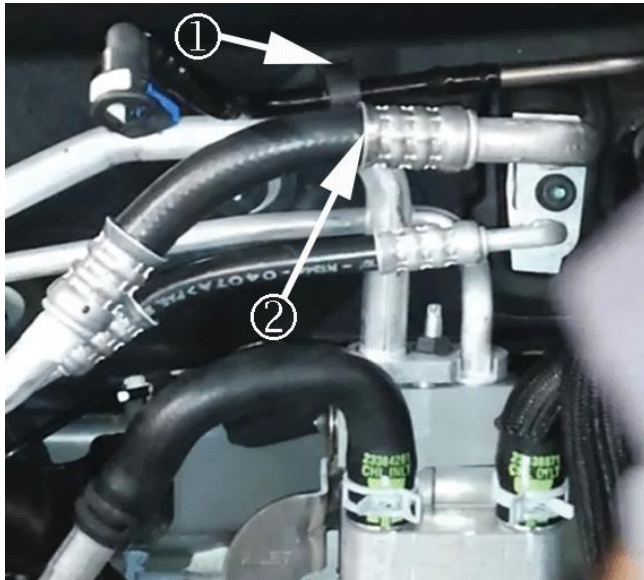
4806969

7. Install an evaporative emission hose protector (1) on the evaporative emission pipe. Position the evaporative emission hose protector directly adjacent to the ferrule edge (2) of the air conditioning evaporator hose. Ensure the evaporative emission hose protector is resting on the rubber portion of the air conditioning evaporator hose to prevent the evaporative emission pipe from coming into contact with the air conditioning evaporator hose.
8. Connect the evaporative emission pipe to the evaporative emission canister purge solenoid valve. Refer to *Plastic Collar Quick Connect Fitting Service* in SI.
9. Install the air cleaner outlet tube.
10. Install the PCV tube.
11. Install the intake manifold cover. Refer to *Intake Manifold Cover Replacement* in SI.

Note: On some vehicles the evaporative emission hose protector may not touch the air conditioning evaporator hose. This is an acceptable condition. On a very small population of vehicles the evaporative emission hose protector may already be installed.
