Service Update

17339 Incorrect Spare Wheel Assembly Installed

Reference Number: N172108840

Subject: 17339 - Service Update
Incorrect Spare Wheel Assembly Installed

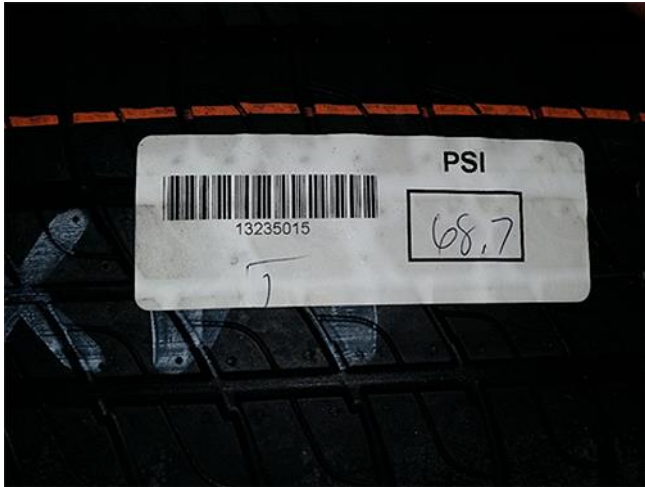
4858273

Chevrolet Impala tire sticker number ends with 5015

2. Find the bar code label on the tread of the tire. Using the information on the bar code, verify the vehicle is equipped with the correct spare wheel/tire assembly.
 - If the correct wheel/tire assembly is installed in the vehicle, no further action is required.
 - If the incorrect wheel/tire is installed, replace the spare wheel (reuse the existing tire). Refer to *Tire Dismounting and Mounting* in SI.
3. Reinstall the rear compartment components as necessary.

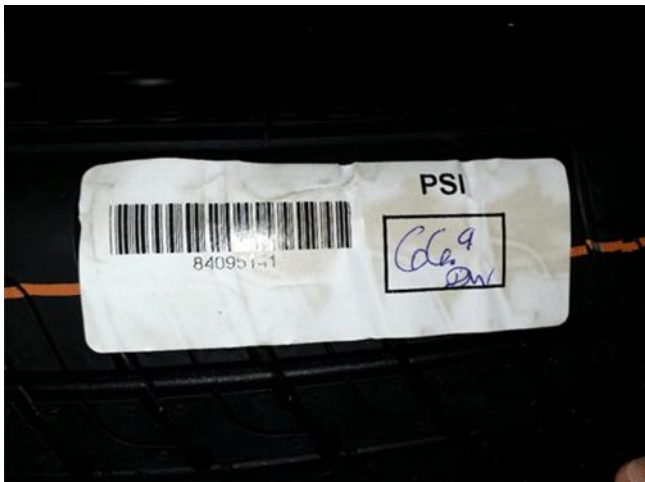
4858274

Buick LaCrosse tire sticker number ends with 5141

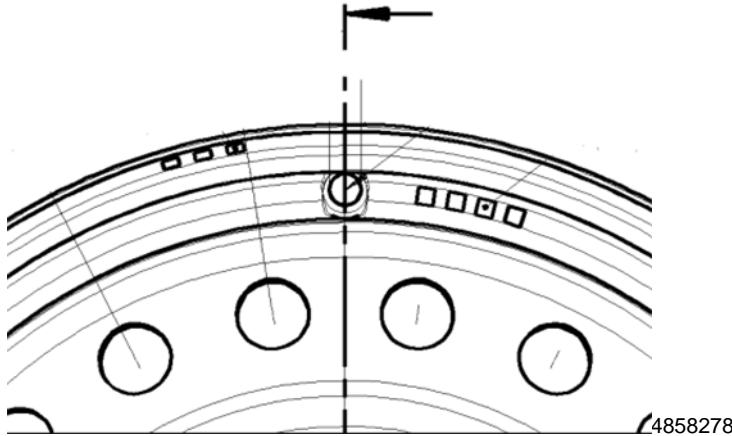
Chevrolet Impala valve stem located between holes in wheel

If the spare tire bar code label is missing or not readable, use the following wheel identification graphics to determine if the correct wheel/tire assembly is installed in the vehicle.

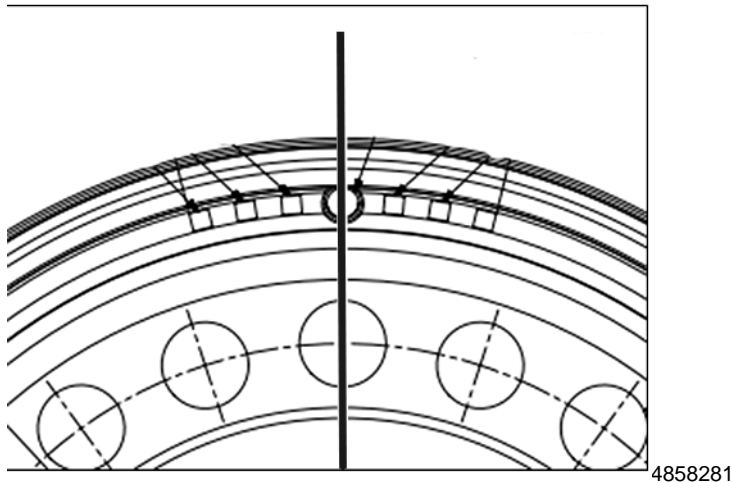
Buick LaCrosse valve stem aligned with hole in wheel
