# **Technical Journal**

Front side door, water intrusion

REF NO: TJ 32728.1.1	ISSUING DEPARTMENT: Technical Service	CAR MARKET: United States and Canada	
3 US 7	PARTNER: '510 Volvo Car USA	ISSUE DATE: 2017-07-24	STATUS DATE: 2017-09-12
FUNC GROUP: 8414	FUNC DESC: Trim moulding at window	Page	1 of 8

Title	Weatherstrip, door window, front	Page	1(6)
Action	Product fix	Operation number:	98687-2

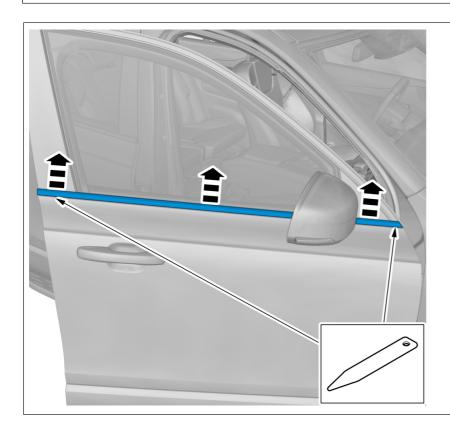
Remove the part carefully

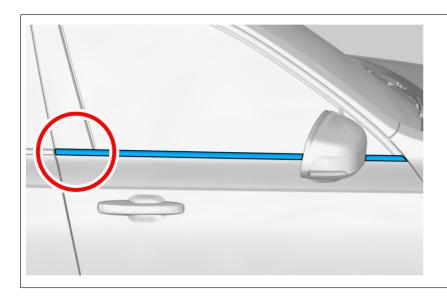
Note! Orientation view

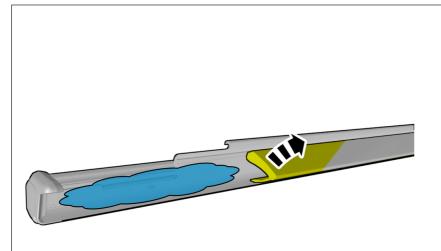
Clean the marked area.

Use: Cleaning agent, 1161721

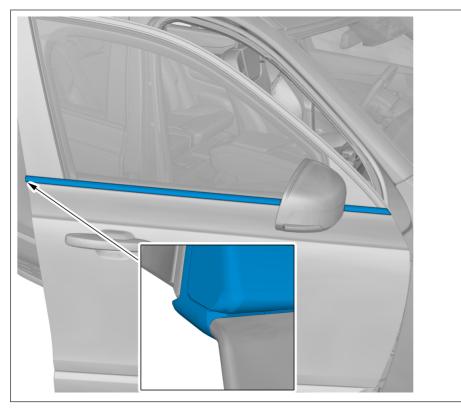
To install, reverse the removal procedure.
