MODEL: Karma Revero**DATE:** July 2017**TITLE:** Wiper Arm Replacement**First Release****APPLICABILITY:** MY17 and MY18 Revero, On Complaint**MARKET REGION:** North America**PURPOSE:** Replacement of passenger side wiper arm

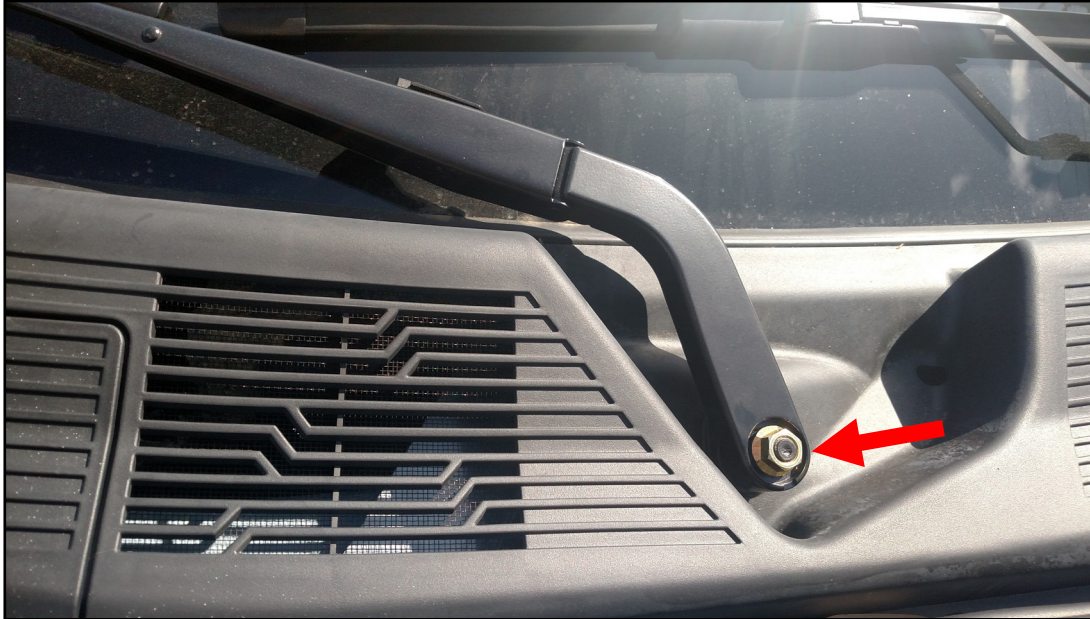
fig.2a

- b. Remove the cap and Remove the nut (install torque 25Nm) (fig. 2a, b) When removing the wiper, undo the hose from the “Y” fitting as shown in fig. 2c,d. The new arm will have nozzles and a hose used to reinstall

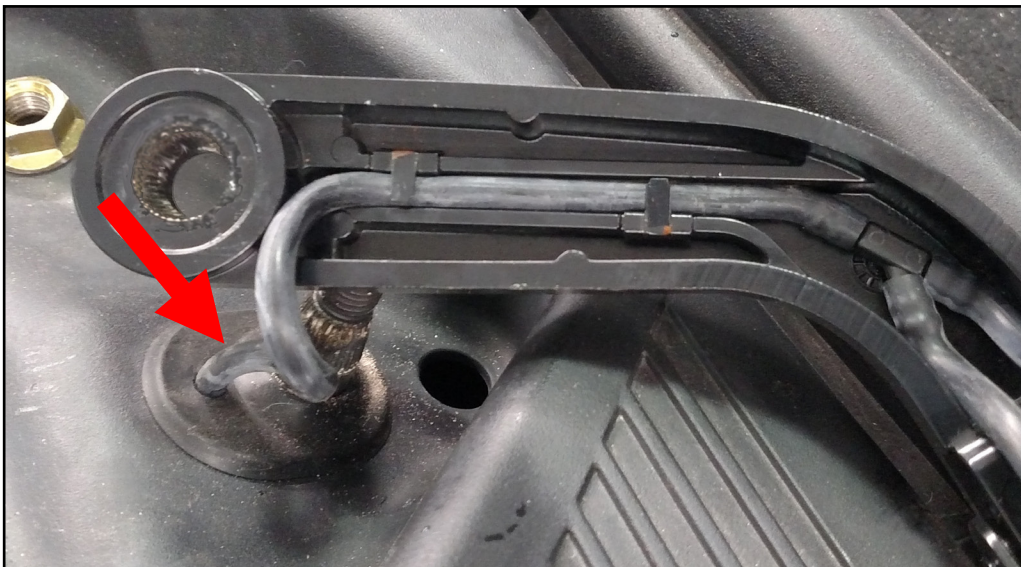
fig.3a

- c. The hose will not detach but may pull out some length from the grommet, (fig. 3a) when attaching to the new wiper arm, be sure to push the excess length back through the grommet.

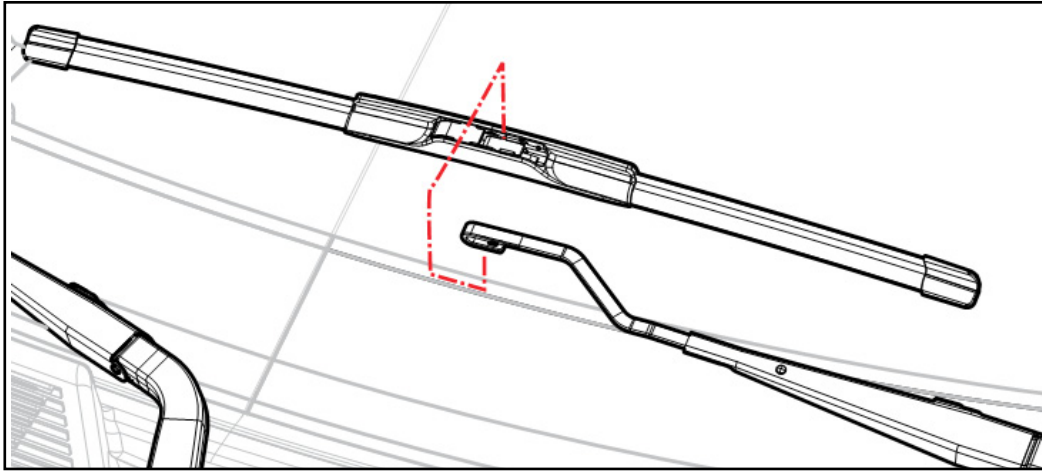
fig.4

- d. Remove the wiper blade and transfer it to the new assembly, if not so equipped (fig.4).
