# TITLE: P5-XC90 Front license plate screws

REF NO:	ISSUING DEPARTMENT:	CAR MARKET:		
TJ 31218.1.3	Technical Service	United States and Canada		
3 US 7	PARTNER:	ISSUE DATE:	STATUS DATE:	
	2510 Volvo Car USA	2017-02-08	2017-02-13	
FUNC GROUP: 8611	FUNC DESC: Bumper, front	Page	1 of 3

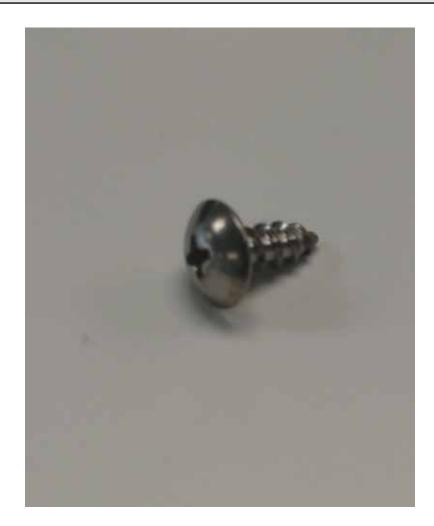
# Technical Journal 31218.1.3

File Name	File Size	
Wurth 02151012.jpg	2.4353 MB

Install front license plate using four (4) Wurth screws P/N 02151012. (For claiming use P/N 2151012)

\*Canadian market use Wurth screw P/N 140.70604 (For claiming use P/N 2151012)
