Technical Journal

Inner door handle, clicking noise

REF NO: TJ 32500.1.0	ISSUING DEPARTMENT: Technical Service		ARKET: s and Canada
3 US 7	PARTNER: '510 Volvo Car USA	ISSUE DATE: 2017-04-10	STATUS DATE: 2017-04-10
FUNC GROUP: 8345	FUNC DESC: handle, inner for side door	Page ⁻	1 of 28

Title	Internal handle, side door	Page	1 (15)
Action	Product fix	Operation number:	98670-2

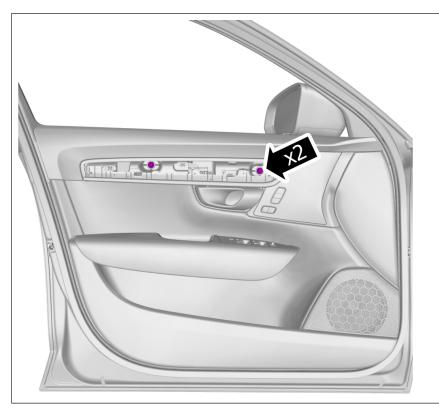
Torque:

M5 , 5 Nm

Remove the screws.

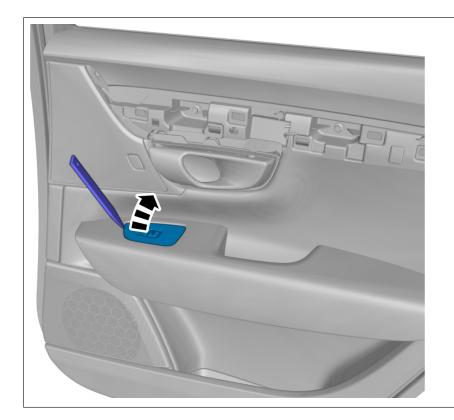
Remove the marked part.

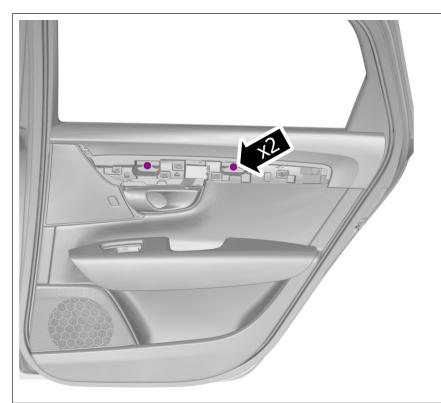
Remove the screws.

Torque:

M5 , 5 Nm

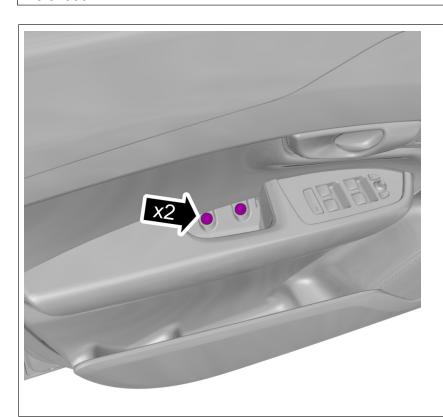
Remove the screws.
