TS 1033014 Fuel Leak Found at High Pressure Fuel Pump Weep Hole for Heavy Duty DD Engines

Summary: Occasionally we see trucks come in with fuel leaking from the high pressure fuel pump weep hole. This is NOT a defect in the pump and further diagnostics need to be performed to find the root cause.

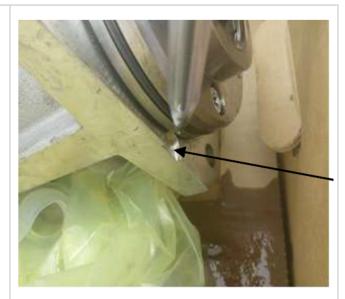
Generally the unit will come in with a complaint of a fuel leak at the fuel pump. You may also have fault codes for fuel filter replacement (94/15 and or 94/16). Check to see if fuel is leaking from the weep hole underneath the high pressure fuel pump. (As shown to the right)

The high pressure fuel pump will need to be replaced as the seal is not serviceable. After the pump has been replaced run the engine at idle and check fuel pressure with a mechanical gauge. Avoid running the engine at a higher rpm so the new pump seal isn't damaged in case the restriction is still present.

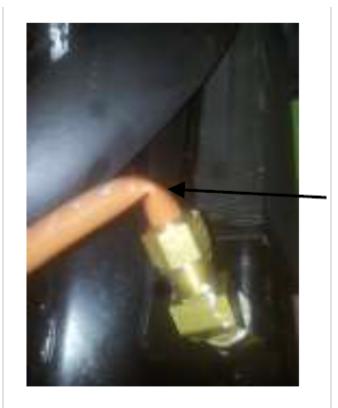
The fuel lip seal in the high pressure pump can fail when low side fuel pressures are extremely high. High fuel pressure is caused from a restriction on the return side of the fuel system. Visually inspect the OEM return fuel lines from the fuel filter module back to the tanks. Look for any severe bends or kinks in the line. The photo to the right shows where the return fuel line was kinked when it was connected to a fuel cooler. Make any repairs needed.

If fuel pressure is higher than spec you will need to find the source of the restriction. Possible cause outside of the OEM fuel system are:

- -Two stage valve stuck closed
- Plugged high pressure fuel flange
