POLARIS[®] TECHNICAL SERVICE BULLETIN

GEM

Bulletin Number: L-17-02-A

SUBJECT: 2017 GEM EPS BOLT INSPECTION

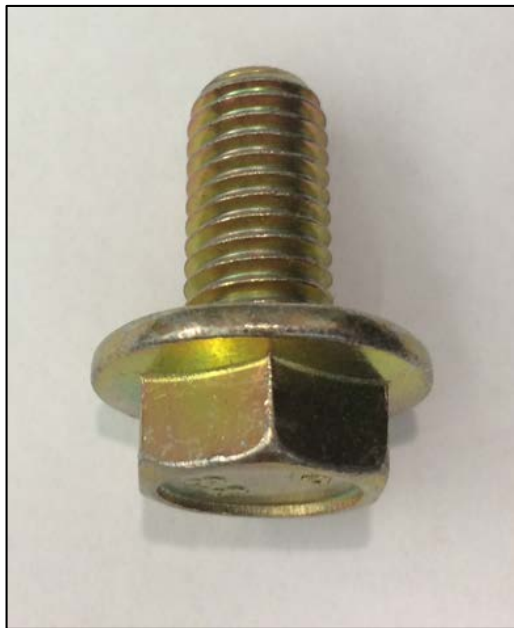
Polaris has found that a limited number of EPS-equipped vehicles were manufactured with bolts that have the incorrect thread pitch. These bolts mount the EPS module to its mounting bracket. These incorrect bolts damage the EPS unit as well as the bolts themselves. Any unit with incorrect bolts will require replacement of the bolts and the EPS unit. These bolts can be identified by their color; the correct bolts are an olive drab finish while the incorrect bolt is a yellow chromate finish.

**INCORRECT FASTENER
(Yellow Chromate Finish)**

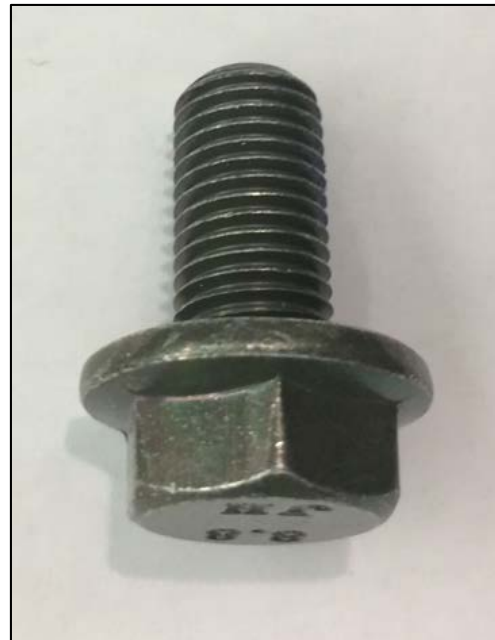
**CORRECT FASTENER
(Olive Drab Finish)**

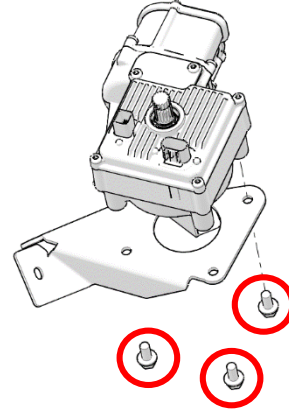
Figure 1

The bolts in question are circled, which can be viewed in Figure 1.

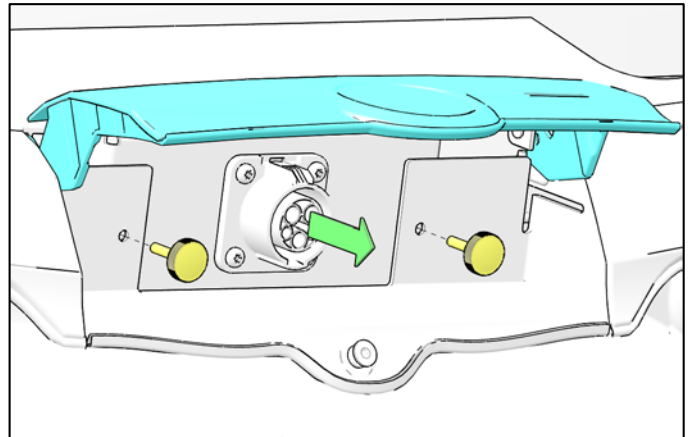
1. Engage parking brake.
2. Remove two hood screws located under the charge port.

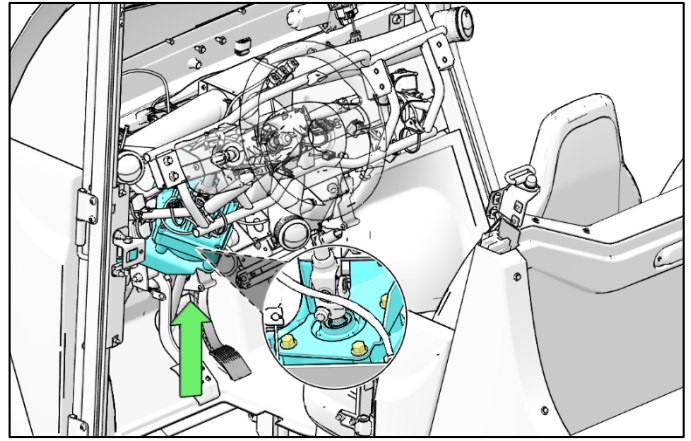
10. Inspect EPS bolt color while being underneath EPS unit and looking upward.

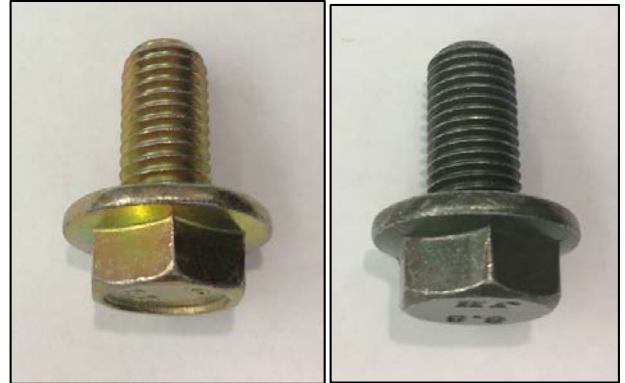
INCORRECT
(Yellow Chromate Finish)

Correct
(Olive Drab Finish)

11. If the fasteners are an olive drab finish then no repair is necessary, reinstall dash components by reversing the order of steps 1-9. Install the bulletin completion decal on the frame, next to the Digital Wrench connector. File bulletin L-17-02-A.

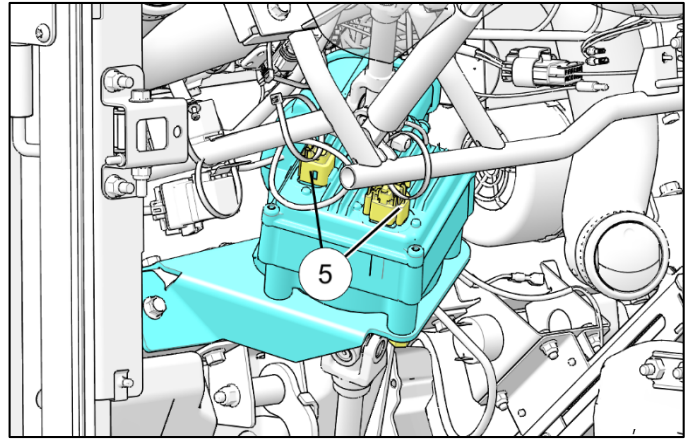
13. Remove two electrical connectors (5) from EPS module.

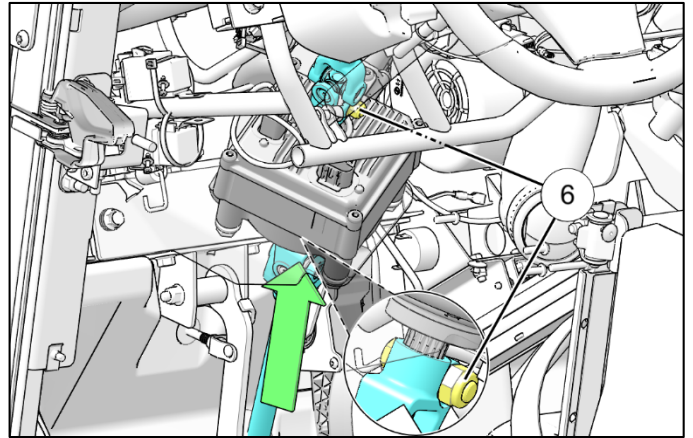
14. Remove top and bottom pinch bolts (6).

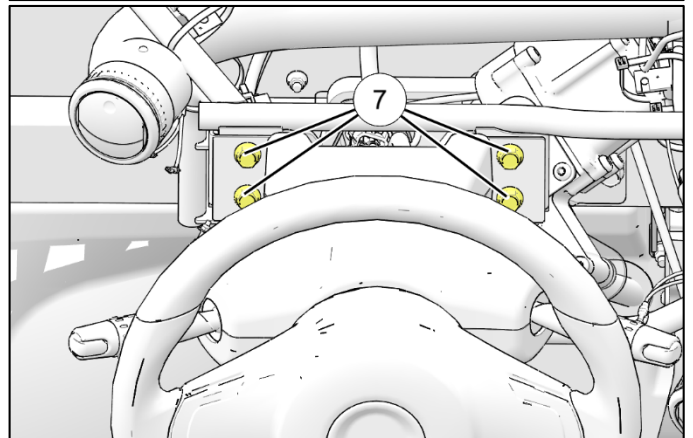
15. Remove four steering column to dash frame fasteners (7).

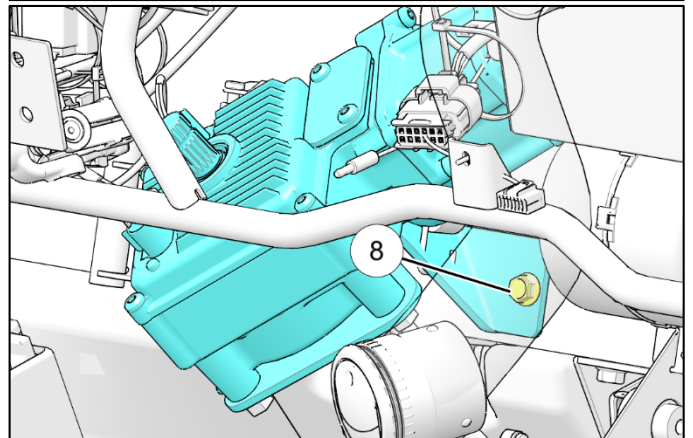
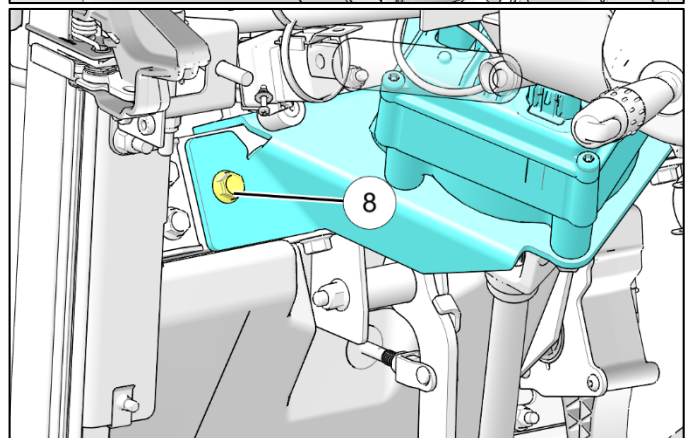
19. Remove two EPS bracket to dash frame fasteners (8).

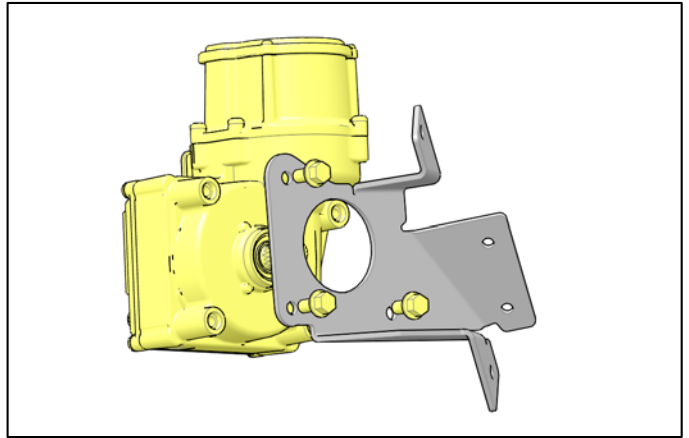
21. Transfer bracket to new EPS unit with new fasteners.

TORQUE
EPS Fasteners
30 ft-lbs (41 Nm)

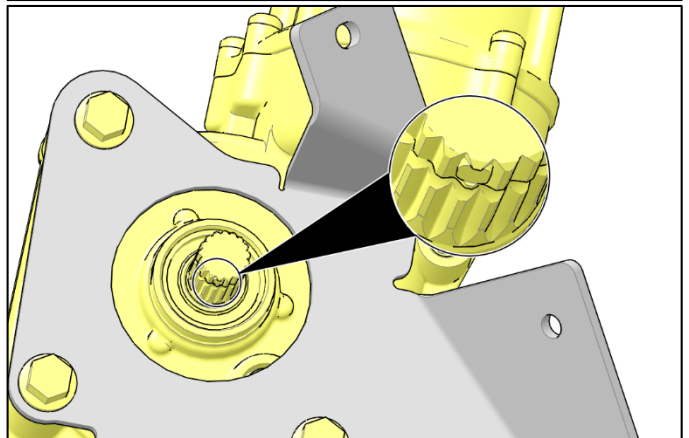
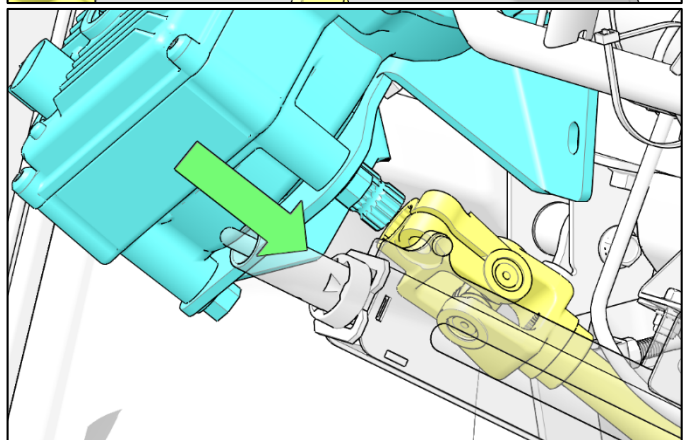
22. Insert EPS into Lower steering shaft by aligning slip joint with skip tooth on EPS Shaft.

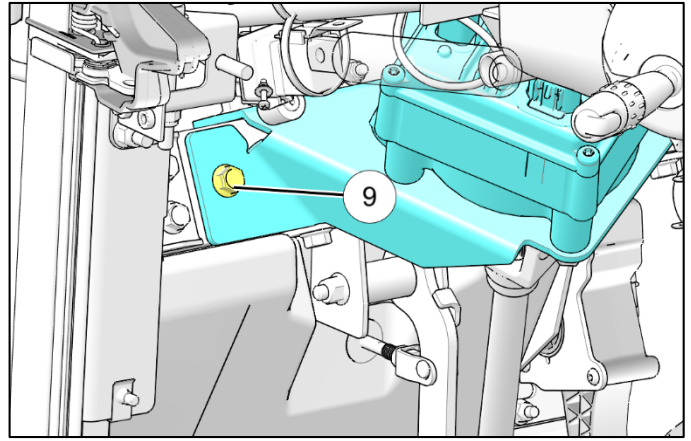
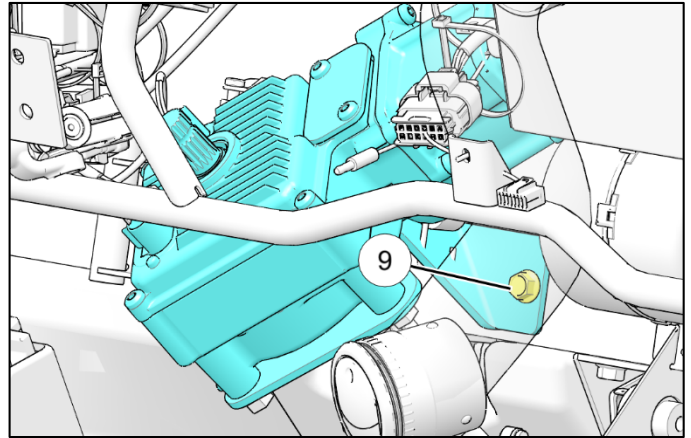
23. Install EPS bracket fasteners ⑨.

EPS Bracket Fasteners
30 ft-lbs (41 Nm)

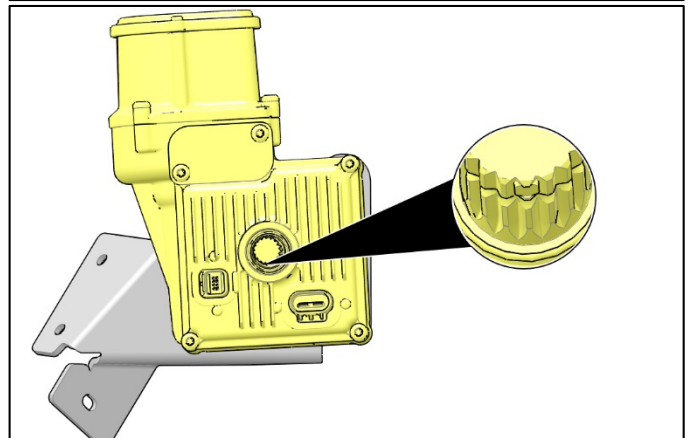
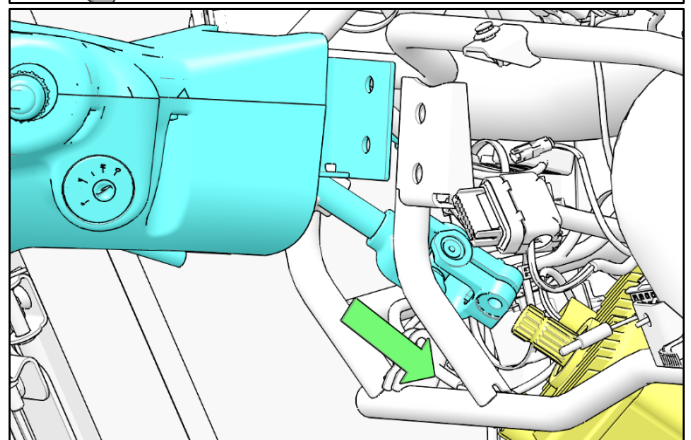
24. Install steering column to EPS by aligning skip tooth into joint.

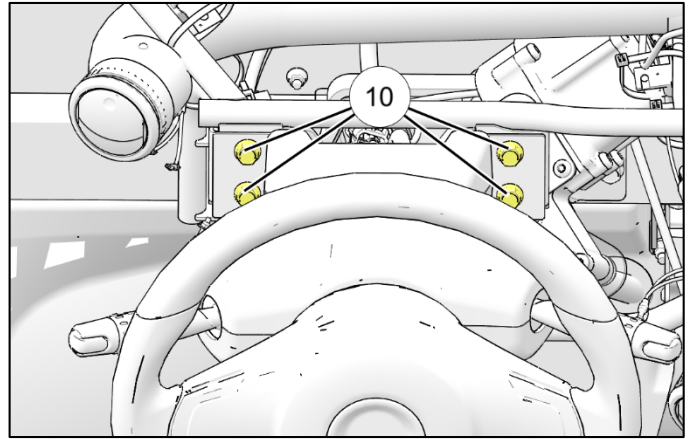
25. Install column to dash frame fasteners ⑩.

Column Fasteners
18 ft-lbs (25 Nm)

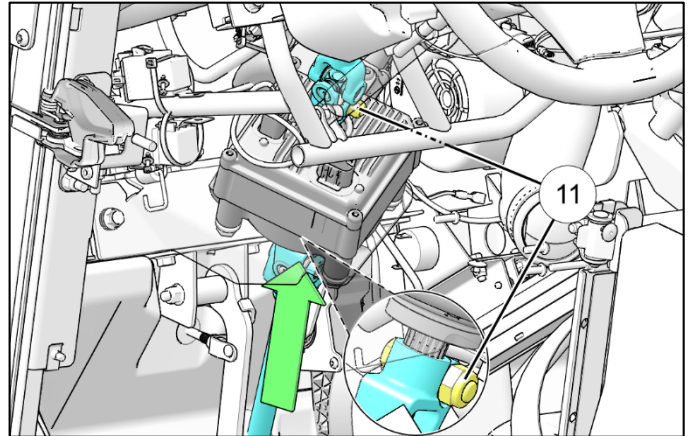
26. Install upper and lower slip joint fasteners ⑪.

Slip Joint Fasteners
18 ft-lbs (25 Nm)
