# Thor Motor Coach Technical Service Bulletin

TSB # **TSB 17-01**

Description/Title: **Arial 3901 Rear Bath Heat Run Installation**

Affected Product Line(s): **Certain 2017 Aria 3901 motor homes**

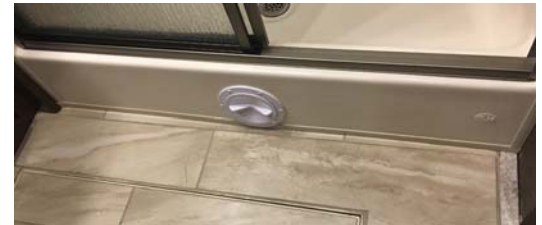
**2. Unscrew the access port at the base of the shower**

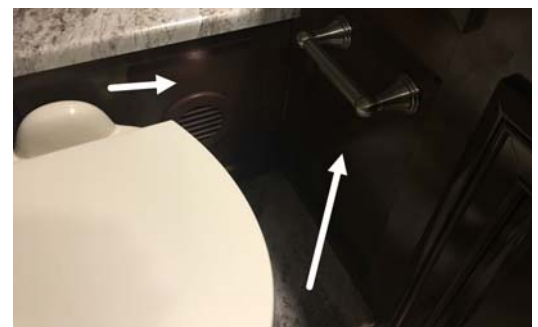
**3. In the front bath room, remove the panels behind the toilet as well as the one directly under the toilet paper holder. Make sure that neither the panels nor the toilet paper holder are damaged during removal.**

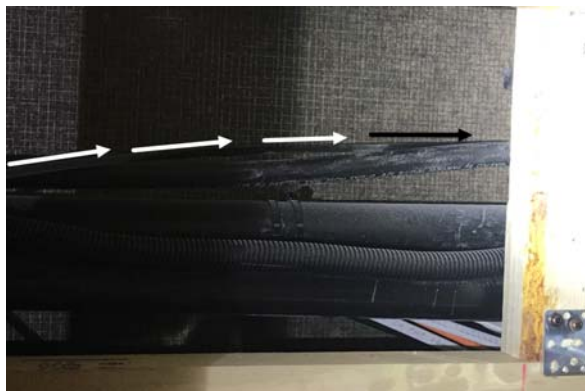
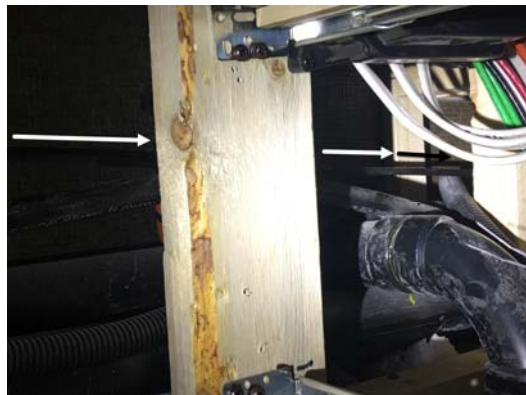
5. Thread a fish tape, or other similar device, underneath the forward most drawer.
6. Feed it along the exterior wall making sure to clear any piping, harnesses, or other structures as you do. This is the path that you will be pulling the flexible heat duct through so ensure that the 2" duct will fit through the openings you are threading the fish tape through prior to starting the repair.

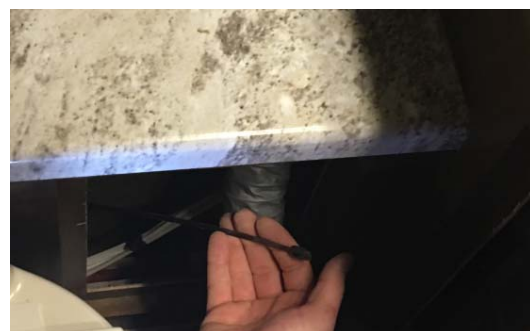
7. Find the end of the fish tape.

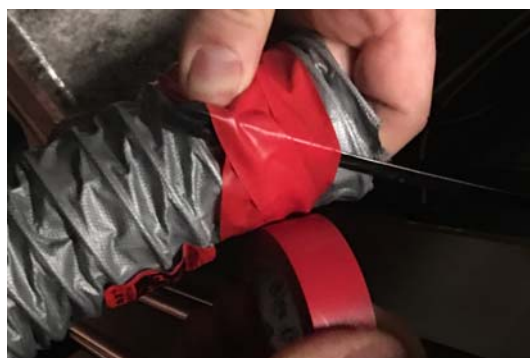
8. Attach the end of the fish tape to one end of the 2" flexible ducting. Be sure the attachment method does not damage the ducting.

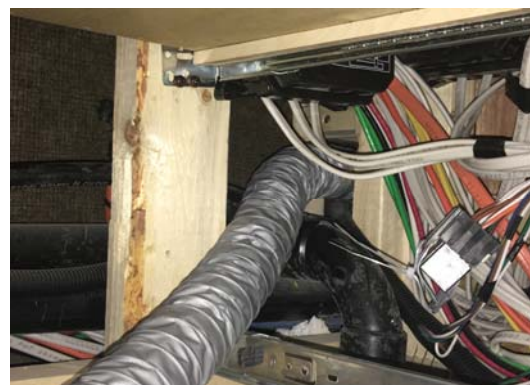
9. Gently pull the 2" flexible ducting along the path taken by the fish tape making sure that it is not snagged or crushed by surrounding pipes, harnesses, etc.

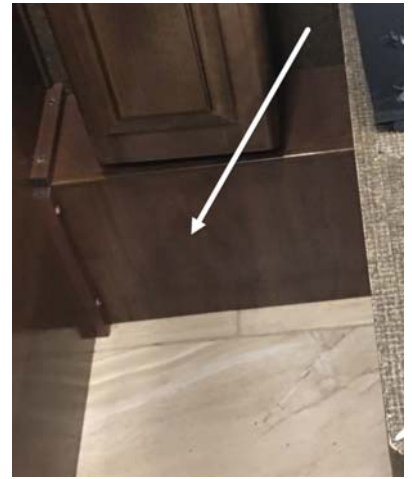
10. Remove the rearmost panel at the floor line of the bedroom

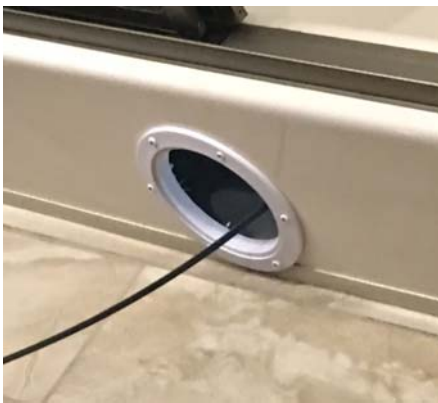
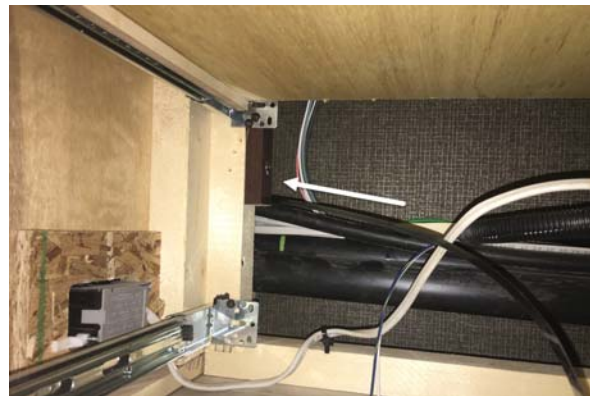
11. Starting in the rear bath, feed the fish tape through the access port opening and under the bed.

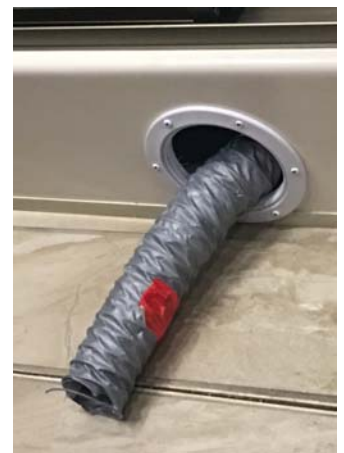
12. Attach the end of the fish tape to the same end of the ducting that you attached it to in step 6 then gently pull the 2" flexible ducting along the path taken by the fish tape making sure that it is not snagged or crushed by surrounding pipes, harnesses, etc.

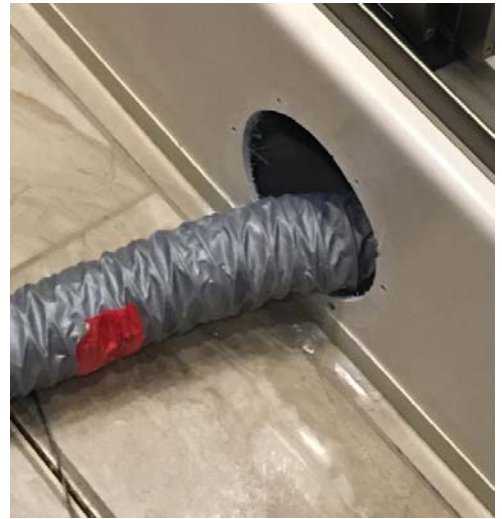
13. Remove the access port collar

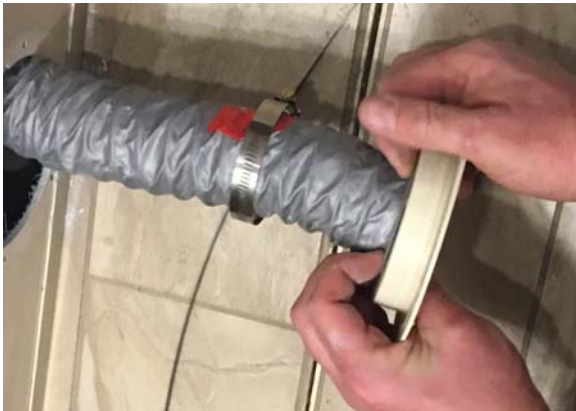
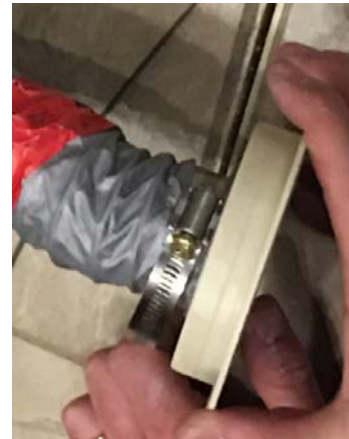
14. Install the Rotaire base and hose clamp to the end of the 2" flexible ducting that was just pulled through the shower base.

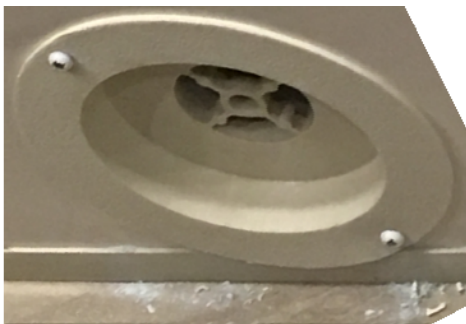
15. Install the completed assembly in the hole left by the access port. Use 2 of the screws from the access port collar installation to secure the Rotaire base to the shower. Install the louvered cover over the base ensuring that it snaps on securely.

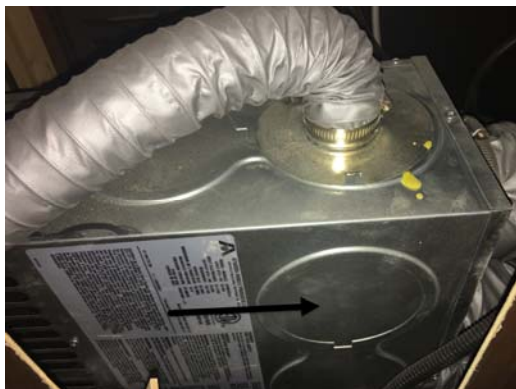
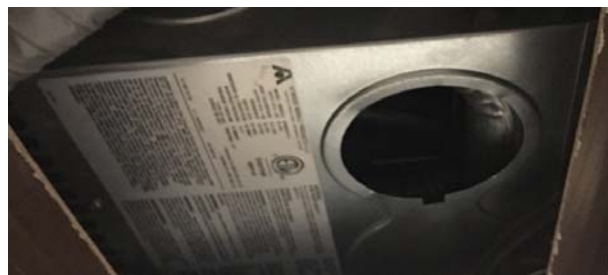
16. In the front bathroom, punch out the top port on the furnace.

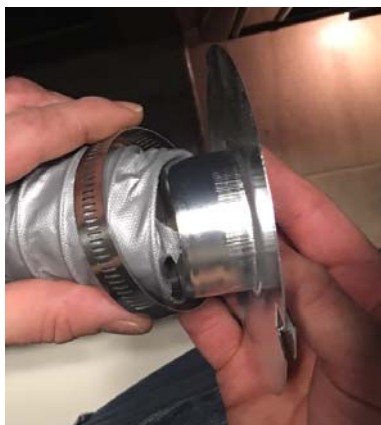
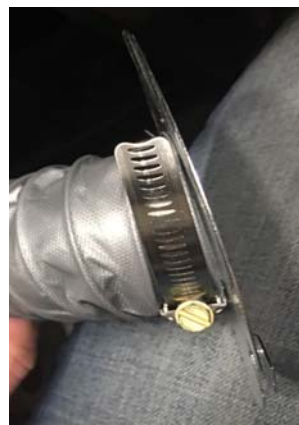
17. Install an adapter and hose clamp onto the end of the ducting.

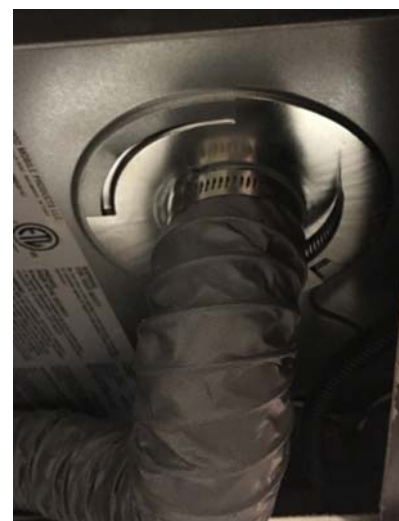
18. Install this assembly onto the furnace.
