**SUBJECT: 2014-2017 Mazda3 and MVSS (Motor Vehicle Safety Standards) Label
Concern Special Service Program (SSP) SSPA8**

2014-2017 MAZDA3 AND 2016 MAZDA2 - MVSS LABEL SSPA8

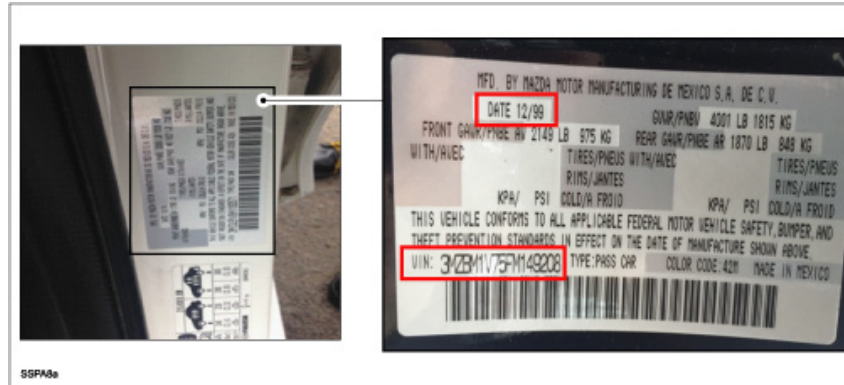
1. Confirm the printed information on the MVSS label.
 - DATE: Confirm that incorrect production month/year 12/99 is printed on the affected vehicle.
 - VIN: Confirm that the same VIN is printed on the MVSS label of the affected vehicle and the new MVSS label you are going to attach.

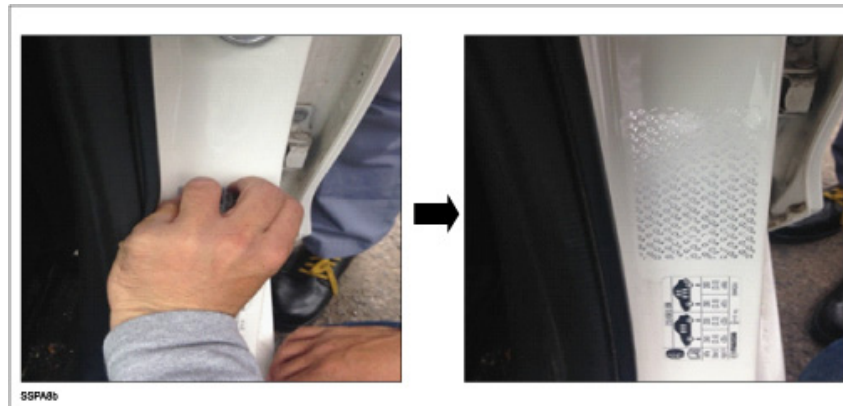
2. Tear off the MVSS label from the edge by hand.

CAUTION: Be careful not to add a scratch to the body.

- If it is difficult to tear off the label, use a dryer to warm the label to make it easier to remove.
- A paste with characters "VOID" will remain after tearing off the label.

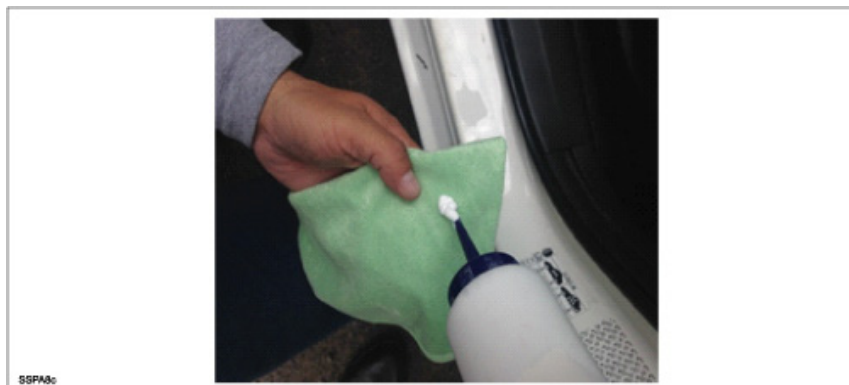
3. Apply a polishing compound to a waste cloth.

NOTE: Mazda recommends using 3M™ Finesse-it™ Polish - K211 or equivalent.

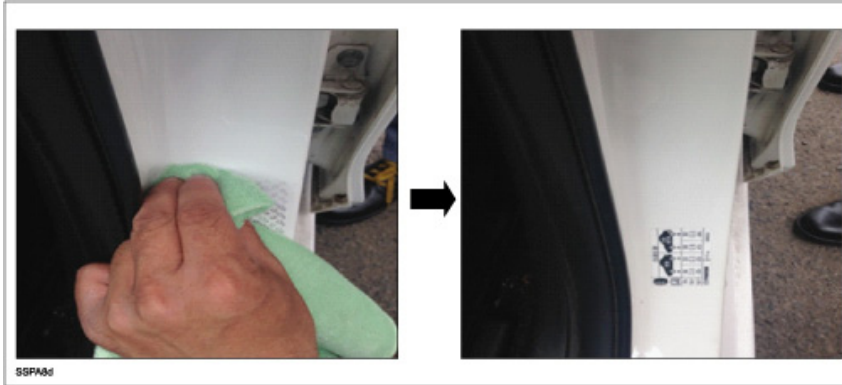
4. Remove the paste completely by polishing.

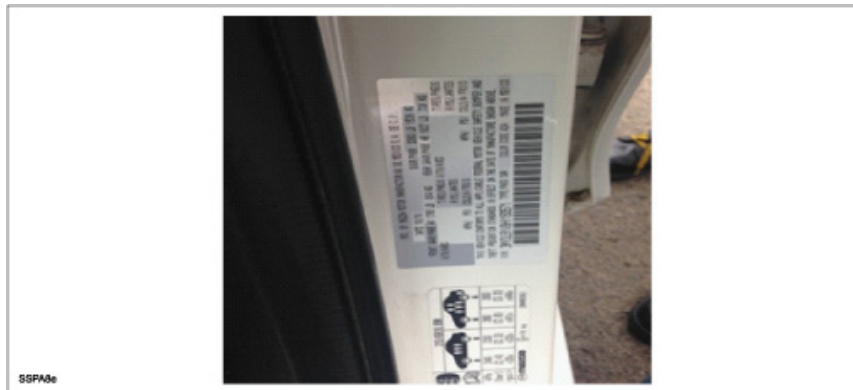
5. Place the new label to the original position.

CAUTION: Apply the new label carefully to prevent air bubbles under the label.

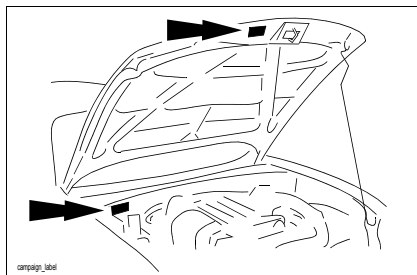
2. Affix it to the hood or bulkhead as shown:
