Technical Service Bulletin

Subject: CRACKS AROUND EDGE OF ACTIVE DRIVING DISPLAY (LOOKS FUZZY)	Bulletin No.: 09-044/17
	Last Issued: 11/13/2017

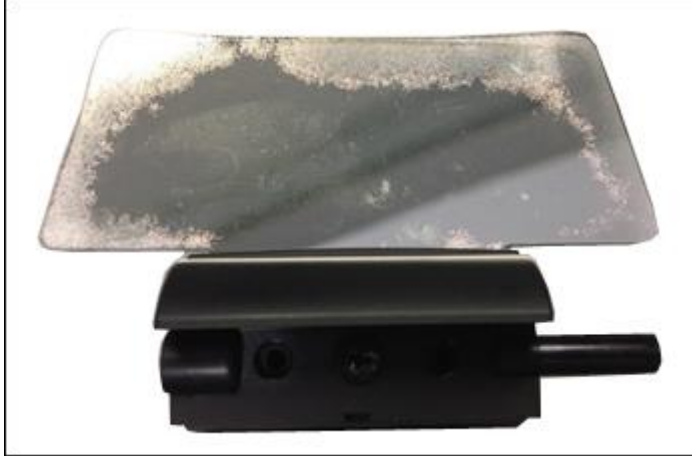
Some vehicles may experience a fuzzy appearance (tiny cracks) around the edge of the Active Driving Display.

1. Verify customer concern.
2. Replace the Active Driving Display. Refer to MGSS online or Workshop Manual section 09-22:
 - Mazda2 - ACTIVE DRIVING DISPLAY REMOVAL/INSTALLATION
 - Mazda3 - ACTIVE DRIVING DISPLAY REMOVAL/INSTALLATION
 - Mazda6 - ACTIVE DRIVING DISPLAY REMOVAL/INSTALLATION
 - CX-3 - ACTIVE DRIVING DISPLAY REMOVAL/INSTALLATION
3. Verify repair.

Part Number	Description	Qty.	Notes
BHR1-55-459 or B62S-55-459	Multi-Meter Lens	1	Active Driving Display BHR1-55-459 has been superseded by B62S-55-459
