August 2017  
FL740A  
NHTSA #17V-402  
Transport Canada #2017-319

## Subject: Brake Check Valve

**Models Affected: Specific Freightliner 108SD, 114SD, and Business Class M2 vehicles manufactured December 16, 2014, through April 27, 2017.**

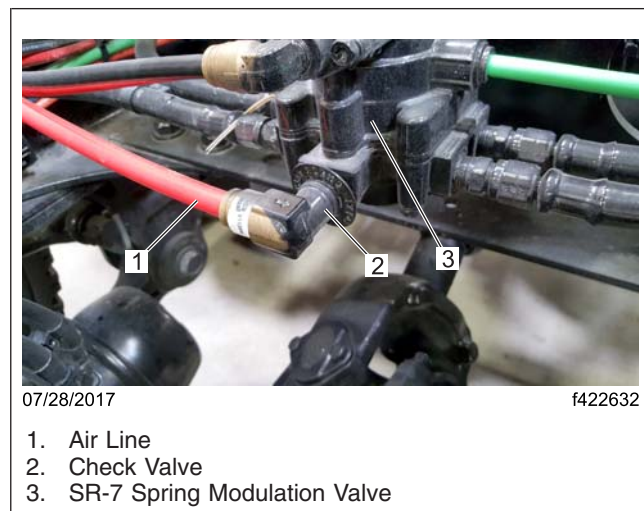
**Fig. 1, SR-7 Spring Modulation Valve**

3. Locate the SR-7 spring modulation valve, shown in **Fig. 1**, and inspect the secondary air port for a check valve fitting. The check valve is integral to the fitting and will have the plastic tag that says 'check valve' on it. See **Fig. 2** for an example of the check valve.

1. Drain the air from the system.
2. Disconnect the air line. See **Fig. 1**.
3. Remove the fitting.
4. Install the new check valve fitting. See **Fig. 2**.
5. Connect the air line.
6. Start the truck to build air pressure in the system.
7. Using a solution of soap and water, test the air line for leaks. If bubbles appear, repair the leak as needed.
8. Clean a spot on the base label (Form WAR259). Write the recall number, FL740, on a completion sticker (Form WAR260), and attach it to the base label.
