# Firestone

## W217602600 INSTALL NOTICE

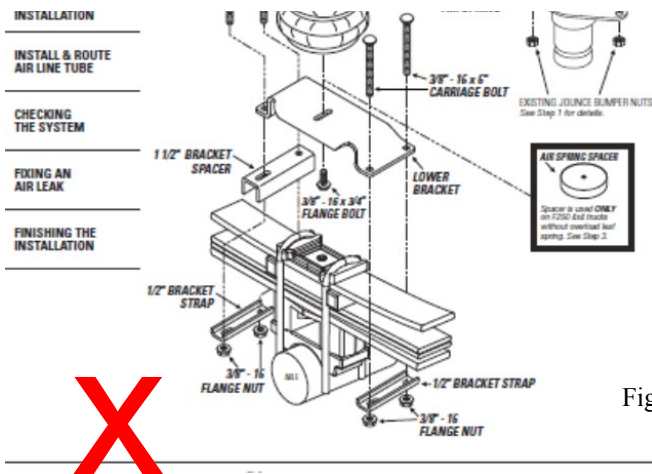
Figure 1

Kits packed before January 11, 2017 have an install manual diagram showing to clamp the lower bracket assembly around both the primary leaf stack and the overload spring (if so equipped) (Figure 1)

Please be advised that when the vehicle is equipped with an overload spring, the lower bracket assembly should be clamped onto the **OVERLOAD ONLY**, as shown in Figure 3. Failure to do so could, on rare occasions and under extreme loads, allow the lower bracket assembly to slide forward on the leaf stack resulting in lower air spring lifting force and possible contact between the upper and lower brackets.

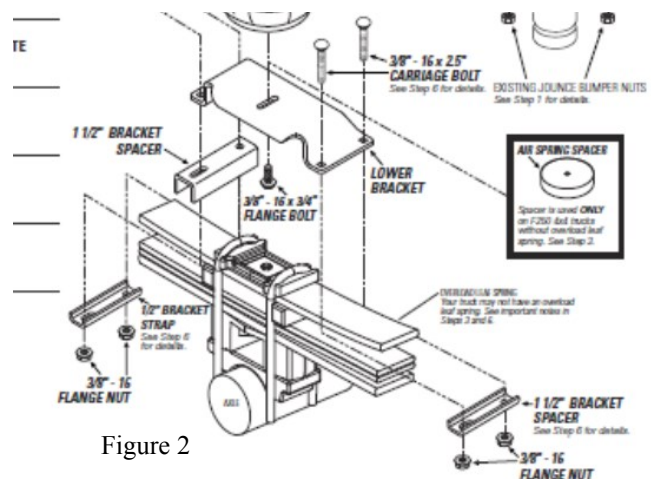
Figure 2

Firestone has since updated the manual to reflect clamping the lower bracket directly onto the overload spring, as shown in Figures 2 and 3.

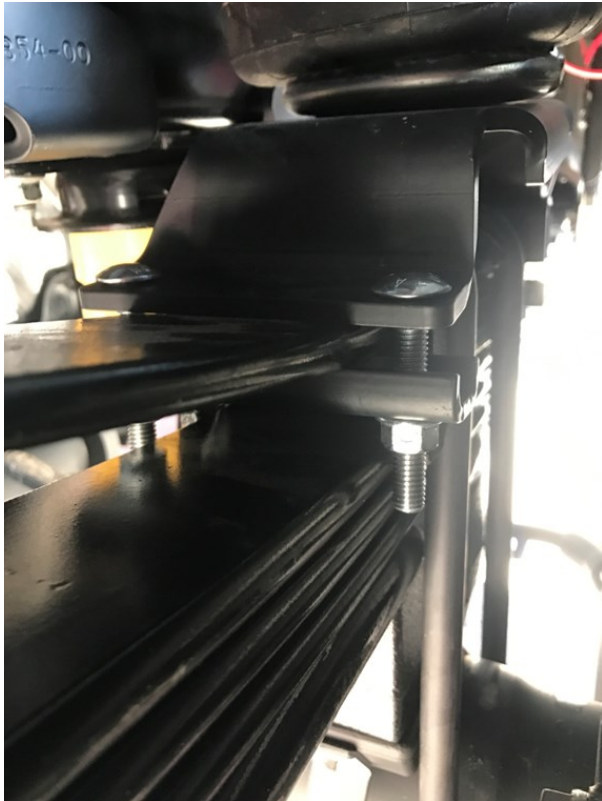
Figure 3. Lower clamp affixed directly to overload leaf spring

If you have sold or installed a kit packed prior to January 11, 2017, you should inspect the installation to ensure it looks like Figure 3, with the lower clamp attached directly to the overload, and not like shown in Figure 4 (below). If you have installed a kit with the lower bracket clamp and bolts around both the primary leaf stack and the overload, as shown in Figure 4, contact us at [rrtech@fsip.com](mailto:rrtech@fsip.com) or at 317 818 8600 extension 1 and 1 for warranty, and Firestone will send at no additional charge replacement short bolts and new nuts to clamp onto the overload only.

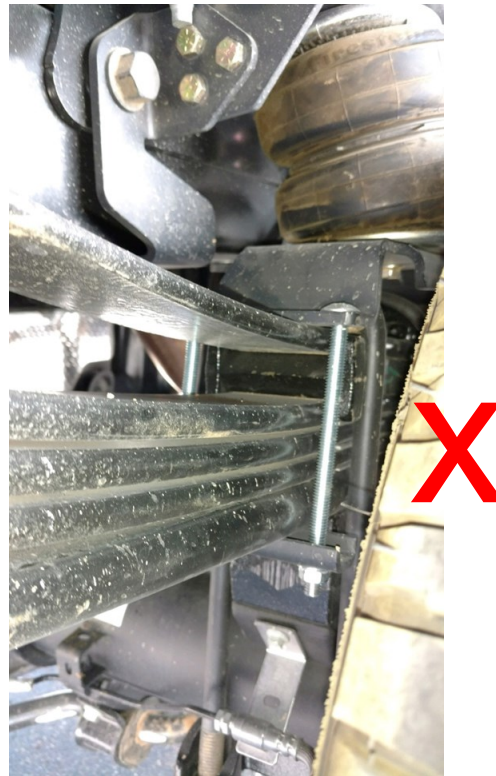
Figure 4, showing incorrect install. The lower clamp should be under the overload (top spring) only, not under the primary leaf stack.
