US 63948656-01

HP Race engine spoiler cracked

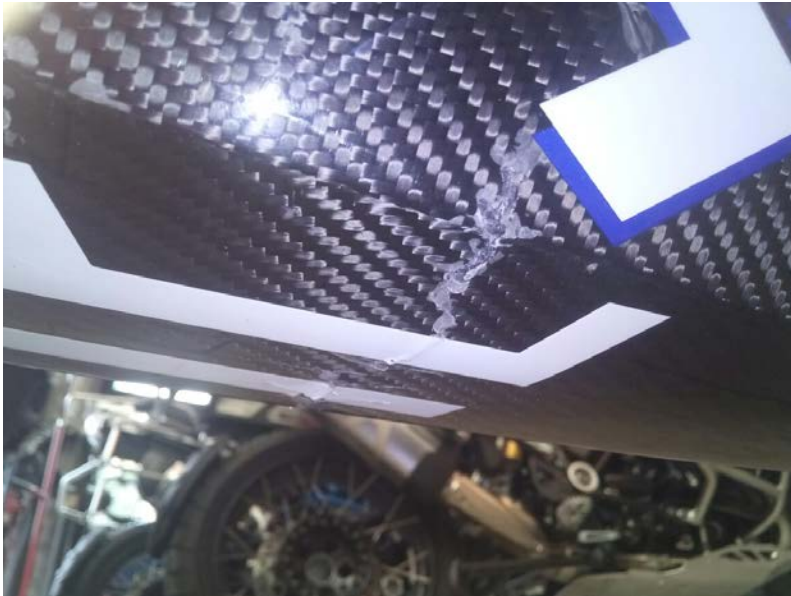
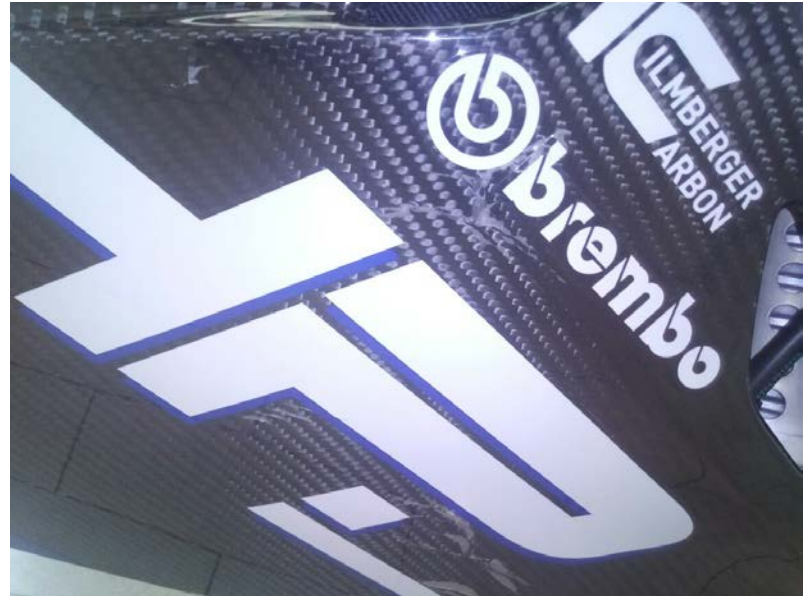
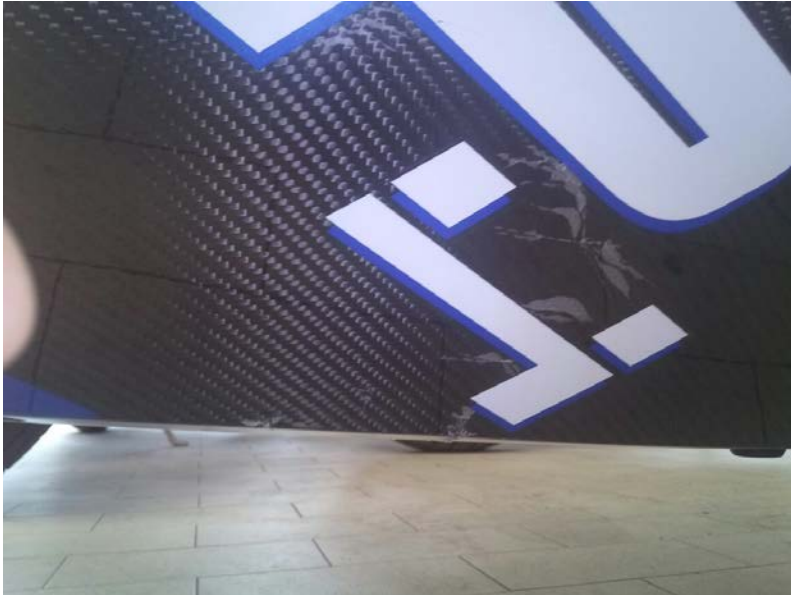
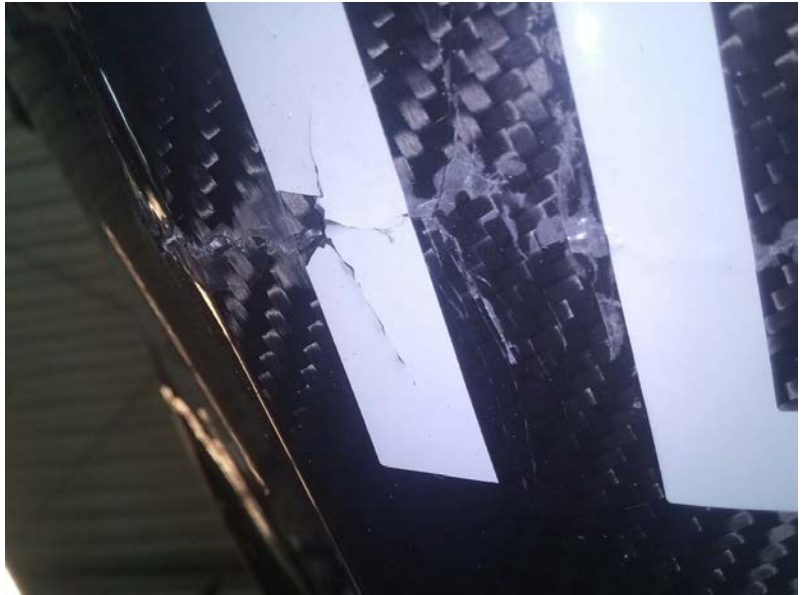
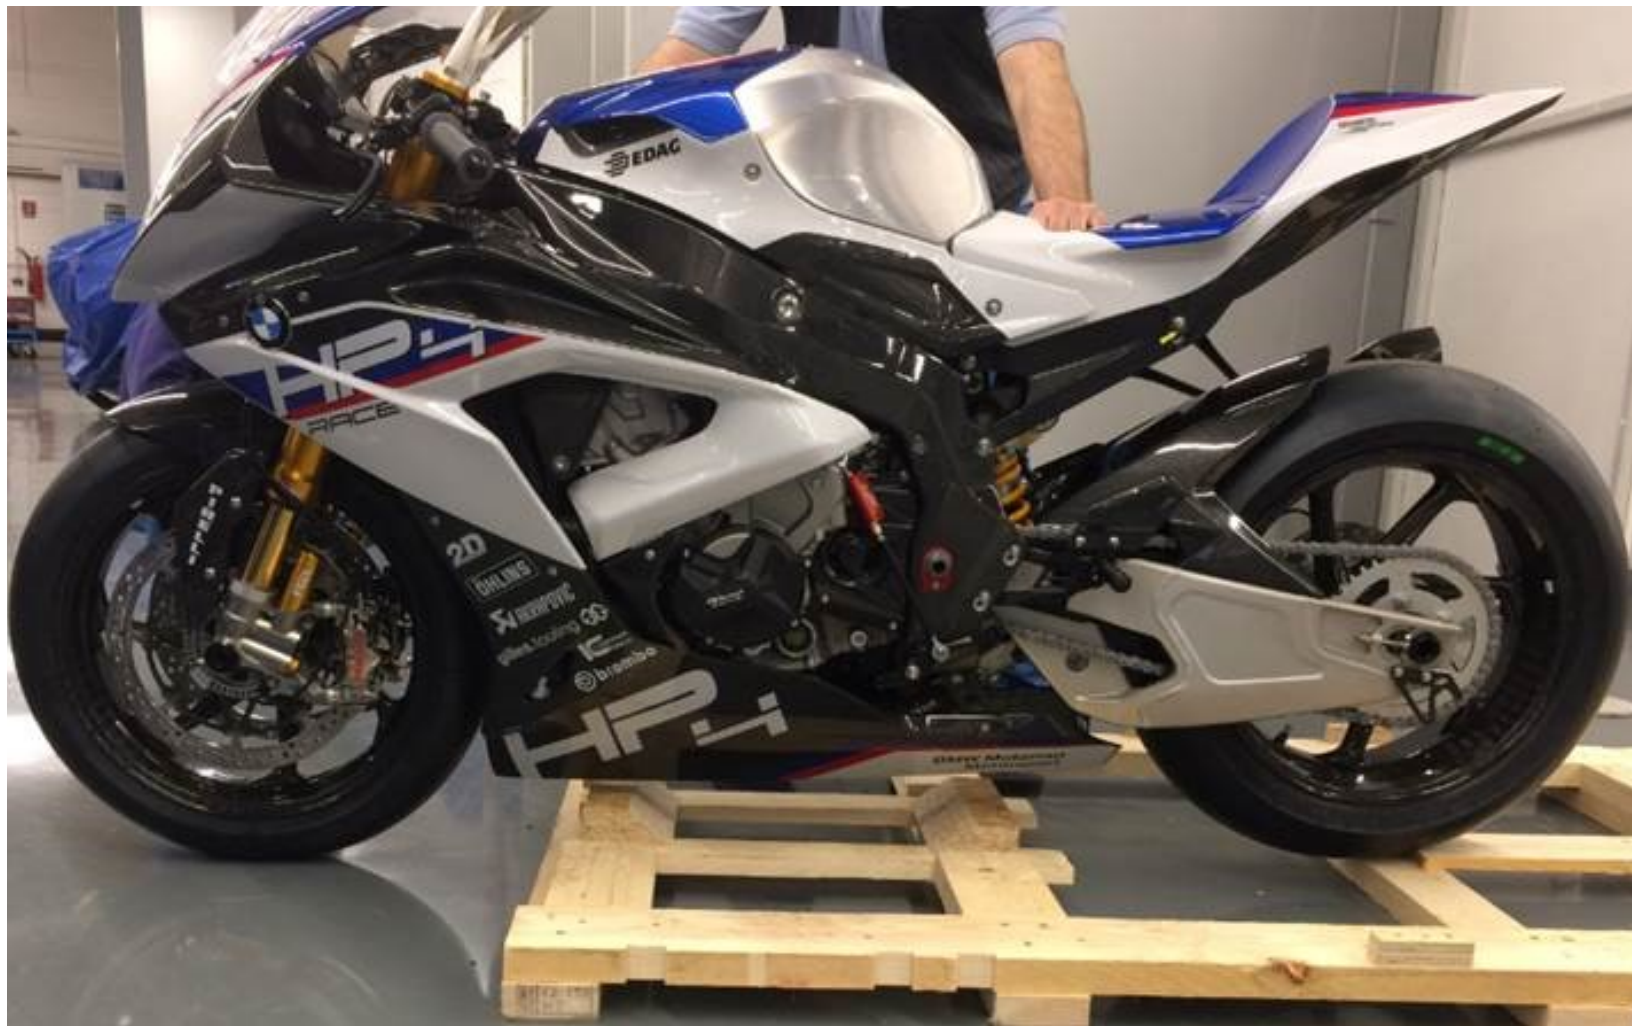
We are getting complaints from some European markets that the HP Race engine spoiler is cracked/broken at the lower edge after unpacking although the packaging is not damaged.

Unlike the usual delivery of a K46 in a reusable frame, the K60 is exclusively delivered WITH the engine spoiler already mounted and also throughout Europe in disposable packaging.

Such damage occurs only if the motorcycle with mounted engine spoiler is pushed forward out of the disposable packaging, see the photo "the moment before". The rear wheel drops/rolls in the recess on the floor and the engine spoiler collides with the front wedge of the packaging.

Please check the condition of the HP Race engine spoiler BEFORE unpacking and sliding off the pallet and document and photograph any existing damage to the engine spoiler.

Please inform the employees in the retail outlets that the HP4 Race must not be rolled forward out of the packaging or not before placing something in the recess.

With immediate effect, after rechecking the motorcycle on the pallet, a warning that the motorcycle must only be rolled backwards out of the packaging is affixed in the factory.
