SS 1033047 M2 Battery Drain Problem – Mismatched INDICATOR and SENSE Circuits

- Business Class M2 Chassis circa 2015 build date
- Cascadia and New Cascadia

CASE STUDY: With Delco Remy 36SI Alternator and ring-terminal style connectors

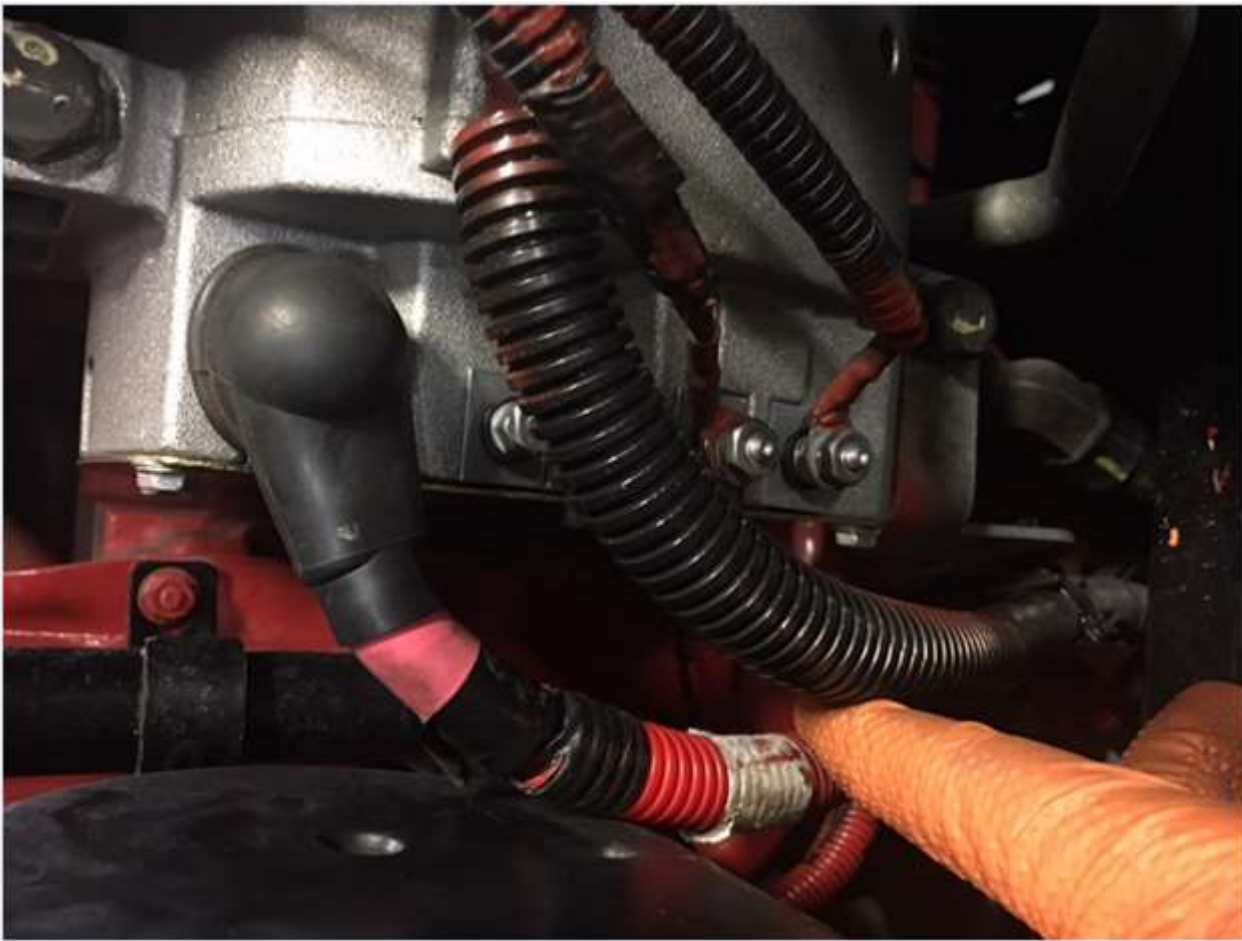
2015 M2106 built w/DR36SI alternator

How the unit was found:

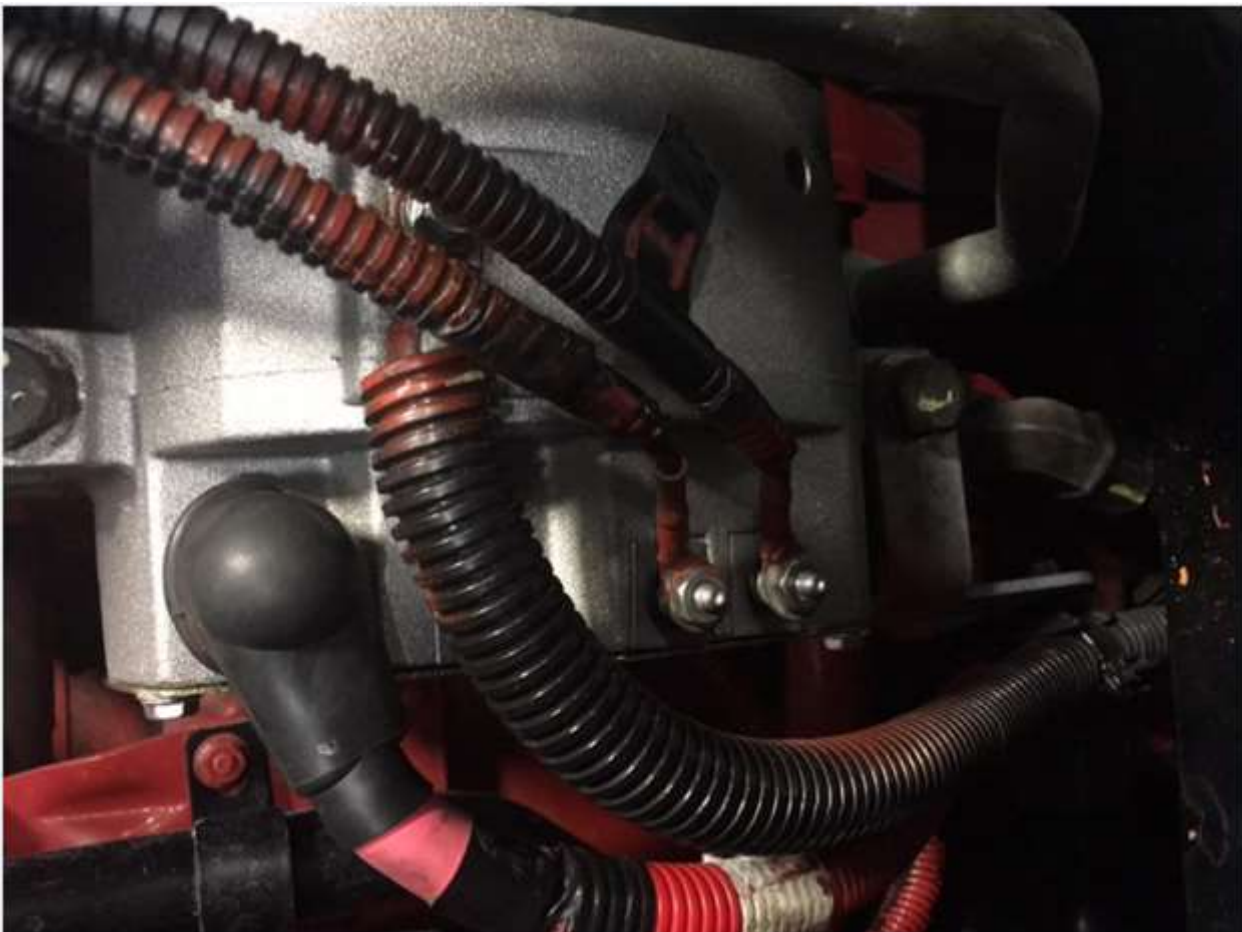
After it's been verified with continuity check of the INDICATOR (notice we marked the INDICATOR circuit with a piece of tape and "I" marked on the tape):

- Measure truck voltage at idle
 - Should get 14.2 volts roughly @ idle and no excessive loads
 - If deviation of 14.6 volts and higher, then possible INDICATOR and SENSE are swapped
- Verify the INDICATOR circuit has continuity to the BHM-C2.P by disconnecting the BHM connector and one of the wires on the alternator
- Mark the verified INDICATOR circuit with tape and "I" marked on it
- Install correctly as described in MOD 12C and the installation diagram

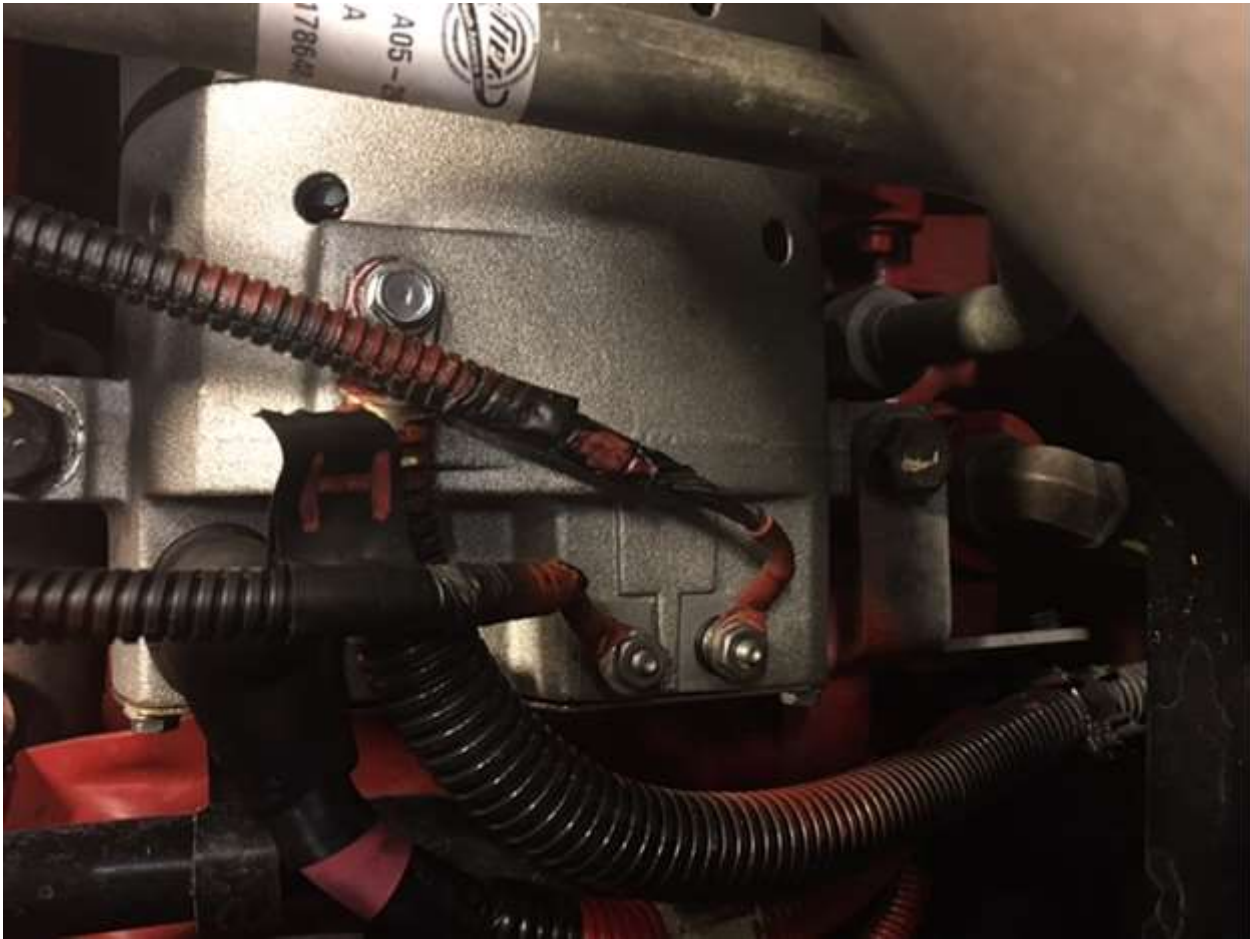
Corrective action applied to the alternator (note the indicator is now on the proper terminal as per drawing):
