NUMBER: 23-049-17

Creaking Noise Coming From Driver's Front Power Seat

2017	(LX)	Chrysler 300
2017	(LD)	Dodge Charger
2017	(LA)	Dodge Challenger

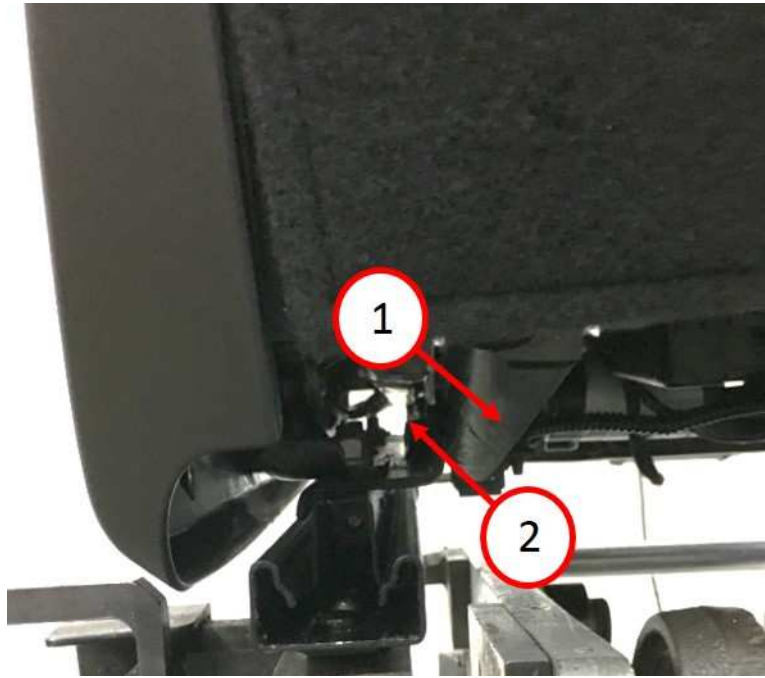
**Fig. 1****Location of Pivot Bracket (View from rear of seat)**

1. Raise the seat to the full-up position and locate the pivot bracket (Fig. 1) .

- 1 - Pivot Bracket
 - 2 - Area of Concern
-

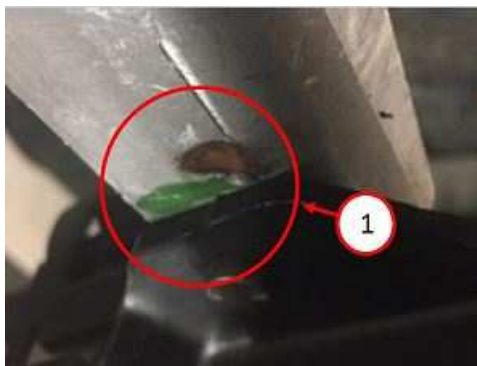
Fig. 2
Rust/Corrosion (Pivot Bracket)

2. Verify rust on the outboard pivot bracket similar to (Fig. 2) and (Fig. 3) .

1 - Example of corroded/rusted pivot bracket (silver) junction.

NOTE: Leave the seat in full-up position for the following steps. Lubricate the rusted/corroded surface on the pivot linkage with MOPAR white spray lube lithium grease (p/n 04318066AE), as shown in (Fig. 4) .

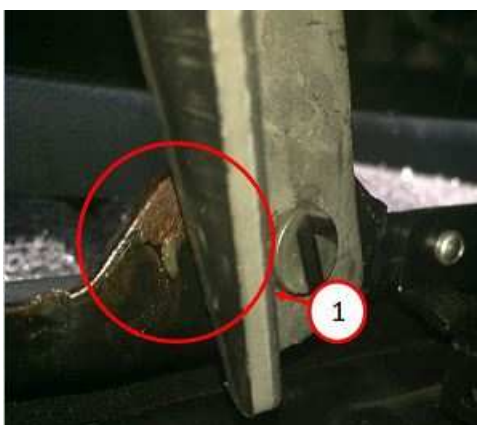
Fig. 3
Rust/Corrosion (Seat Track)

1 - Examples of corroded/rusted seat track.

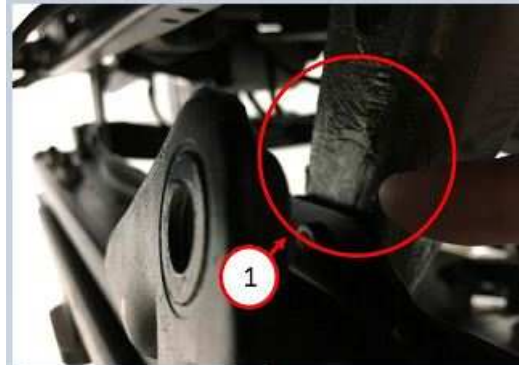
Fig. 4
Lubrication of Pivot Bracket Connection

1 - Pivot Bracket Junction with Grease Applied.
