**NUMBER:** 02-009-17

**GROUP:** 02 - Front Suspension

Creak/Rattle Noise Heard From Front Suspension

2015-2017 (B1) Jeep Renegade (Brazil)

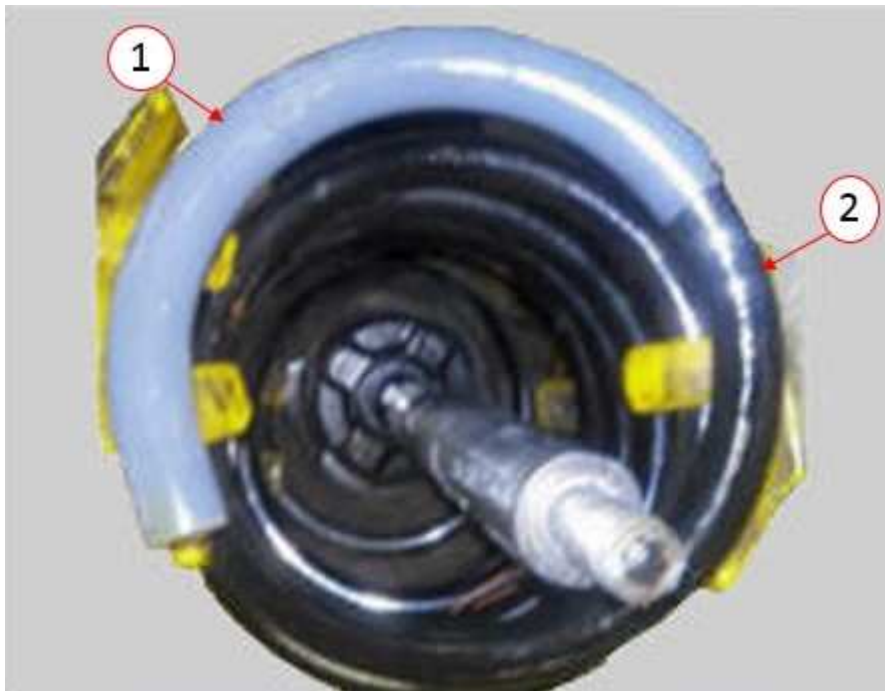
**Fig. 1**  
**Sleeve Position on Front Coil Spring**

6. Install the sleeve on the upper coil link of the both coil springs, with the help of neutral soap, until the sleeve edge be flush with coil spring edge (Fig. 1) .

**NOTE: Ensure the length of the sleeve is 270 mm (10.6 in).**

- 1 - Sleeve  
2 - Coil Spring
