NUMBER: 23-048-17

Instrument Panel Center Storage Drawer Binding

This bulletin involves removing the felt tape from the center storage drawer to prevent binding.

Chrysler Pacifica

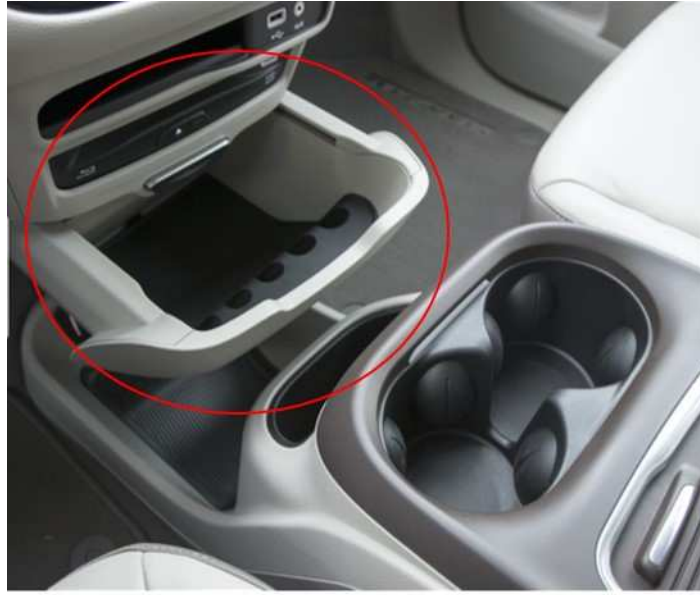
Fig. 1
Center Storage Drawer

Customers may experience the center storage drawer in the lower instrument panel binding when opening or closing the drawer.

This condition is caused from the felt tape that is installed on the pivot latch for the center storage drawer.

1. Remove the center storage drawer (Fig. 1) . Refer to the detailed service procedures available in DealerCONNECT> TechCONNECT under: 23 - Body/Instrument Panel/Bin, Instrument Panel/ Removal.

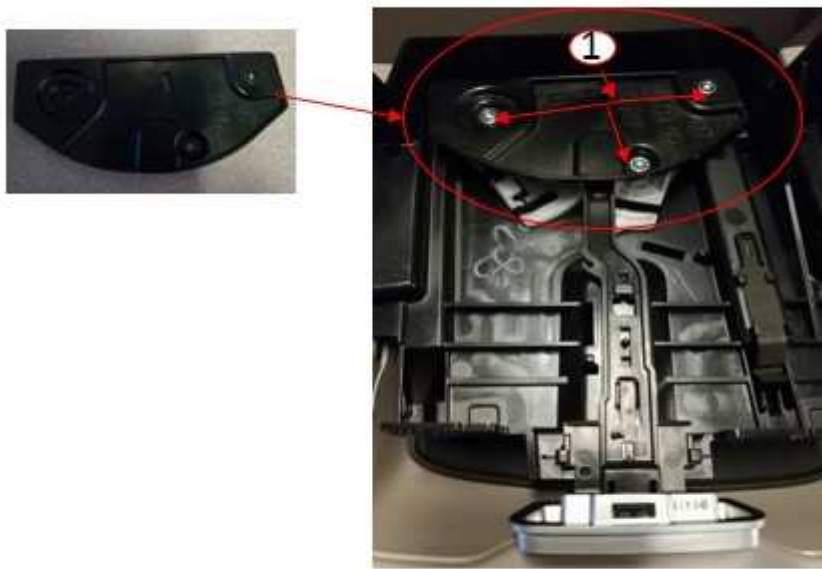
Fig. 2
Cover Plate

1 - T20 Torx Screws

2. Remove the screws that retain the latch cover plate (Fig. 2) .

3. Storage drawer must be in the full open position for reassembly.
 - a. Install the latch on the pivot (Fig. 6) .
 - b. Install the compression spring (Fig. 5) .
 - c. Install the striker plate (Fig. 4) .
 - d. Install the torsion spring (Fig. 3) .
 - e. Install the center storage drawer latch cover plate and tighten the screws (Fig. 2) .
4. Install the center storage drawer (Fig. 1) . Refer to the detailed service procedures available in DealerCONNECT> TechCONNECT under: 23 - Body/Instrument Panel/Bin, Instrument Panel/ Installation.

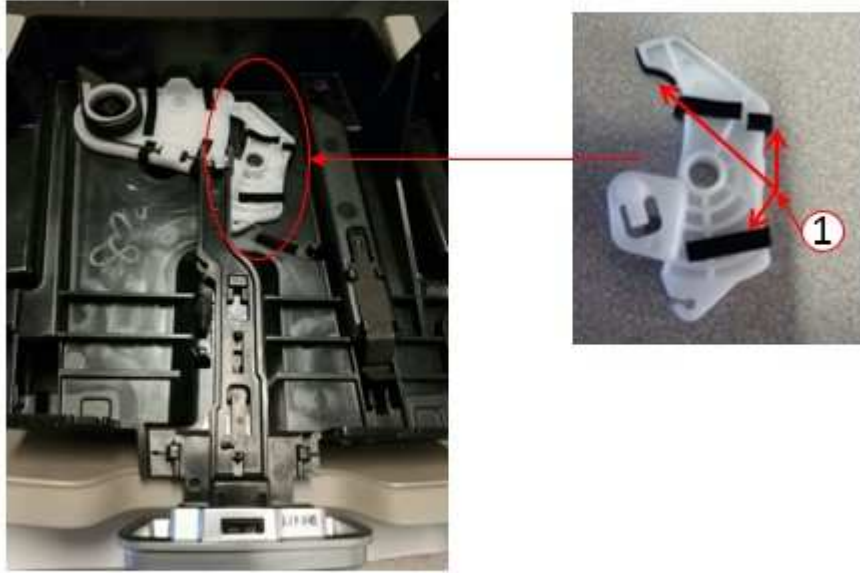
Fig. 6
Latch Pivot

1 - Felt Tape

- d. Lift the latch off of the pivot and remove the three pieces of felt tape (Fig. 6) .
