Dealer Service Instructions for:

Customer Satisfaction Notification T13 Manual Transmission Shift Lever

Models

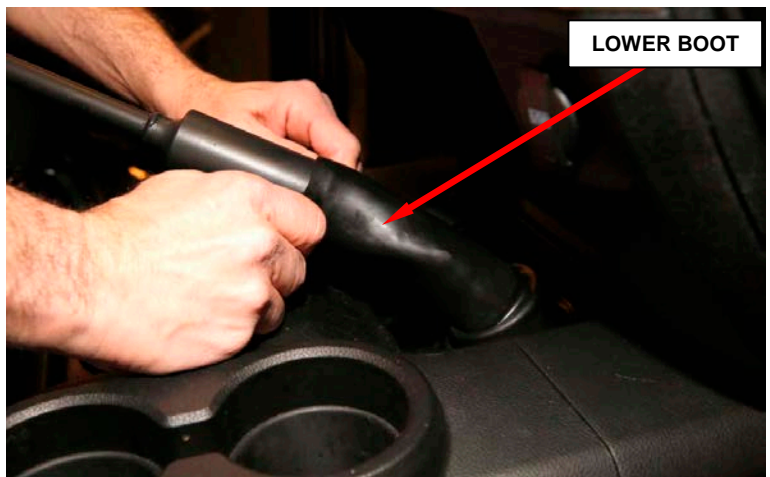
Figure 5 – Lower Shifter Boot

6. Grasp the lower boot sides and peel the lower boot in a downward direction to expose the gearshift attachment nuts (Figure 5).
7. Remove and discard the two gearshift lever nuts and gearshift lever.

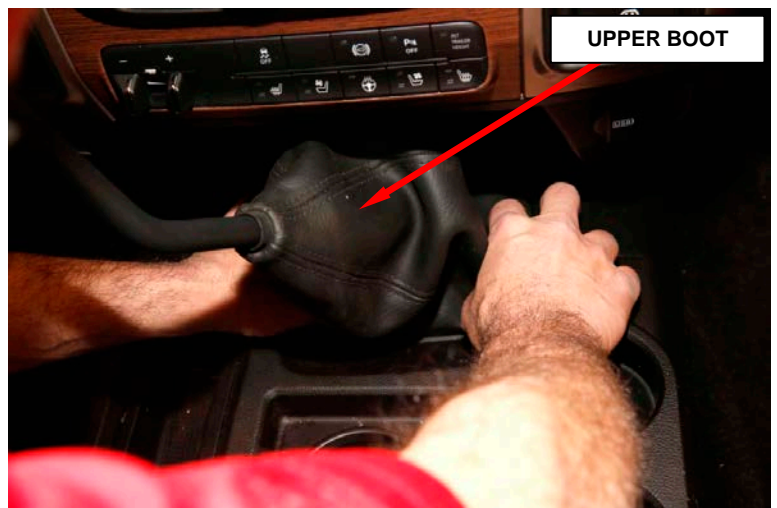
Figure 8 – Upper Shifter Boot

11. Install the gearshift lever upper boot onto the gearshift lever and push on the base of the boot downward to engage the clips to the center console housing (Figure 8).
