NUMBER: 02-004-17

GROUP: Front Suspension

Rattle Noise Heard From Front Suspension

Chrysler Pacifica

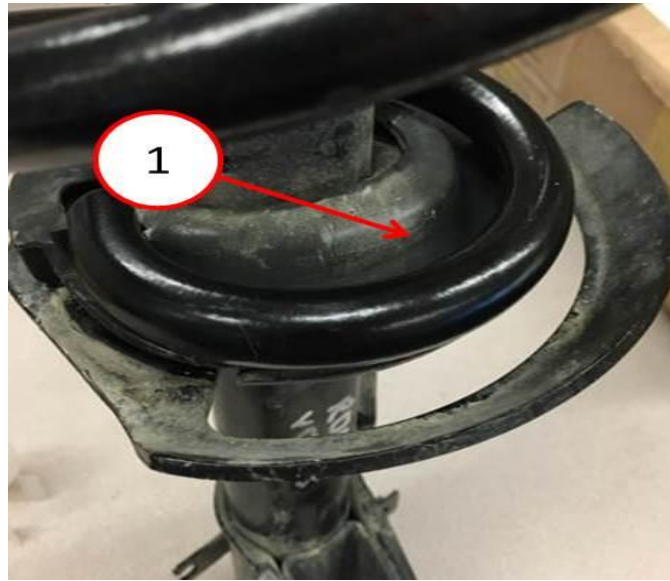
Fig. 1 Incorrect Assembly

3. Inspect the front struts to see if the coil spring is rubbing on the strut tube. Refer to (Fig. 1) and (Fig. 2) for examples of improper spring/strut assembly.

1 - Excessive Gap Between Insulator And Coil Spring.

1. Remove the front strut assemblies from the vehicle. Refer to the detailed repair procedures available in: DealerCONNECT> TechCONNECT under: Service Info> 02 - Front Suspension/Front/Strut, Suspension, Assembly/Removal.
2. Disassemble the front struts. Refer to the detailed repair procedures available in: DealerCONNECT> TechCONNECT under: Service Info> 02 - Front Suspension/Front/Strut, Suspension, Assembly/Disassembly.

NOTE: The lower spring isolator may need to be replaced if it is worn or out of shape.

3. Assemble the front strut. Refer to the detailed repair procedures available in: DealerCONNECT> TechCONNECT under: Service Info> 02 - Front Suspension> Front> Strut, Suspension, Assembly.
4. Install the front strut assemblies to the vehicle. Refer to the detailed repair procedures available in: DealerCONNECT> TechCONNECT under: Service Info> 02 - Front Suspension/Front/Strut, Suspension, Assembly/Installation.
5. Reset the vehicle toe setting to specifications. Refer to the detailed repair procedures available in: DealerCONNECT> TechCONNECT under: Service Info> 02 - Front Suspension/Wheel Alignment/Standard Procedure.

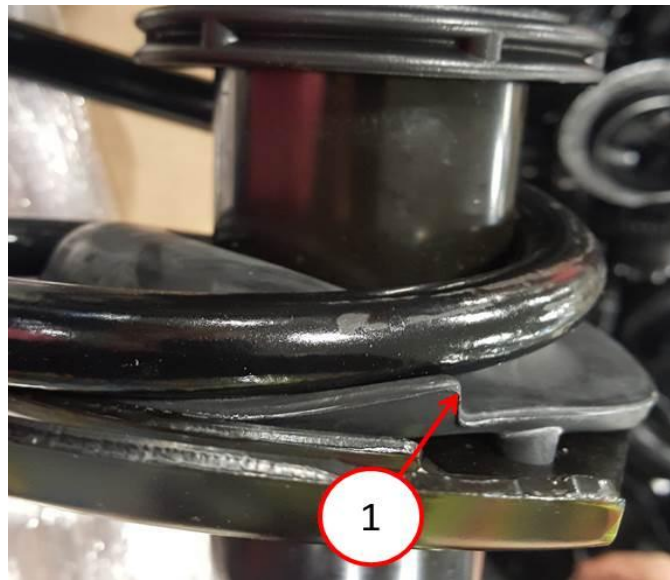
Fig. 2 Incorrect Spring Seating

1 - Incorrect Coil Spring Seating On Insulator.

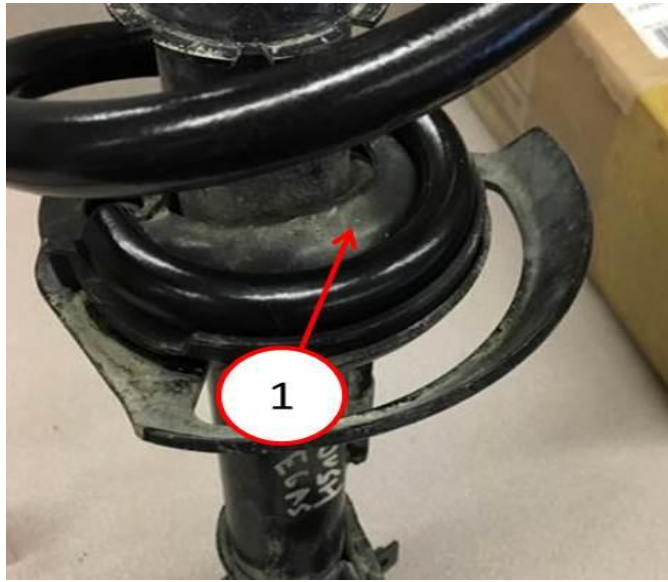
Fig. 3 Correct Assembly

A correct spring/strut assembly is shown in (Fig. 3).

1 - Correct Seating Of Coil Spring To The Insulator.

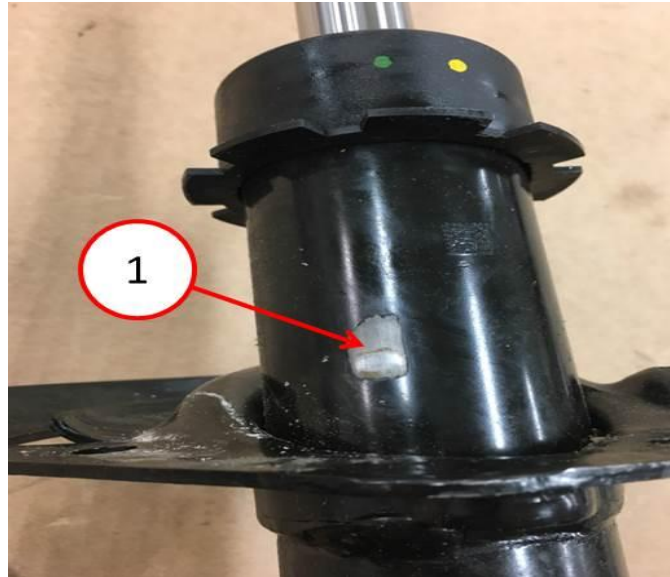
Fig. 4 Witness Mark

NOTE: Only perform the repair on the strut that shows a witness mark.

4. Is the spring contacting the strut tube or is there presence of a “witness mark” as seen in (Fig. 4)?
 - a. Yes>>> Continue with the Repair Procedure [Step #1](#).
 - b. No>>> This Bulletin does not apply. Normal diagnostic should be performed.

1 - Witness Mark.
