NUMBER: 02-006-17

GROUP: 02 - Front
Suspension

Clunking or Popping Noise While Going Over Bumps

2016	(RT)	Chrysler Town & Country
2016 - 2017	(RT)	Dodge Caravan
2017	(RU)	Chrysler Pacifica

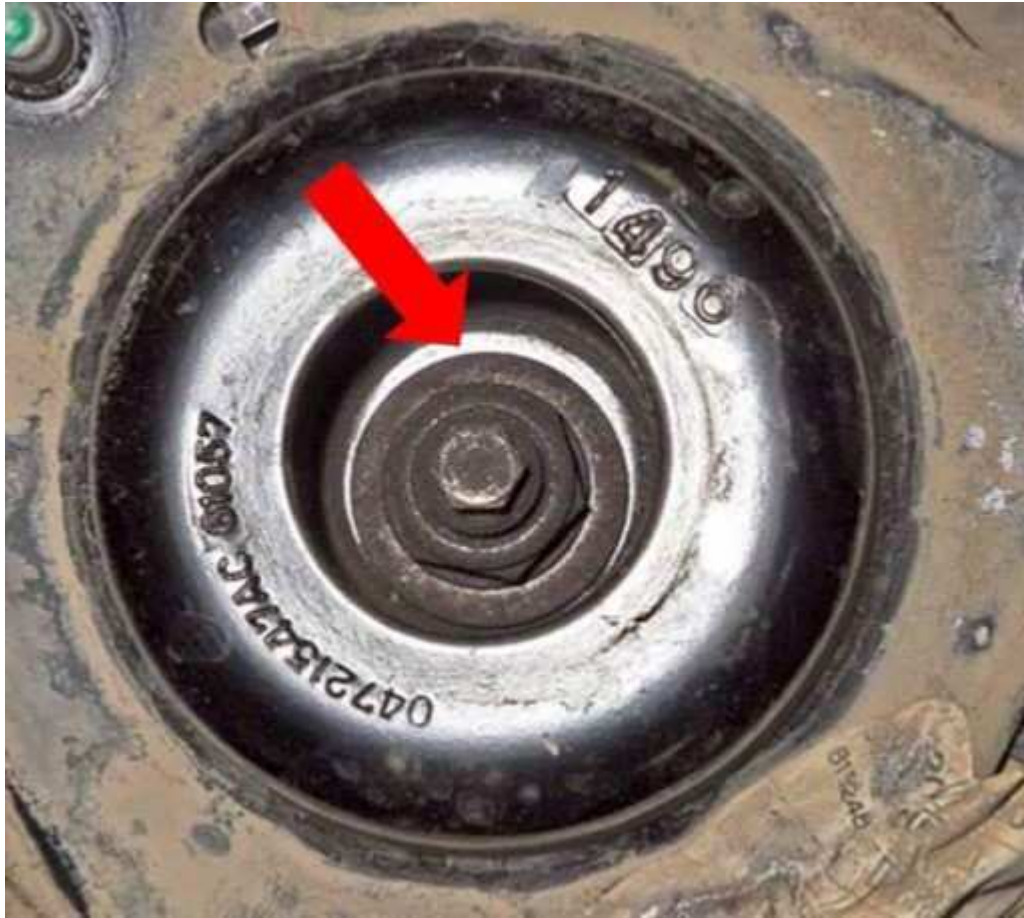
Fig. 1

2. Inspect the top of the mounts for a shiny metallic surface. Can a shiny metallic surface be seen on either upper strut mount (Fig. 1) ?
 - a. YES >>> Proceed to the Step 3.
 - b. NO >>> This bulletin does not apply. Further diagnosis should be performed.

Upper Mount Cap Removed Showing Shiny Surface - Replace Mount

1. Replace one or both upper strut mounts, fasteners and re-assemble one or both struts.
2. Install the strut assemblies:
 - For **RT vehicles** refer to the detailed service procedures available in DealerCONNECT> TechCONNECT under: Service Info>02 - Front Suspension/Front/Strut, Suspension, Assembly/Installation. This bulletin has been completed.
 - For **RU vehicles** refer to the detailed service procedures available in DealerCONNECT> TechCONNECT under: Service Info>02 - Front Suspension/Front/Strut, Suspension, Assembly/Installation. This bulletin has been completed.

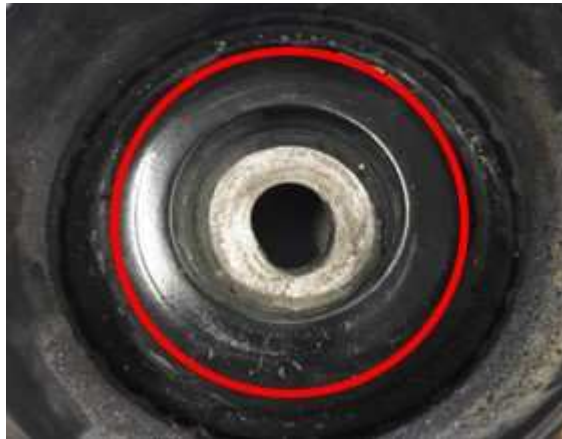
4. Inspect the upper strut mount(s) for damage. Was damage found on the upper mount (Fig. 2) or (Fig. 3) ?
 - a. YES >>> Proceed to [Step 5](#).
 - b. NO >>> This bulletin does not apply. Further diagnosis should be performed.

Fig. 2
Top Mount Hole Is Oval Shape Damage

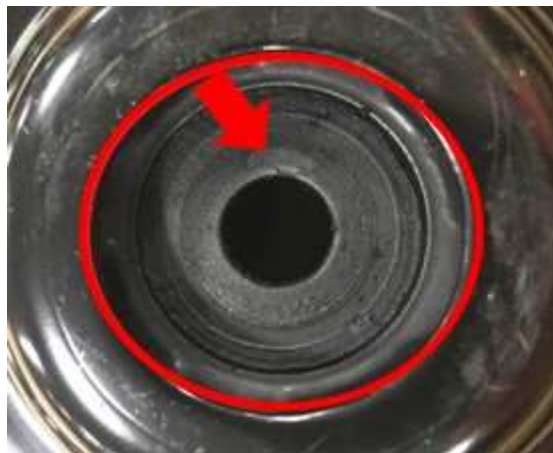
Fig. 3
Rubber Coating On Mount Damaged

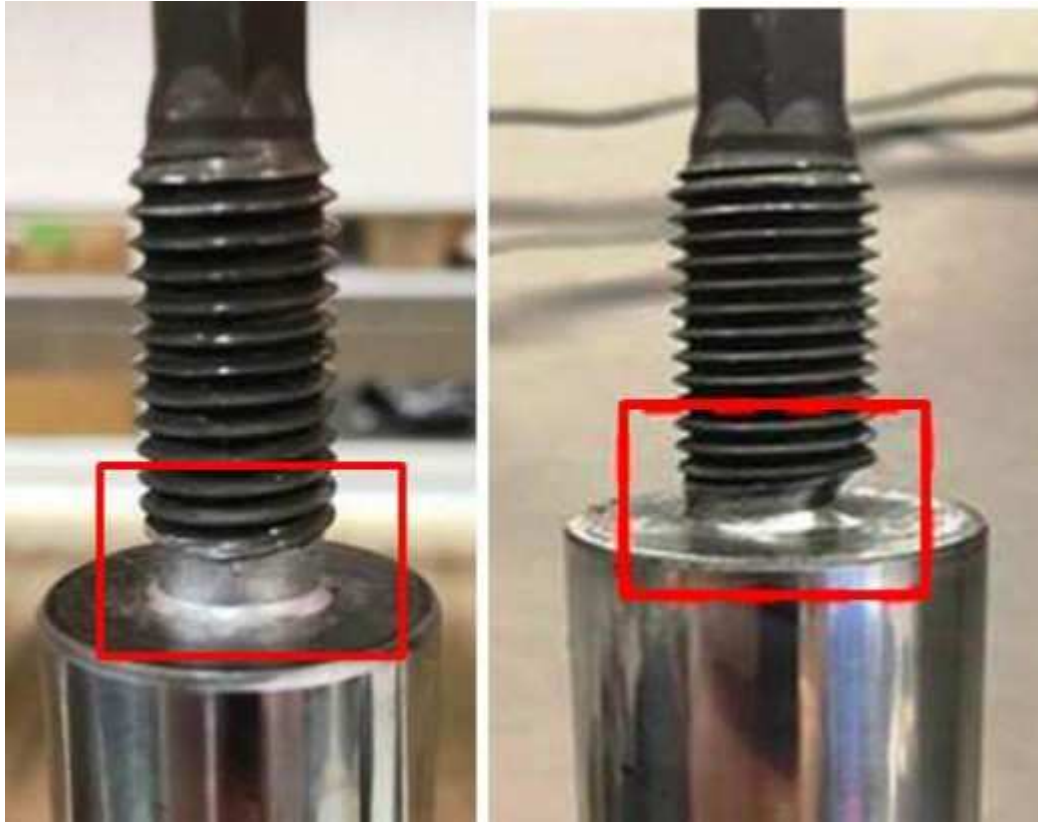
- 5. Inspect strut stem(s) for damage. Was damage found on the strut stem(s) (Fig. 4) ?
 - a. YES >>> Continue to the Repair Procedure [Step 3](#).
 - b. NO >>> Continue to the Repair Procedure [Step 1](#).

Fig. 4
Strut Stem Damage - Replace Strut

3. Replace one or both strut assemblies and mounts:
 - For **RT vehicles** refer to the detailed service procedures available in DealerCONNECT> TechCONNECT under: Service Info>02 - Front Suspension/Front/Strut, Suspension, Assembly/Installation. This bulletin has been completed.
 - For **RU vehicles** refer to the detailed service procedures available in DealerCONNECT> TechCONNECT under: Service Info>02 - Front Suspension/Front/Strut, Suspension, Assembly/Installation. This bulletin has been completed.

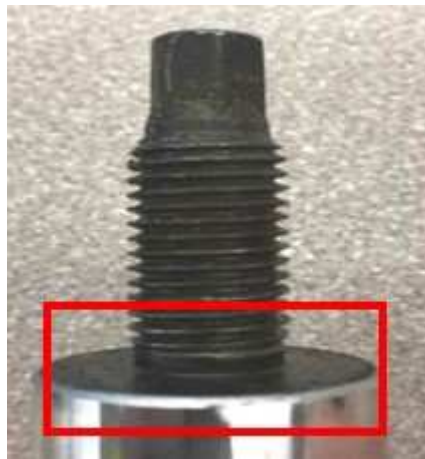
Fig. 5
No Damage To Strut – Do Not Replace Strut
