**NUMBER:** 08-059-17

Door Ajar Warning Light Always Stays Illuminated

This bulletin involves aligning the sliding door switch contact button on either sliding door.

2014 - 2017 (VF) RAM ProMaster

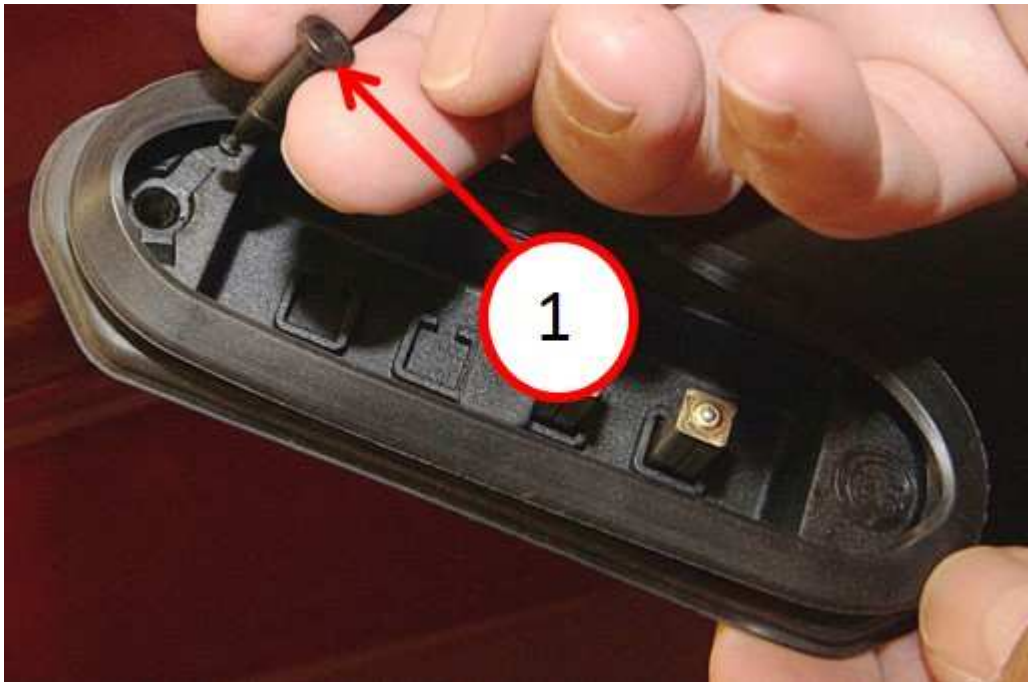
Fig. 1  
Push Pin And Contact Switch Board

Remove the plastic push pin from the door and contact switch board (Fig. 1) .

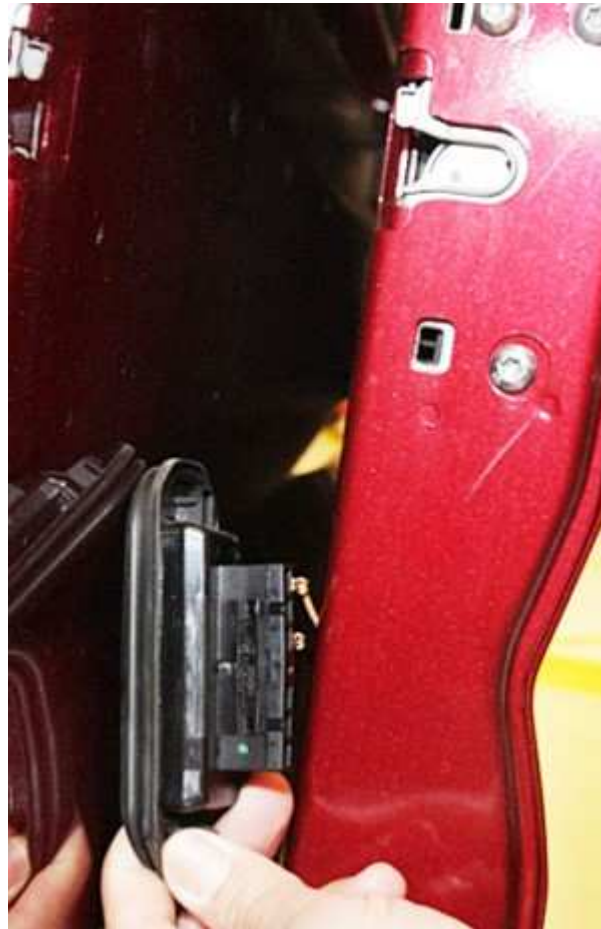
**Fig. 2**  
**Contact Switch Board**

3. Remove the contact switch board from the sliding door (Fig. 2) .

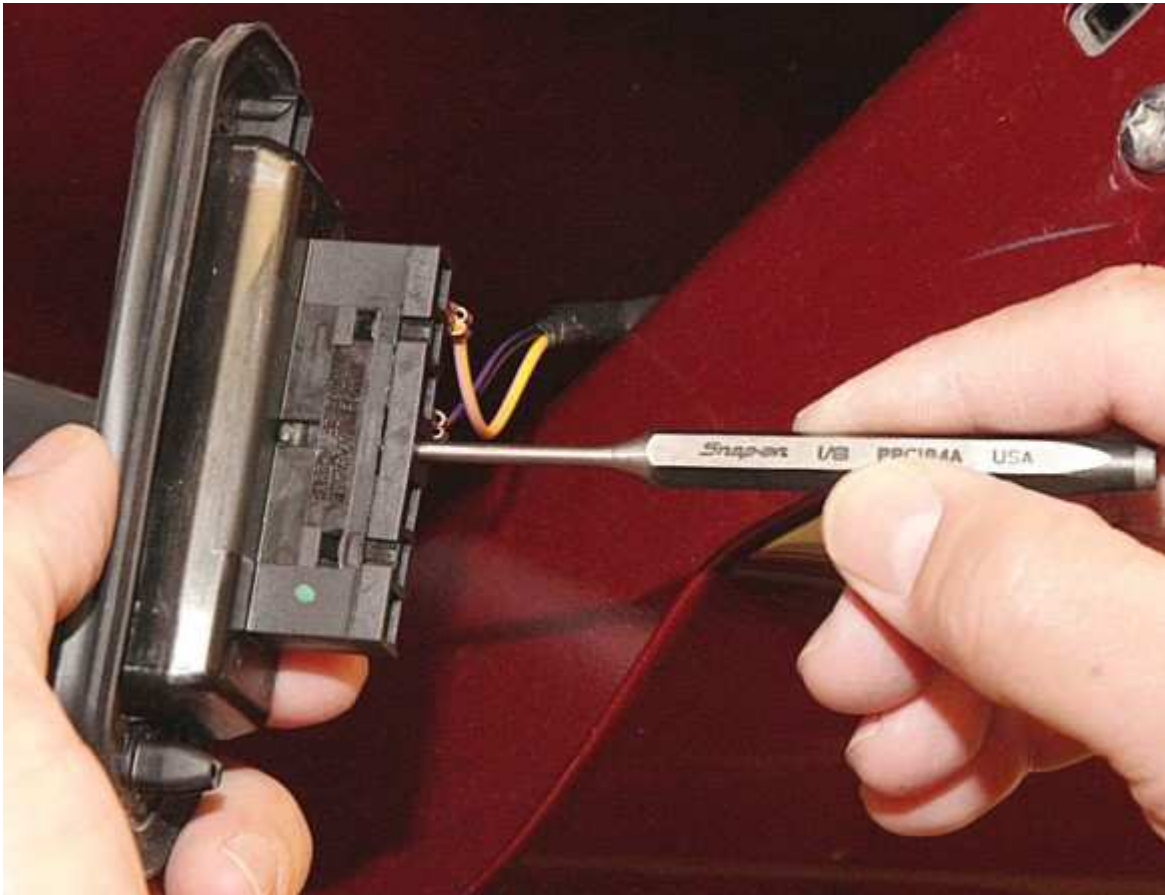
**Fig. 3**  
**Punch Pushing Back Of Button**

Using a 3.17 mm (1/8") punch or equivalent tool, push the back of the contact board button through the hole on the contact switch, outward (Fig. 3) and fully remove the contact board button from the contact board (Fig. 4) .

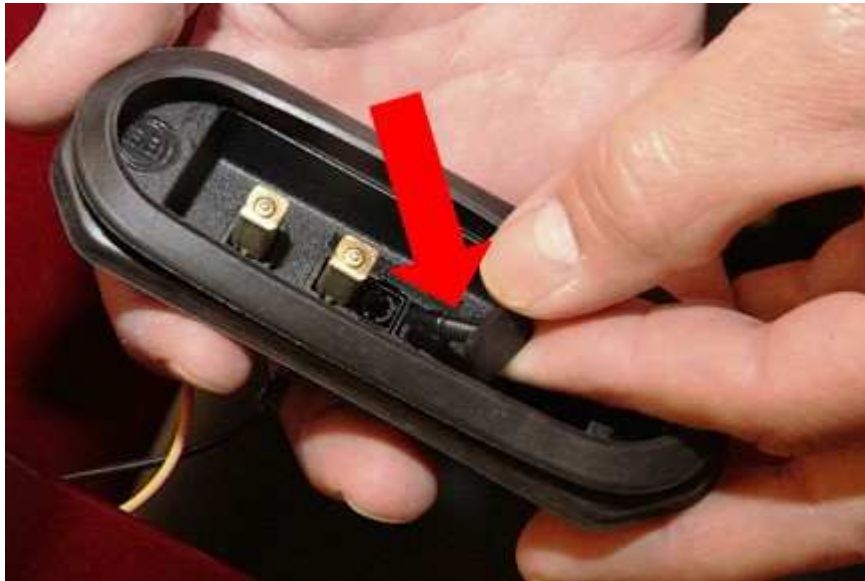
**Fig. 4**  
**Contact Board Button**

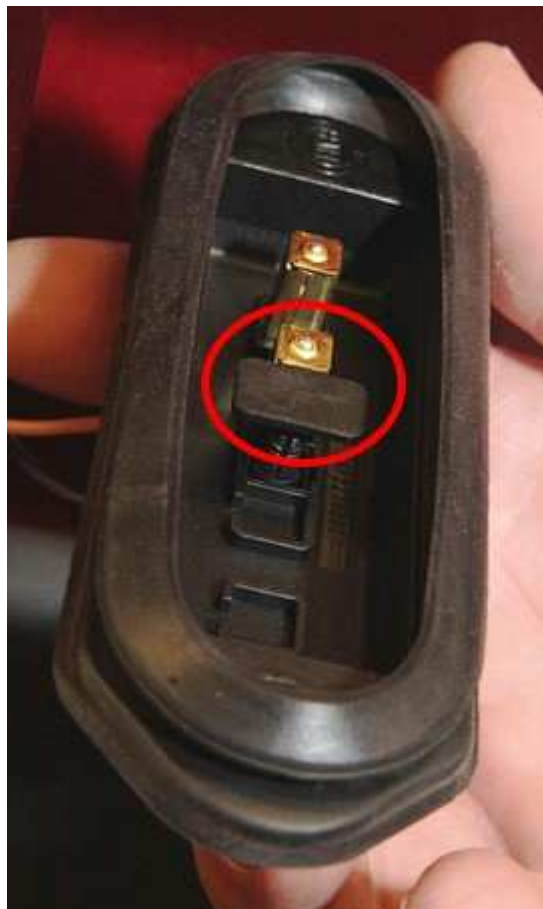
**Fig. 5**  
**Contact Board Button Installed**

5. Install the contact board button by pushing the button into the contact board hole until one click is heard and contact button is level with the metal contact button above it (Fig. 5) . Do not push the contact button further into the contact board.
