NUMBER: 21-038-17

Tighten Transmission Extension Housing Bolts

This bulletin involves tightening the fasteners extension housing bolts to proper torque.

2017	(DS)	RAM 1500 Pickup
2017	(DX)	RAM Truck (Mexico)

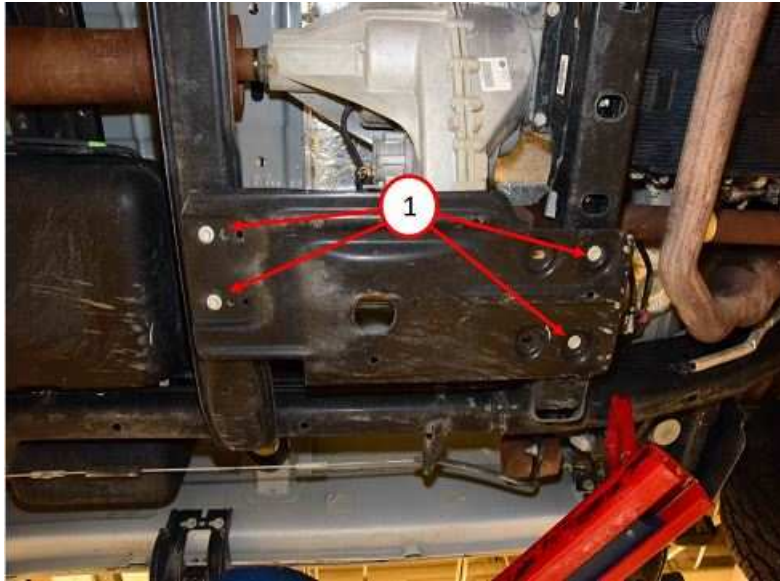
Fig. 1
Transfer Case Skid Plate

1 - Transfer Case Skid Plate Bolts

- Remove bolts (Fig. 1) and remove transfer case skid plate (if equipped). Refer to the detailed service procedures available in DealerCONNECT> TechCONNECT under: Service Info>13 - Frame and Bumpers/Under Body Protection/Plate, Skid, Transfer Case/Removal

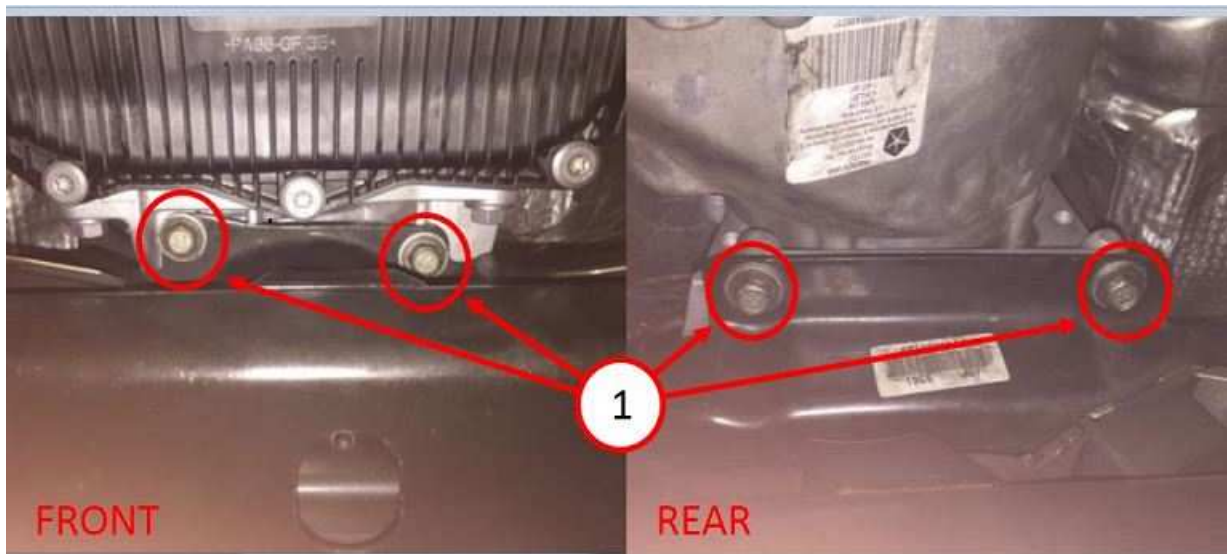
Fig. 2
Transmission Mount Bolt Locations

1 - Transmission Mount Bolts

- Remove the four bolts securing the transmission mount to transmission (Fig. 2) .

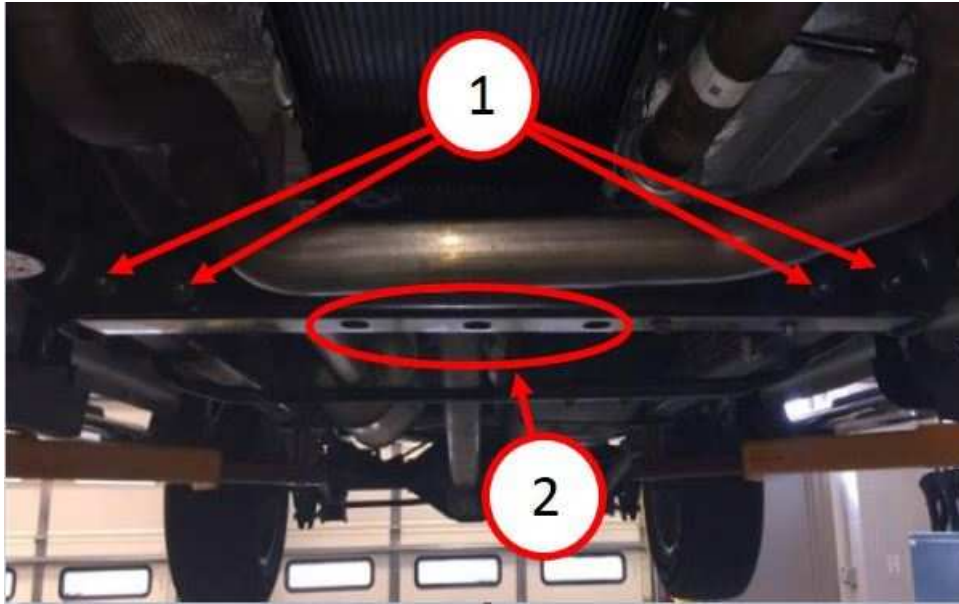
Fig. 3

Transmission Mount Nut Locations

- 1 - Crossmember Nuts and Bolts
2 - Transmission Mount Nut Access Holes

4. Loosen the three nuts securing the transmission mount to the cross member (Fig. 3) . Place screw-jack under transfer case to support driveline. Remove the four nuts and bolts (Fig. 4) attaching the crossmember to frame and remove the crossmember.

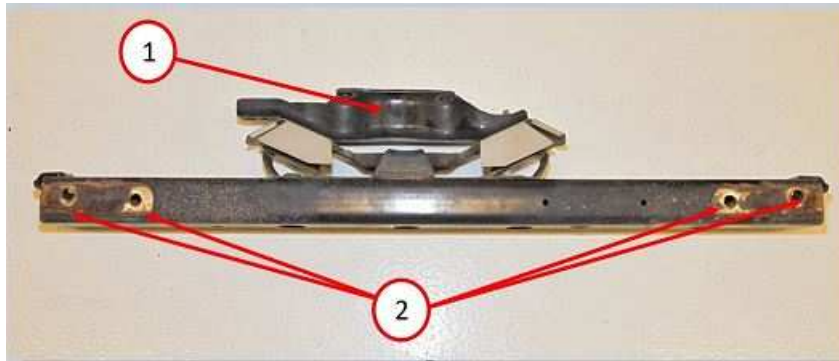
Fig. 4

Transmission Mount and Crossmember

- 1 - Transmission Mount
2 - Crossmember Bolt Holes

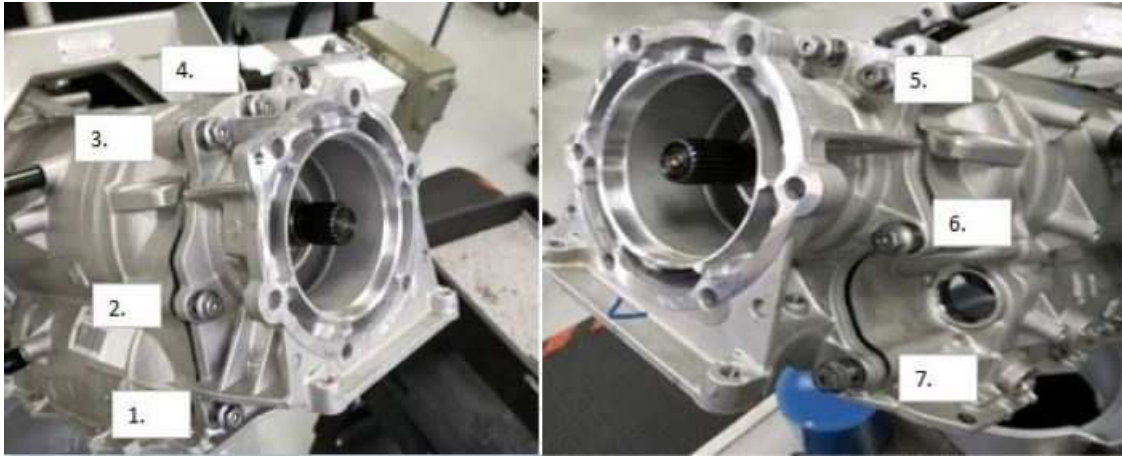
Fig. 5

Location of the Transmission Extension Housing Bolts (Illustration shown for bolt location only)

5. Start with the bottom two bolts. Tighten extension housing bolts to 55 N·m (41 ft. lbs.) (Fig. 5) .

6. Use screw-jack to lower driveline so that you can access the top bolts, tighten all five remaining extension housing bolts to 55 N·m (41 ft. lbs.).
