NUMBER: 24-003-17

HVAC Condenser Damage

This bulletin involves Inspecting the A/C condenser for damage and leaks.

Chrysler Pacifica

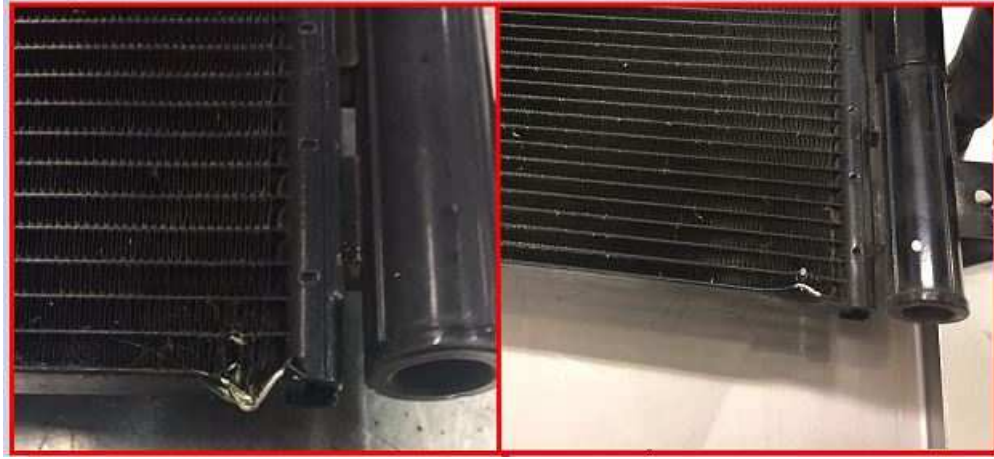
Customers may experience the air conditioning system blowing warm air. Two close-out panel/front belly pan fasteners may have contacted the A/C condenser.

Fig. 1
A/C Condenser Damage

1. Remove the A/C condenser. Refer to the detailed service procedures available in DealerCONNECT> TechCONNECT under: Service Info> 24 - Heating and Air Conditioning/ Plumbing> Front/Condenser> A/C/Removal.
2. Install the A/C condenser. Refer to the detailed service procedures available in DealerCONNECT> TechCONNECT under: Service Info> 24 - Heating and Air Conditioning/ Plumbing> Front/Condenser> A/C/Installation.
3. Discard the two front belly pan/close-out panel bolts shown in (Fig. 2) .

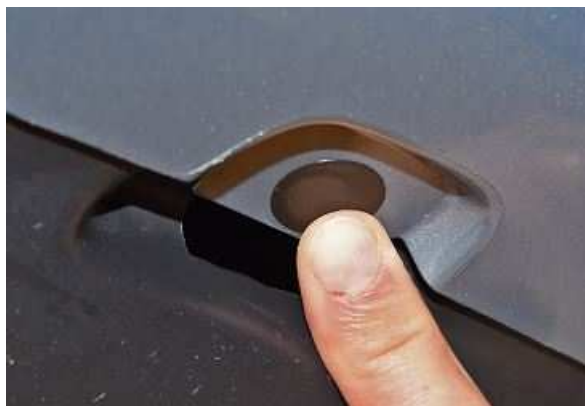
Fig. 3
Black Tape Circle Applied

5. Clean the area around the holes (on the lower front fascia) with isopropyl alcohol.
6. Cover the hole with (P/N 55276821AA) tape circles (Fig. 3) .
