Technical Journal

Front side door, water intrusion

REF NO: TJ 32728.1.0	ISSUING DEPARTMENT: Technical Service	CAR MARKET: United States and Canada	
PARTNER: 3 US 7510 Volvo Car USA		ISSUE DATE: 2017-07-24	STATUS DATE: 2017-08-29
FUNC GROUP: 8414	FUNC DESC: Trim moulding at window	Page 1 of 8

Title	Weatherstrip, door window, front	Page	1 (6)
Action	Product fix	Operation number:	98687-2

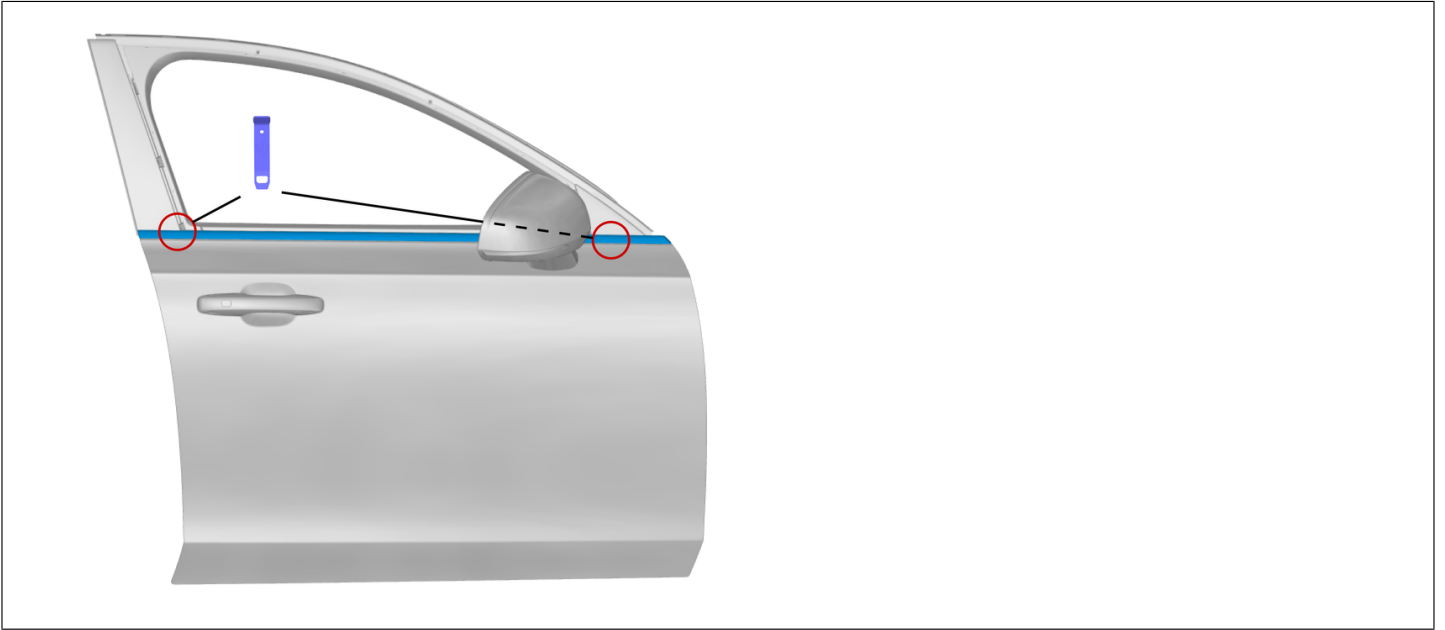
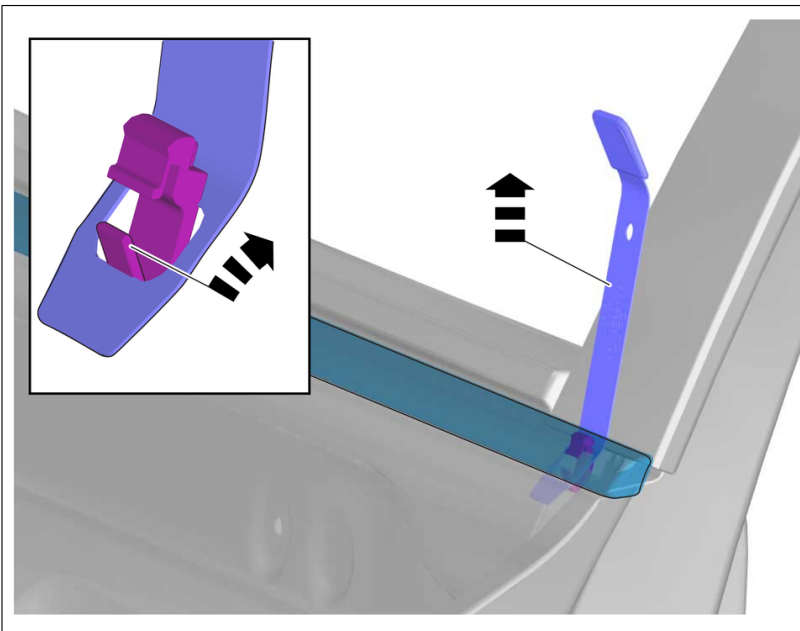
Special Tool: T9997620, Clip tool

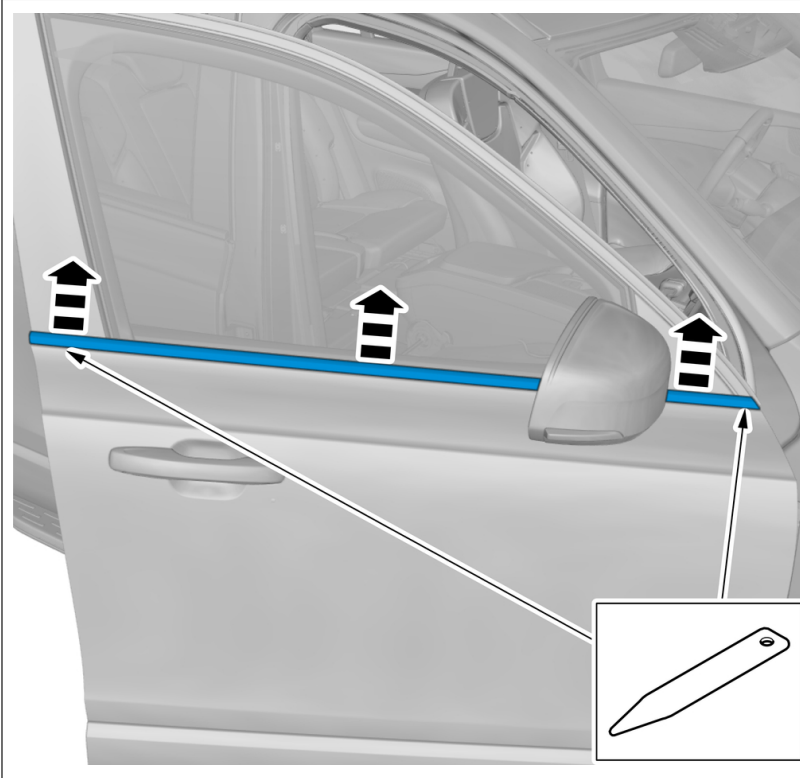
Remove the part carefully

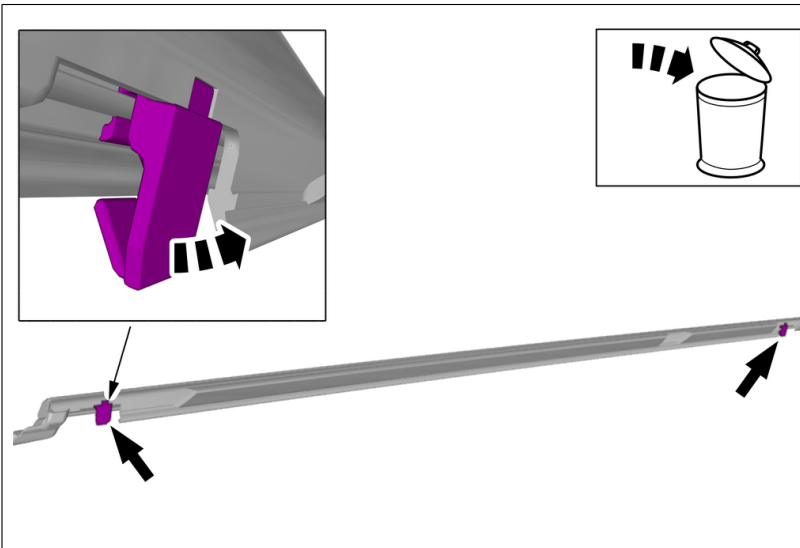
The part is not to be reused.

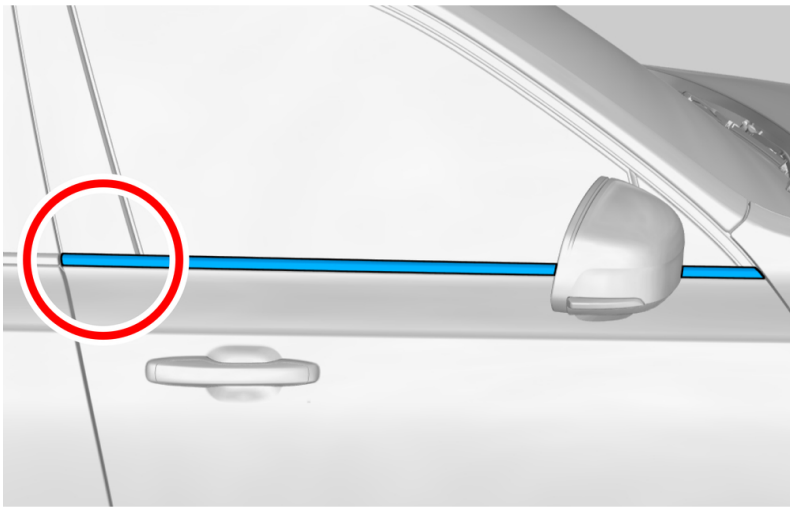
Note! Orientation view

Clean the marked area.

Use: Cleaning agent , 1161721

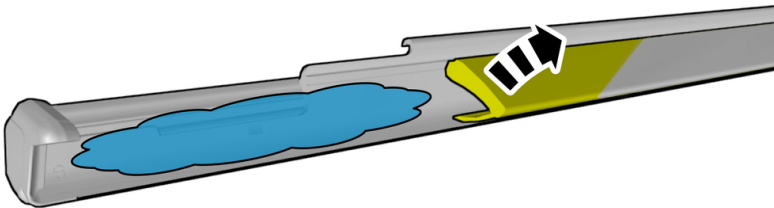
mm

Install tape 31698754.

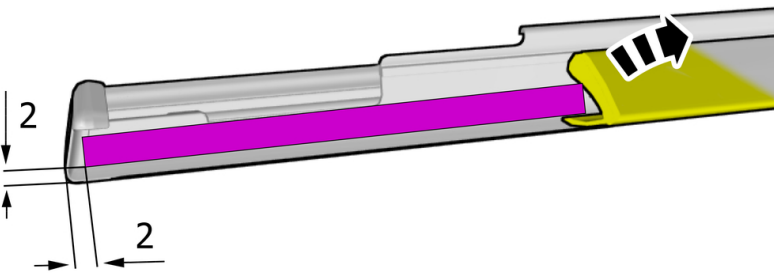
Install the clip(s).
