Campaign No. 2017010005, February 2017

SUBJECT: **Model 447, Model Year 2017**
Replace Front Passenger-side Air Bag

Campaign No. 2017030013, March 2017

SUBJECT: **Model 906, Model Years 2007-2008**
Replace Driver's Side Airbag and Steering Wheel

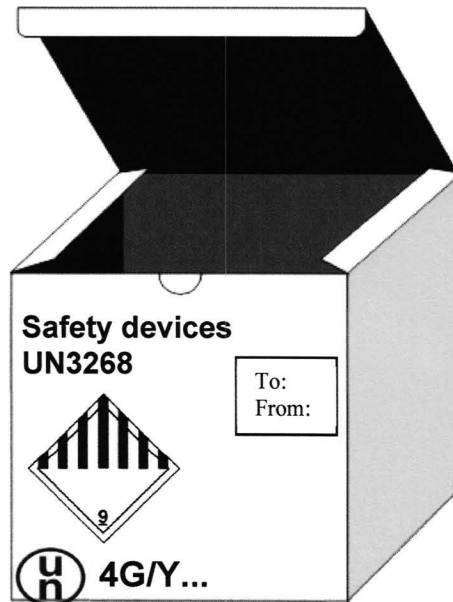
- **Note:** The Packing Group and the EX# are no longer required to be printed on the HAZMAT bill of lading.
- **Package example:**

- Carefully open received box and remove new airbag. Keep box intact & save all contents!
- Place used airbag into replacement airbag box, re-using any packaging material (e.g., cardboard inserts) used for the new airbag. Package as the new airbag was packaged.
- Use plastic adhesive tape 50 mm wide to secure the box closed. Do not obscure labels or text on the box with the tape.
- Ensure that the 4G fiberboard box is not ripped or damaged.

- A **Class 9 Miscellaneous** label must be clearly visible on one side of the box.

- The following words ("marking") must also be clearly visible on the same side of the box as the Class 9 label:
Safety devices
UN3268 (font size must be $\geq \frac{1}{2}$ inch)
- Affix "To/From" address label to same or adjacent packaging face as the hazardous markings/labels.
- The UN 4G code preprinted near the bottom edge of the box must also be clearly visible.

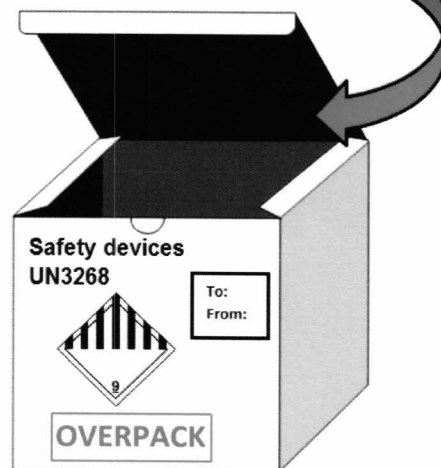
- The OVERPACK must have the identical markings and label as the boxes contained inside.
- The OVERPACK must have the "OVERPACK" statement on the same face as the hazard markings and labels. **Package example:**

- Place each individual airbag box (noted above) inside a larger non-UN spec box to keep shipment together.
- This larger box is called an "OVERPACK."

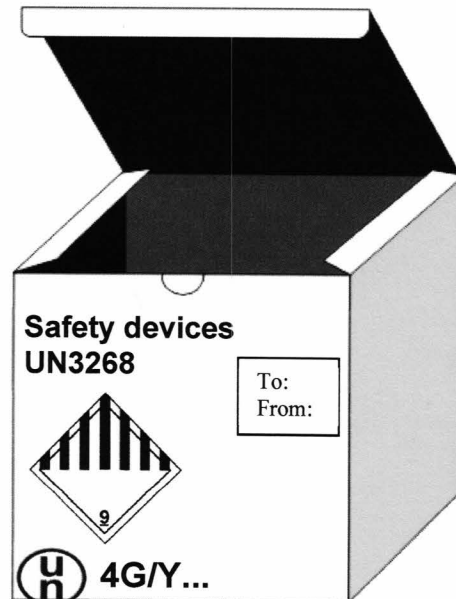
- Note:** The Packing Group and the EX# are no longer required to be printed on the HAZMAT bill of lading.
- Package example:**

- Carefully open received box and remove new airbag. Keep box intact & save all contents!
- Place used airbag into replacement UN specified 4G fiberboard box, re-using any packaging material (e.g., cardboard inserts) used for the new airbag. Package exactly as the new airbag was packaged.
- Use plastic adhesive tape 50 mm wide to secure the box closed. Do not obscure labels or text on the box with the tape.
- Ensure that the 4G fiberboard box is not ripped or damaged.

- The following words ("marking") must also be clearly visible on the same side of the box as the Class 9 label:
Safety devices
UN3268 (font size must be $\geq \frac{1}{2}$ inch)
- Affix "To/From" address label to same or adjacent packaging face as the hazardous markings/labels.
- The UN 4G code preprinted near the bottom edge of the box must also be clearly visible.

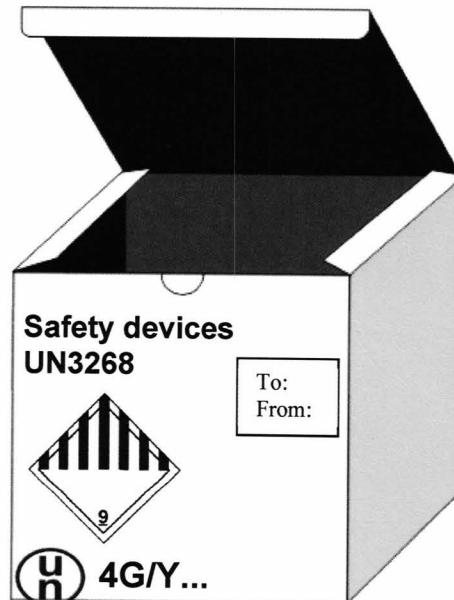
- Note:** The Packing Group and the EX# are no longer required to be printed on the HAZMAT bill of lading.
- Package example:**

- Carefully open received box and remove new airbag. Keep box intact & save all contents!
- Place used airbag into replacement UN specified 4G fiberboard box, re-using any packaging material (e.g., cardboard inserts) used for the new airbag. Package exactly as the new airbag was packaged.
- Use plastic adhesive tape 50 mm wide to secure the box closed. Do not obscure labels or text on the box with the tape.
- Ensure that the 4G fiberboard box is not ripped or damaged.

- The following words ("marking") must also be clearly visible on the same side of the box as the Class 9 label:
Safety devices
UN3268 (font size must be \geq 1/2 inch)
- Affix "To/From" address label to same or adjacent packaging face as the hazardous markings/labels.
- The UN 4G code preprinted near the bottom edge of the box must also be clearly visible.

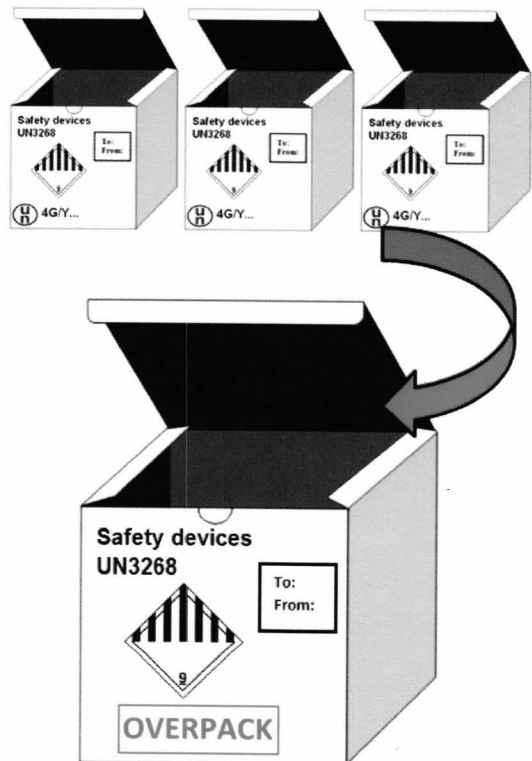
Package example:

- The OVERPACK must have the "OVERPACK" statement on the same face as the hazard markings and labels.

- Carefully open received UN spec box and remove new airbag. Keep the box intact & save all contents!
- Place used airbag back into replacement airbag box, re-using any packaging material (e.g., cardboard inserts) used for the new airbag. Package as the new airbag was packaged.
- Use plastic adhesive packaging tape 50 mm wide to secure box closed. Do not obscure labels or text on box with tape.

- Affix "To/From" address label to same or adjacent packaging face as the hazardous markings/labels.
- The UN 4G code preprinted near the bottom edge of the box must also be clearly visible.
