**SERVICE ADVISORY # 17-276****State Wide Frameless Window**

It has been determined certain State Wide frameless windows were manufactured with a poor adhesive bond between the glass and aluminum frame, and attachments on crank out and egress windows.

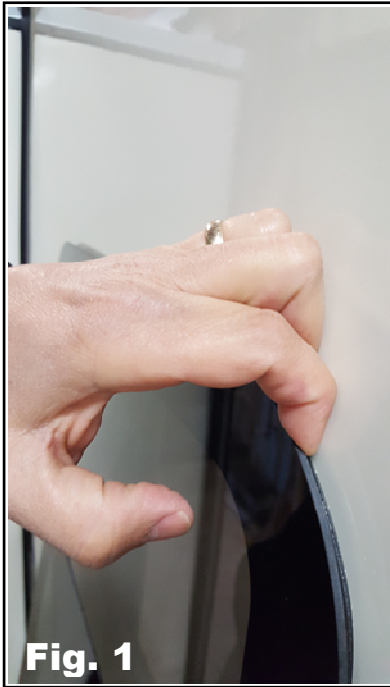
Using under 20 pounds of force or the amount of force that it would take to open a car door, test all windows in several areas around the outside of window by gently tugging on the glass at the frame Figure 1, at the hinge Figure 2, and the latch assembly Figure 3, as shown in pictures below.
