SERVICE ADVISORY # 17-280**Hideout Bedroom Furnace Vent**

It has been determined some 2017 Hideout 308BHDS and 281DBS models were built without the 4 inch rotaire vent installed in the bedroom wall. This service advisory explains how to correct the situation.

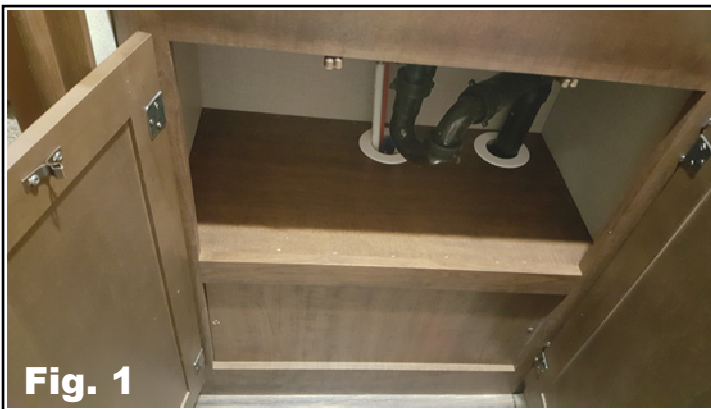
Locate the access panel behind the bathroom vanity cabinet door and remove the 2 screws holding the bottom access panel, Figure 1, to find the 2 inch ducting as shown in Figure 2.

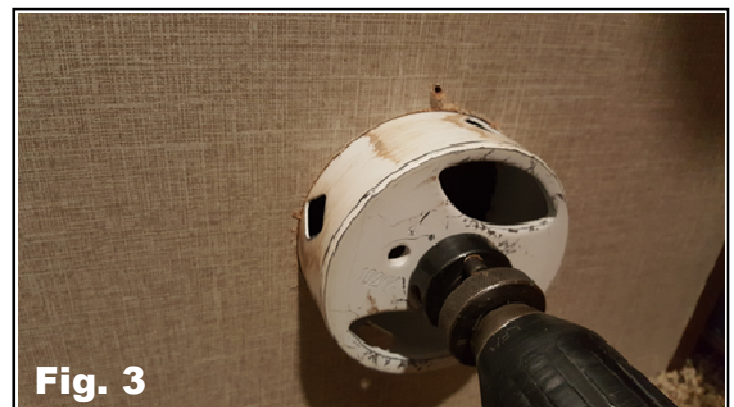
From the outside of the bathroom wall, drill a 4" hole, 6" up from the floor and centered in the wall through the inner and outer panel, Figure 3.

Clean saw dust and debris with vacuum.

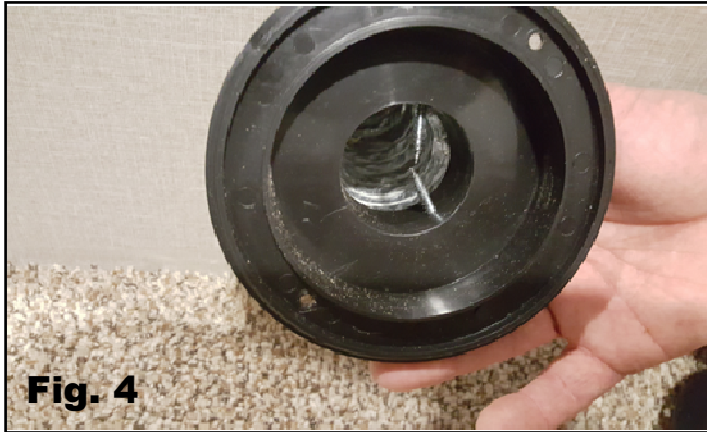
Pass the heat duct through the hole and fasten the rotary vent to the duct. Use 2 screws to attach the duct to the vent, Figure 4. Install complete vent to wall and press rotary vent into place, Figure 5.
