Technical Service Bulletin

SUBJECT:		No: TSB-17-52A-001	
FRONT SEAT BELT STOPPER BUTTON INSTALLATION		DATE: February, 2017	
		MODEL: 2013-15 Outlander Sport/RVR	
CIRCULATE TO:	<input type="checkbox"/> GENERAL MANAGER	<input checked="" type="checkbox"/> PARTS MANAGER	<input checked="" type="checkbox"/> TECHNICIAN
<input checked="" type="checkbox"/> SERVICE ADVISOR	<input checked="" type="checkbox"/> SERVICE MANAGER	<input checked="" type="checkbox"/> WARRANTY PROCESSOR	<input type="checkbox"/> SALES MANAGER

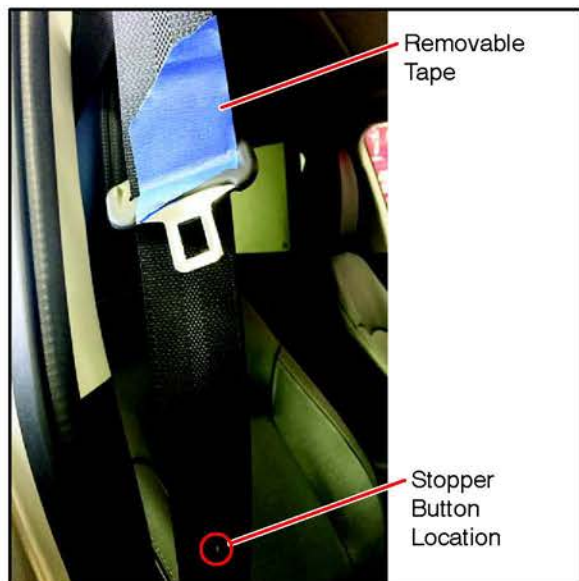
1. Remove any remaining pieces of the broken stopper button.

CAUTION Use care to prevent damaging the seat belt webbing.

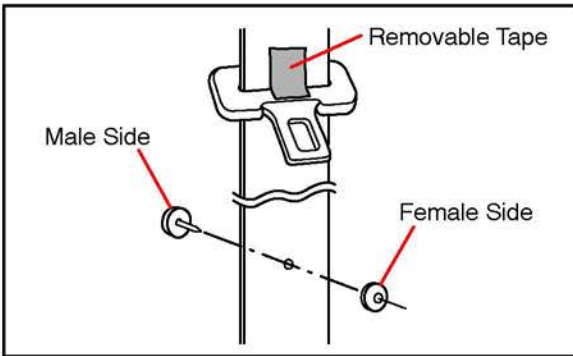
2. Slide the metal tongue of the seat belt upwards, above the location of the original stopper button. Temporarily secure it with removable tape.

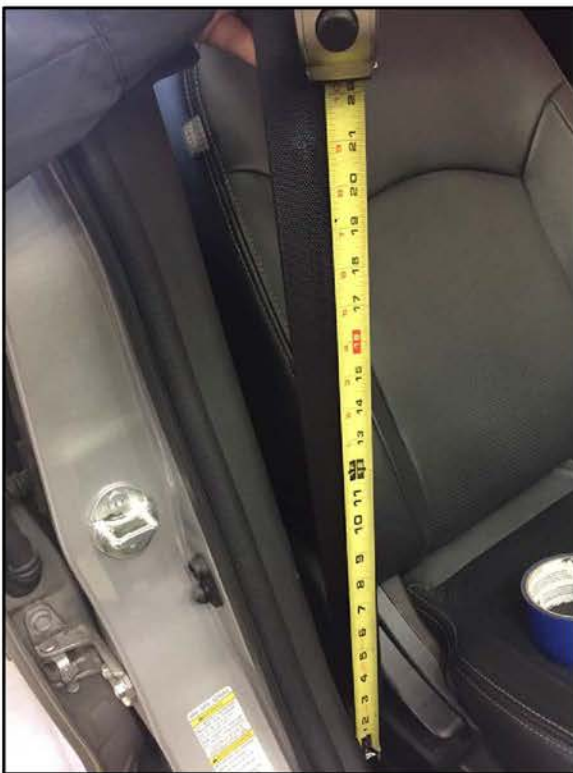
3. Insert the male side of the stopper button from the back side of the webbing at the location of the original stopper button. Install the female side of the stopper button from the opposite side of the webbing as shown.

If the original stopper button location cannot be determined, use the location outlined in step 4 below.

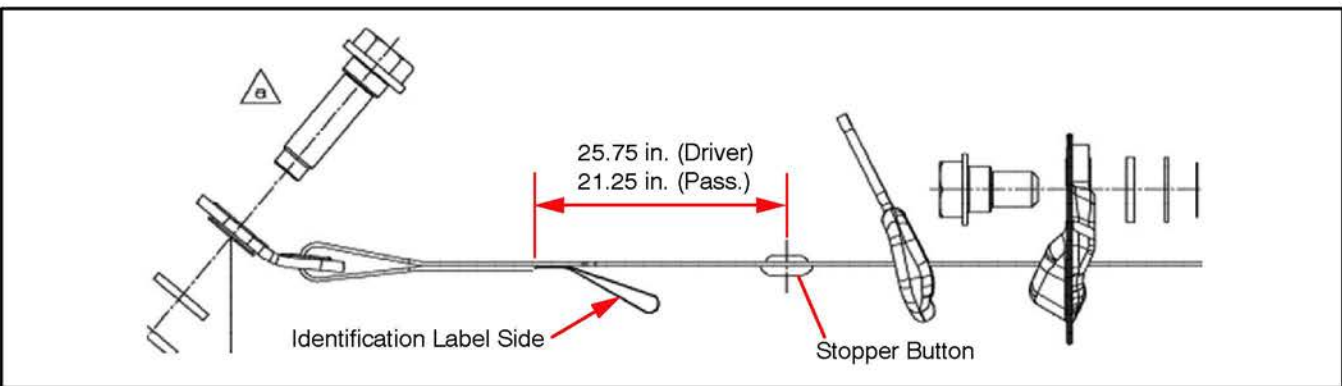
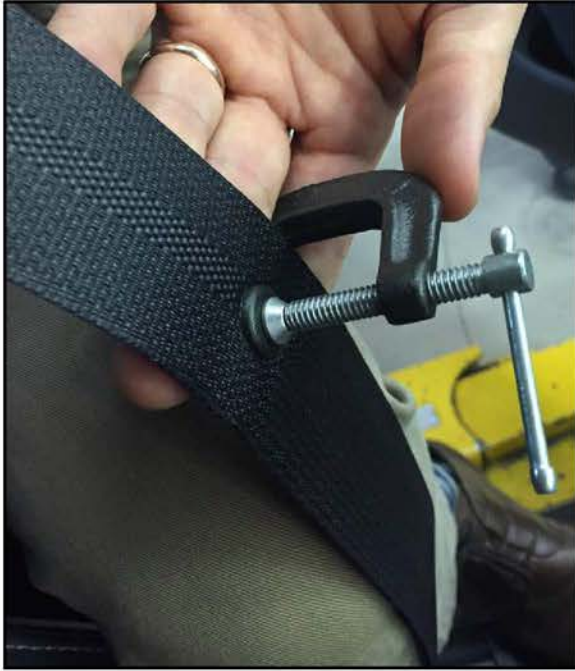
4. If the original location of the seat belt stopper button cannot be determined, locate the position as follows:

- Driver side: Approximately 25.75 inches (655 mm) above the stitching point where the belt folds back onto itself.
- Passenger side: Approximately 21.25 inches (540 mm) above the stitching point where the belt folds back onto itself.
- Mark this location along the centerline of the seat belt webbing.

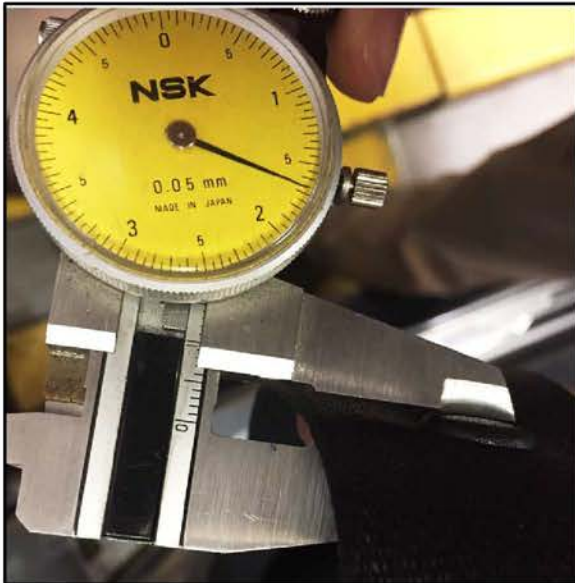
5. Squeeze the button using a small “C” clamp (approximately 1.5–inch span) to complete the installation.

Be careful NOT to bend the spike when squeezing the 2 parts together. A click should be felt when the 2 button parts snap together.

IMPORTANT: The clamp must flatten the spike of the male side of the button.

Make sure the surface is smooth after the spike is snapped off, and there is no gap between the belt webbing and both button parts.
