Vibration Symptom - Tire Imbalance: Replacing Tires With Loose Acoustic Foam (SY 02/17)

Model Year: **2017**

Model Line: **Panamera (971)**

Subject: **Tires with acoustic foam**

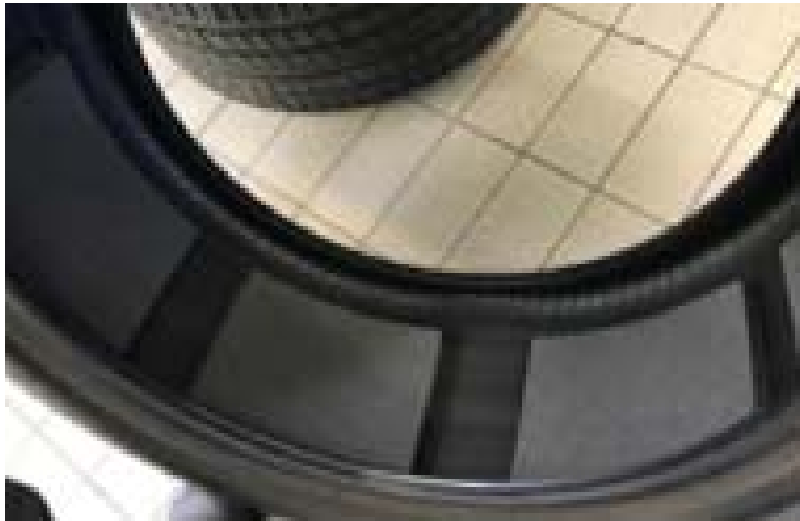
*Good*

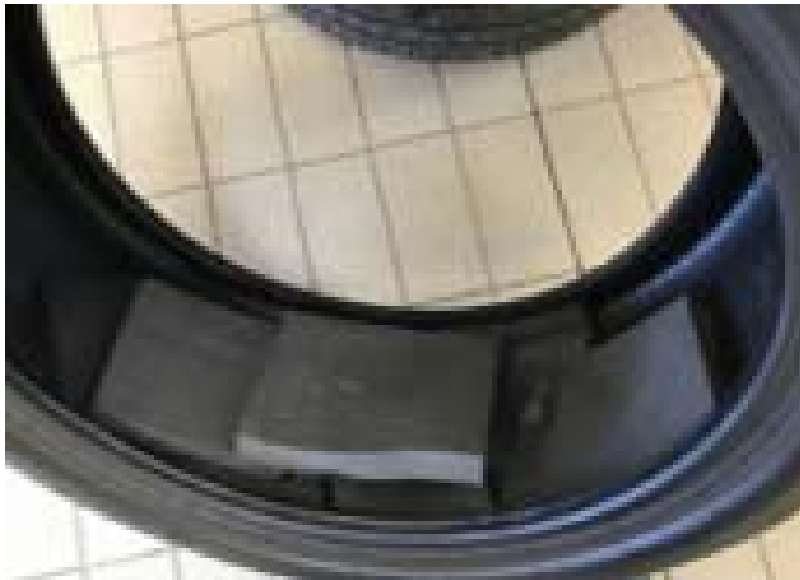
This acoustic foam can become detached from the tire under certain conditions.

⇒ **The loose acoustic foam** can cause **tire imbalance** and **vibrations**

*Bad*

⇒ In the event of a customer complaint and if there are loose blocks of acoustic foam in one or more of the tires, all four tires must be replaced.
