51968-01885 Version 9

Recall: Front Passenger's Airbag Inflator May Produce Excessive Pressure After Long-Term Exposure To High Absolute Humidity

Supersedes 14-046, dated June 16, 2015; see Revision Summary

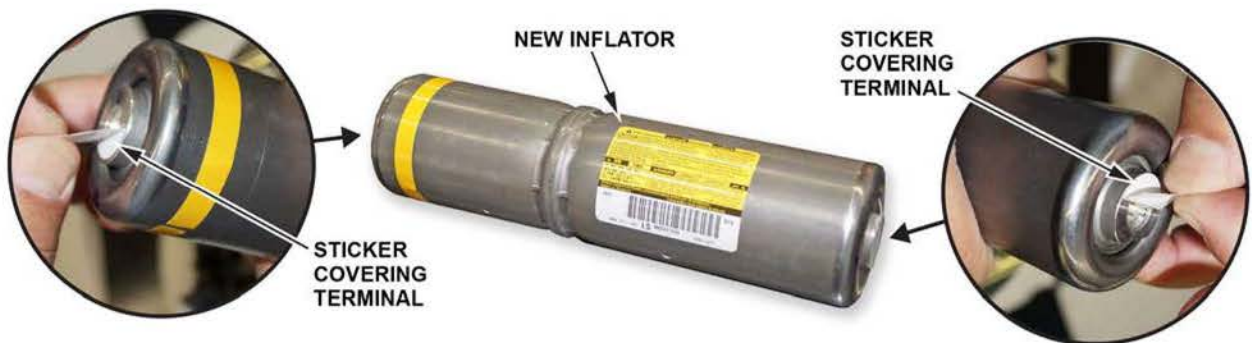
15. Remove the stickers covering the terminals on both sides of the new inflator.

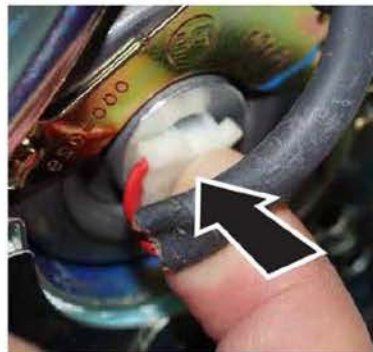
② Press the connector into place until it clicks.

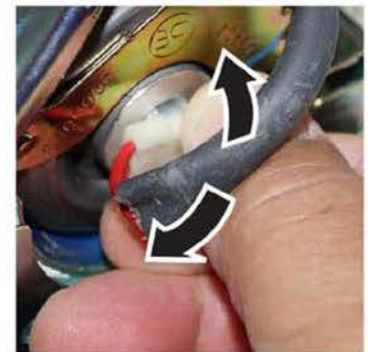
③ Wiggle the connector to make sure it's secure.

- After you hear each connector click, wiggle it to make sure it is secure.

NOTE: If the connector is not properly aligned, it will come out.
