HYUNDAI Technical Service Bulletin	GROUP CAMPAIGN	NUMBER 18-01-001
	DATE January, 2018	MODEL AZERA (HG) SONATA (LFA) SANTA FE SPORT (AN) SANTA FE (NC) TUCSON (TL) SONATA (LF HEV/PHEV)
SUBJECT: INHIBITOR SWITCH REPLACEMENT (SERVICE CAMPAIGN T2M)

Description: This bulletin describes the service procedure to replace the inhibitor switch. A possible symptom is Diagnostic Trouble Code P0705 (Transmission Range Sensor Circuit).

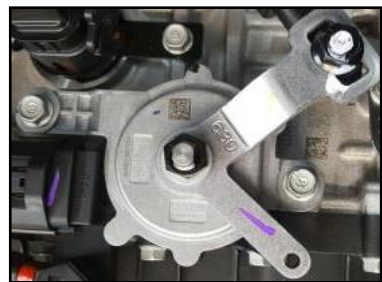
MODEL	PART NUMBER	DESCRIPTION	PHOTO
Azera (HG) Sonata (LFA) Santa Fe Sport (AN) Santa Fe (NC) Tucson (TL) Sonata Hybrid (LF HEV) Sonata Hybrid Plug-in (LF PHEV)	427003B700QQH	Inhibitor Switch

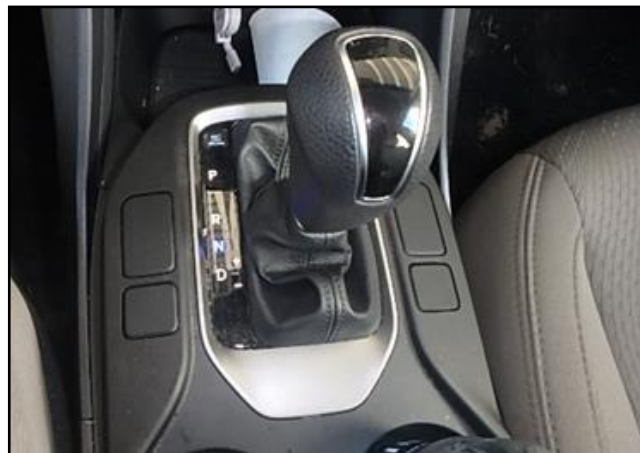
1. Apply the parking brake.

Turn the ignition to the **ON** position and move the shift lever to the **N** position.

Turn the ignition switch to the **OFF** position.

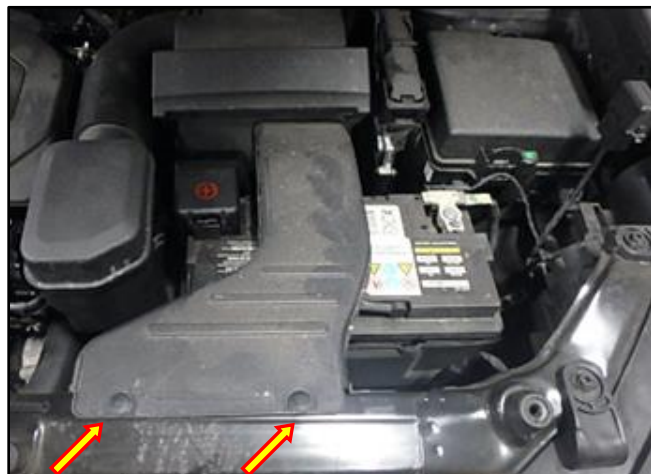
Open the hood and remove the plastic tabs and remove the air duct.

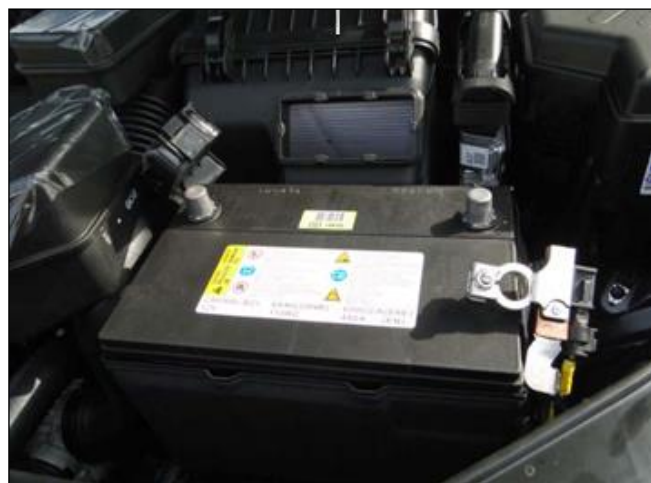
**4. Remove the negative and positive battery cables.**

Remove the battery hold down bolt and remove the battery.

Torque: 7~9 lb-ft (1.0~1.2 kgf.m, 10~12 N.m)

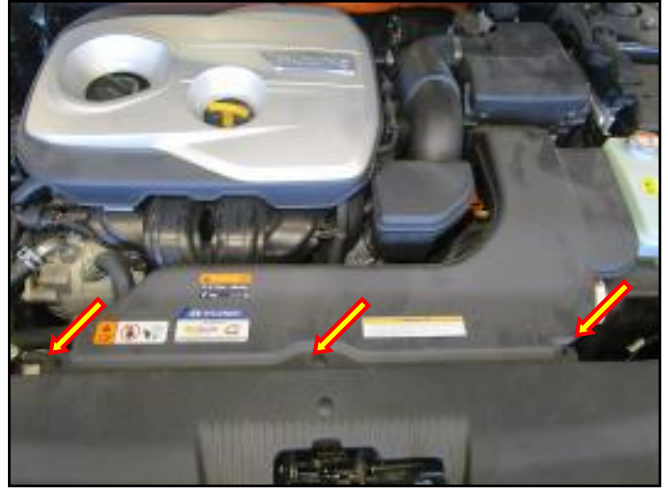
Remove the plastic tabs and remove the air duct.

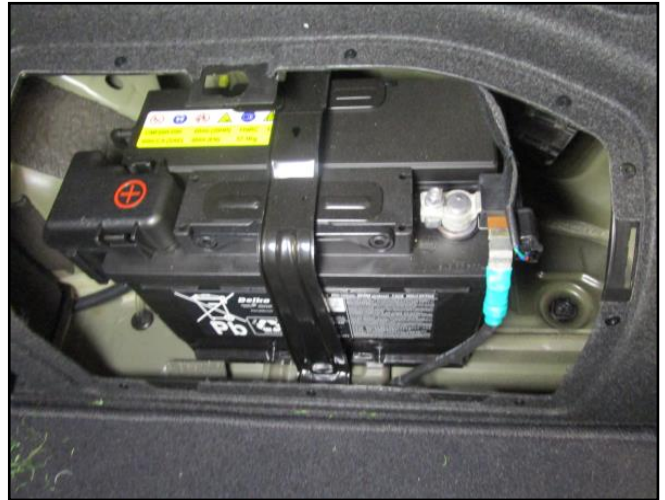
9. Record the preset radio stations and reset after repairs are completed.

Disconnect the negative battery cable.

Torque: 7~9 lb-ft (1.0~1.2 kgf.m, 10~12 N.m)

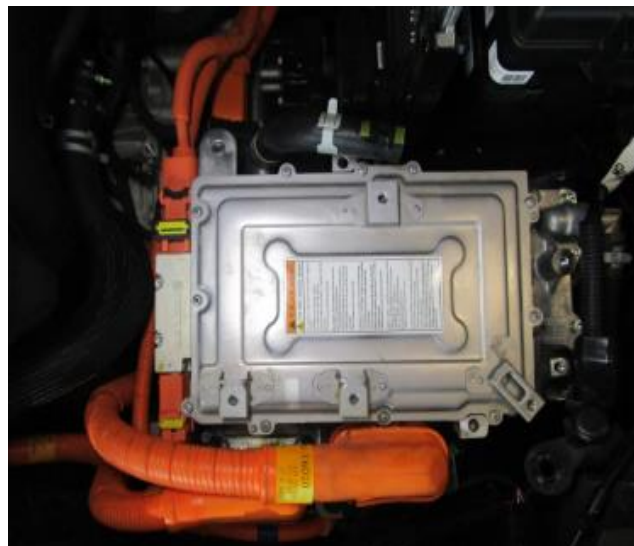
Install 3 bolts that secure the HPCU.

Torque: 14~22 lb-ft (2~3 kgf.m, 20~29 N.m)

Reconnect the power cables and ground cable.

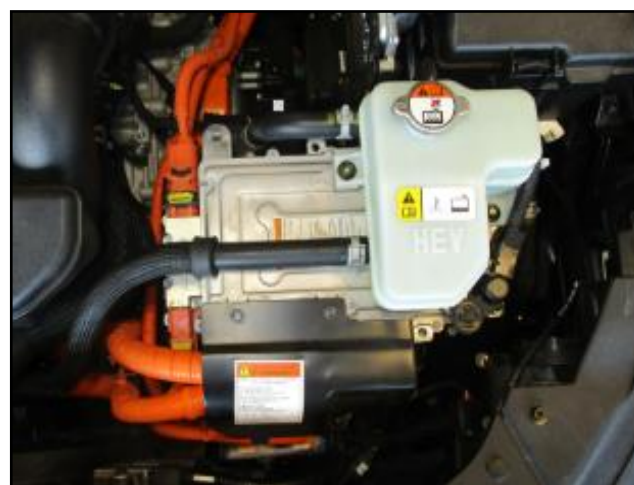
19. Install 2 bolts and 1 nut that secure the coolant reservoir.

Torque: 3~4 lb-ft (0.4~0.6 kgf.m, 4~6 N.m)

Reinstall the coolant reservoir and hoses.

Refill the coolant.

Attach a GDS and perform air bleeding. Select **S/W Management, HEV Motor Control System** and **Electric Water Pump Control**.
