HYUNDAI Technical Service Bulletin

GROUP BODY ELECTRICAL	NUMBER 18-BE-002
DATE JANUARY, 2018	MODEL(S) MULTIPLE MODELS

SUBJECT: AVN5 AND D-AUDIO: APPLE IPHONE FREQUENT BLUETOOTH CONNECTION LOSS

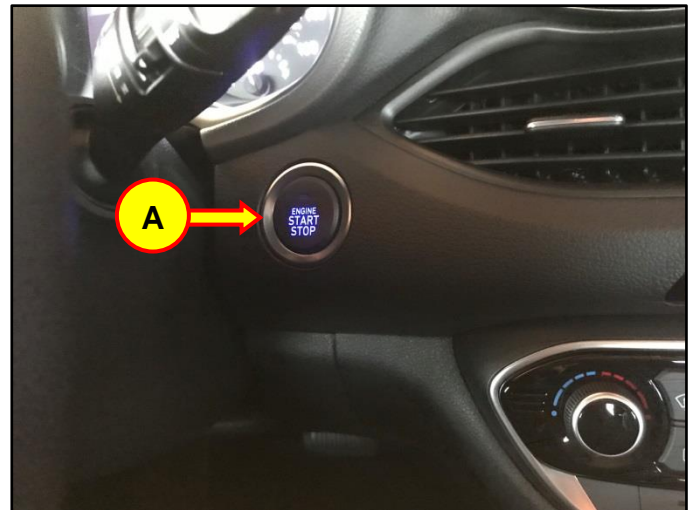
1. Depress the brake pedal and press the START STOP BUTTON (A) to start the vehicle.

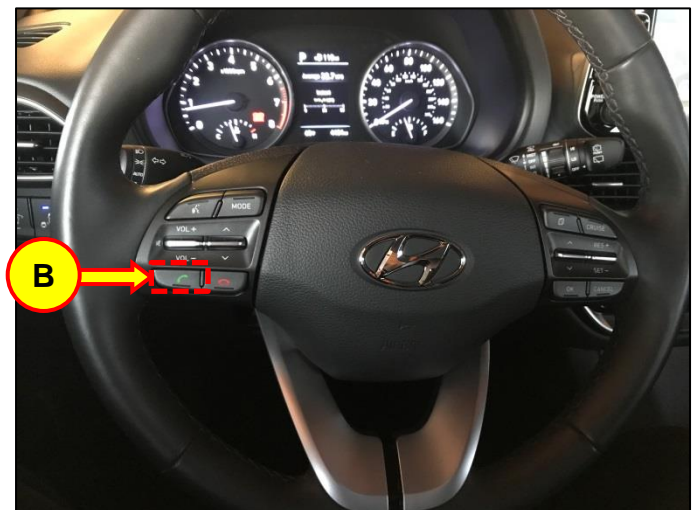
2. Pair your Apple iPhone to the vehicle:

- Press the Answer Call button to begin pairing process (B).
- Select the vehicle name on your phone.
- Tap Pair on Apple device (C).
- Tap Allow on Apple device (D).

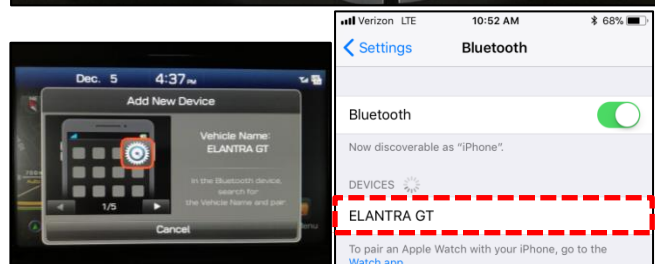
If a device has already been paired to the vehicle, then go to Setup->Bluetooth->Bluetooth Connection to pair a new device.

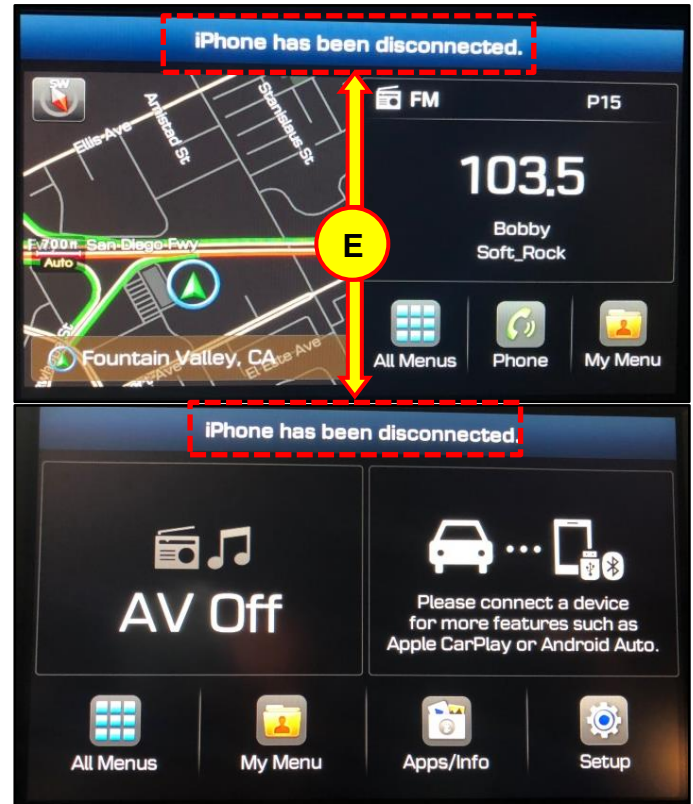
3. Once the device has been paired successfully to the vehicle, verify the device is not losing connection with the vehicle. (wait 5~10mins)

If the device loses Bluetooth connection constantly (E), then a head unit replacement is needed.
