GROUP Electrical	MODEL 2017MY Model (QL)
	NUMBER PS526	DATE January 2018

SUBJECT: BROKEN CHARACTERS AND SYMBOLS ON BASE AUDIO

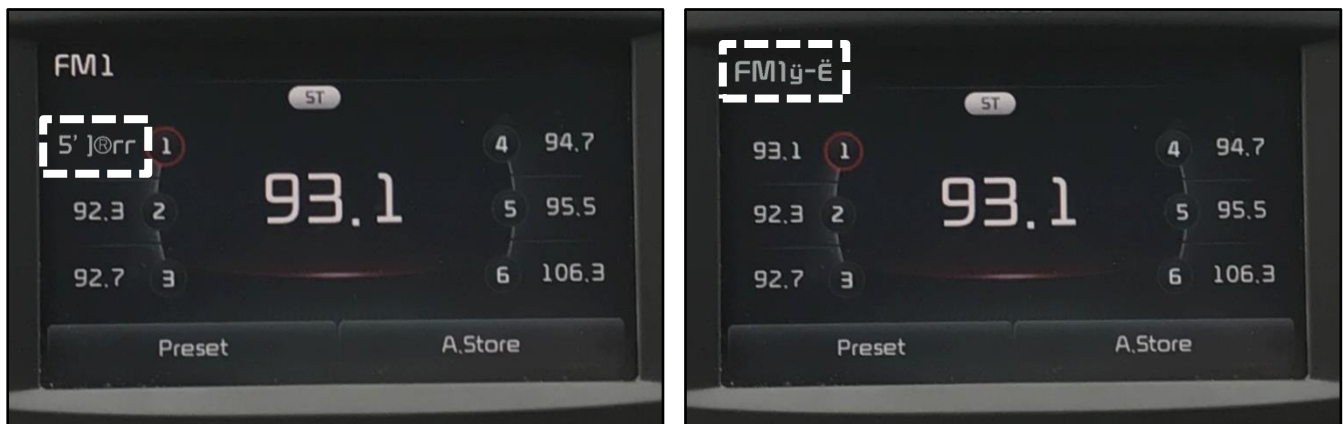
- “When turning on the vehicle, the car radio shows broken characters and symbols near the station numbers”.
- “Intermittently at start up, the screen will display unidentifiable symbols.”

Two example displays with the concern are shown below.

Note: the concern can occur in other areas of the display however, typically occurs on a radio screen (FM or Satellite).

If this concern occurs, replace the head unit with a remanufactured unit, if applicable.
