GROUP BOD	MODEL 2018MY Niro (DE HEV)
	NUMBER 180 (Rev 1, 1/25/2018)	DATE December 2017
TECHNICAL SERVICE BULLETIN		
SUBJECT: SERVICE ACTION: FUEL FILLER DOOR SPRING REPAIR (SA326)

This bulletin provides the procedure to repair the fuel filler door pop-up spring on all 2018MY Niro (DE) vehicles, produced from July 24, 2017 through December 7, 2017 which may not allow the fuel filler door to open properly. Kia is requesting the completion of this Service Action on all affected vehicles in dealer stock, prior to delivery. Before conducting the procedure, verify that the vehicle is included in the list of affected VINs.

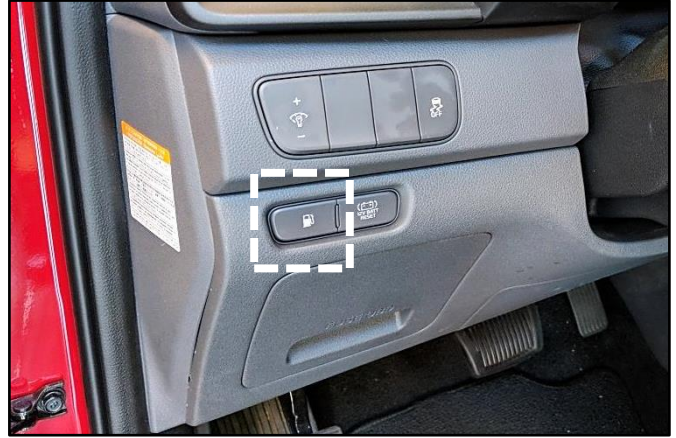
1. Open driver's door and press the fuel door button located on the lower left side of the interior dash.

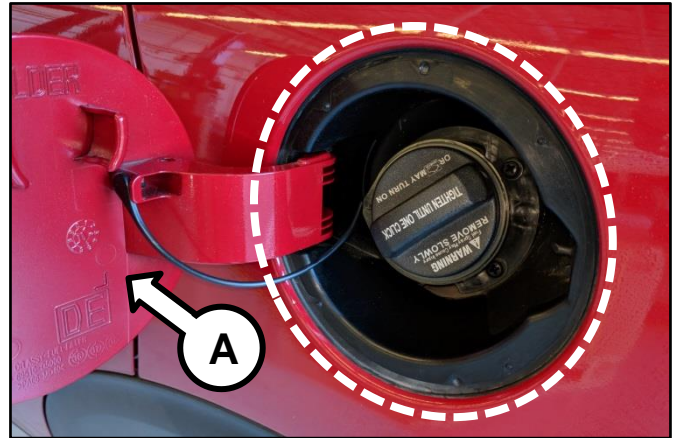
2. Open the fuel filler door (A).

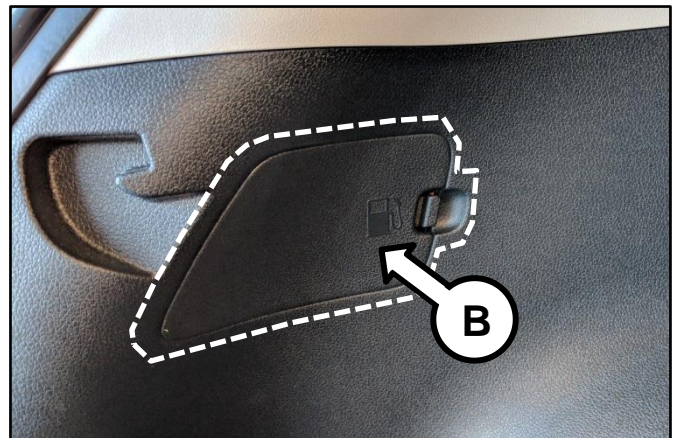
- 2a. If fuel filler door (A) is stuck closed, open the rear liftgate. Locate and remove the emergency fuel filler door manual release cover (B) inside the left side of the trunk compartment trim.

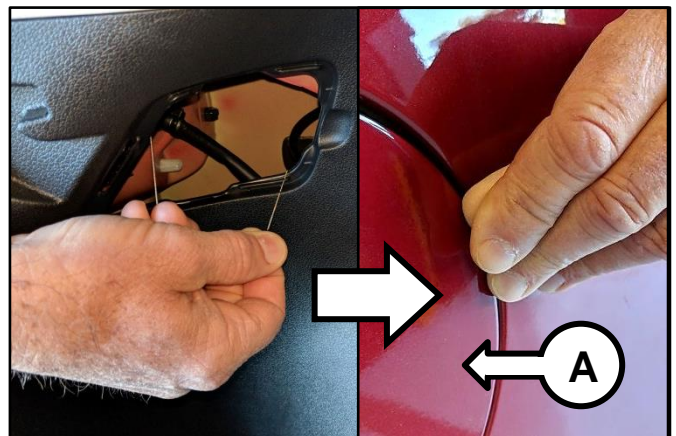
- 2b. Pull the emergency fuel door manual release cable outward as shown with your right hand, while also lifting the fuel filler door (A) on the outside of the vehicle with a left hand finger.

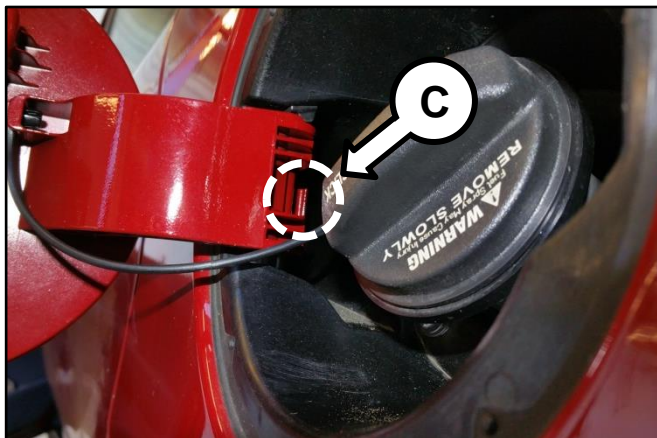
3. Locate the fuel filler door spring end (C).

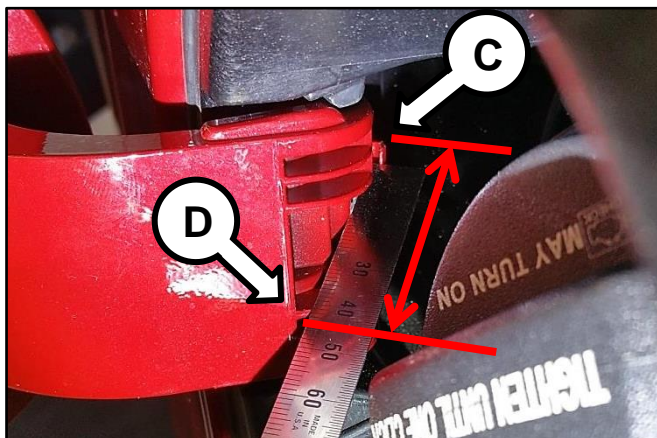
4. Measure the distance from the fuel filler door spring end (C) to the door goose neck edge (D) as show.

Specified distance required: (43 - 45mm)
1.69 - 1.77 inches.

If distance is less than specified above, proceed to step five (5). No further actions is required if within specification.

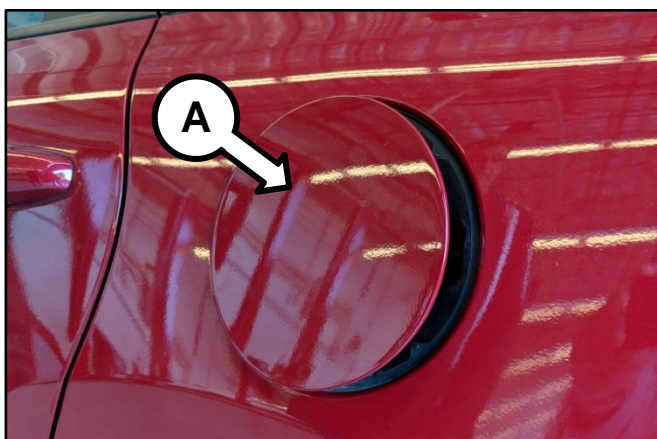
6. Open the fuel filler door (A), as outlined on step one (1). Repeat three (3) times. The door should pop-up open allowing for enough room to insert a finger to pull door.
