To All Authorized Lamborghini Dealers and Service Centers
Service Area Manager
From Customer Service Department
Subject Information Bulletin: fix air intake in Lamborghini Aventador.
Group BI.02.18
Date January, 12, 2018
Pages 3

Information Bulletin: fix air intake in Lamborghini Aventador.

Aventador

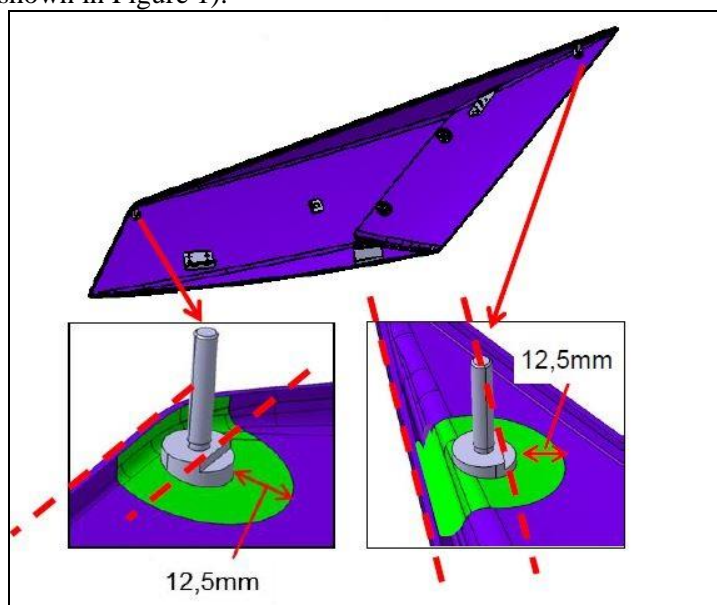
Figure 1

Respect the parallelism with the reference edge on PIN and the edge of the fix air intake (as shown in Figure 1).

We would also like to inform you that the phases of rework to replace a detached PIN are the following:

- Remove of the residues from the base of the PIN;
- Grind/sand with P120 the bonding surface;
- Degrease with Acetone;
- Replace the PIN with Pliogrip 7779-B (cod. 062870360); use the footprint of previous bonding as a reference;
