08193 Version 7

Warranty Extension: MIL Comes On With DTCs P0301 thru P0304

Year	Model	Trim	VIN Range
2008–10	Odyssey	EX-L, Touring	Check the iN VIN Status for Eligibility

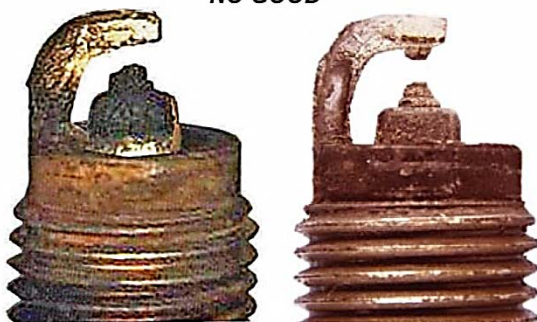
2. Remove and check the spark plug(s) on the affected cylinders (example: if P0301 is stored, check the spark plug on cylinder No. 1).

Are the spark plug(s) fouled?

GOOD

NO GOOD

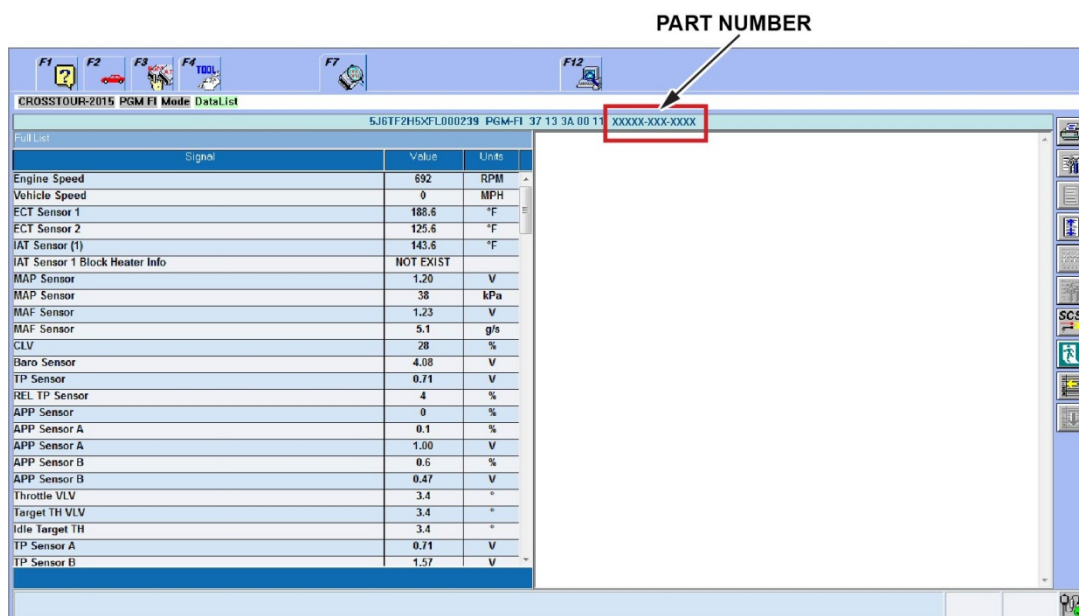
- Check the PCM software version P/N located above the **PGM FI Data List**.

Year/Model	Program ID (or later)	Program P/N (or later)
2008 Odyssey (EX-L, Touring)	GWA950	37805-RGW-A95
2009–10 Odyssey (EX-L, Touring)	GWA050	37805-RGW-A05

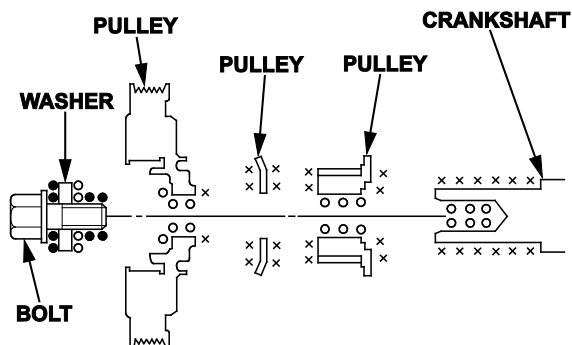
13. Depending on the diagnosis, remove the appropriate WU-TWC support bracket bolts.
14. Remove the EGR lower pipe nuts.
15. Remove the crankshaft pulley bolt but not the pulley.

NOTE: Make sure to apply new oil to the bolt flange and threads before reinstallation.

X : Remove any oil

O : Clean

● : Lubricate with new engine oil

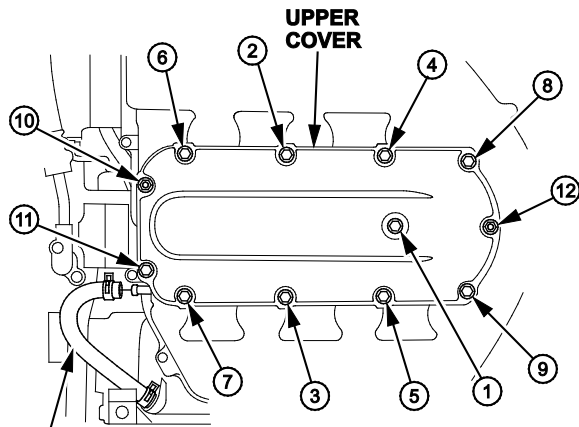
28. Remove the engine intake upper cover bolts and nuts. Then remove the cover and the PCV hose.

SPECIFIED TORQUE
6 x 1.0 mm
12 N·m (8.7 lb-ft)

PCV HOSE

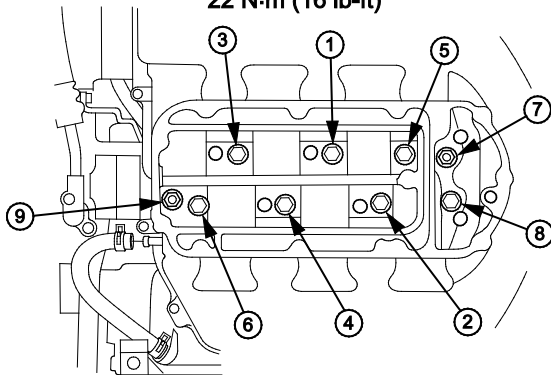
29. Remove the intake manifold bolts and nuts in three steps, then remove the intake manifold.

SPECIFIED TORQUE
22 N·m (16 lb-ft)

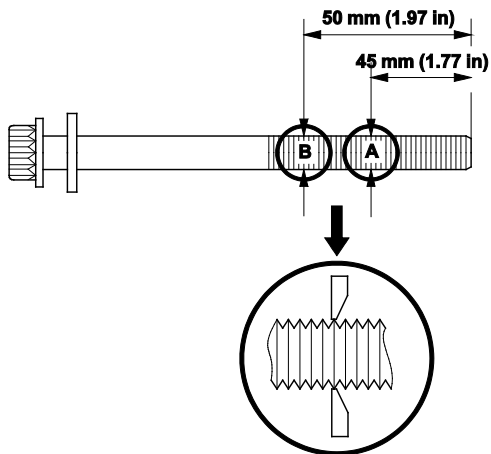
41. Measure the head bolts to determine if they need replacement. If either diameter is less than **11.3 mm (0.445 in)**, replace the cylinder head bolt.

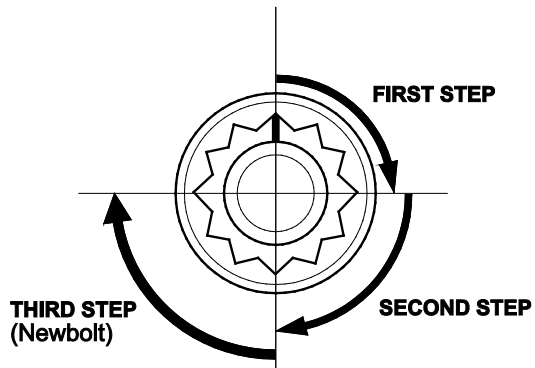
NOTE: Below are the head bolt torque specifications for reinstallation.

- First step: torque the cylinder bolts in sequence to **29 N•m (22 lb-ft)**.
- Second step: tighten in sequence an additional **90 degrees**.
- Third step: tighten in sequence an additional **90 degrees**.
- If the bolts are new, tighten an additional **90 degrees**.

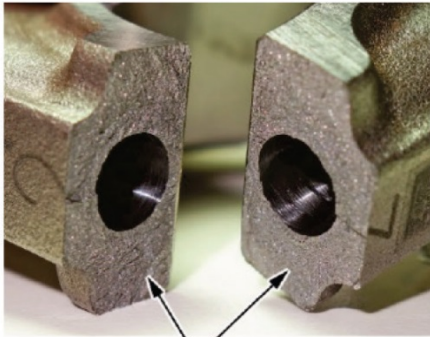
The uneven mating surfaces are uniquely matched and not interchangeable.

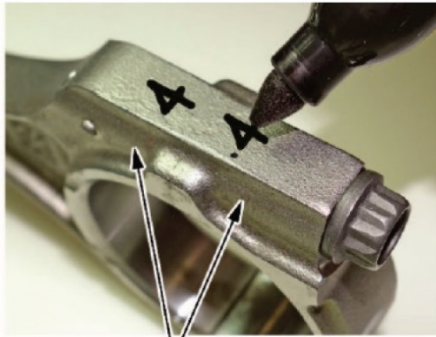
Mark the connecting rod and rod cap with the cylinder number.

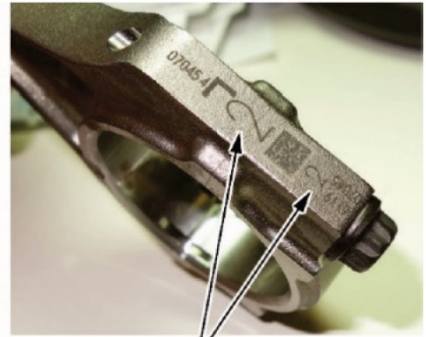
These are manufacturing marks, and do not indicate the cylinder number.

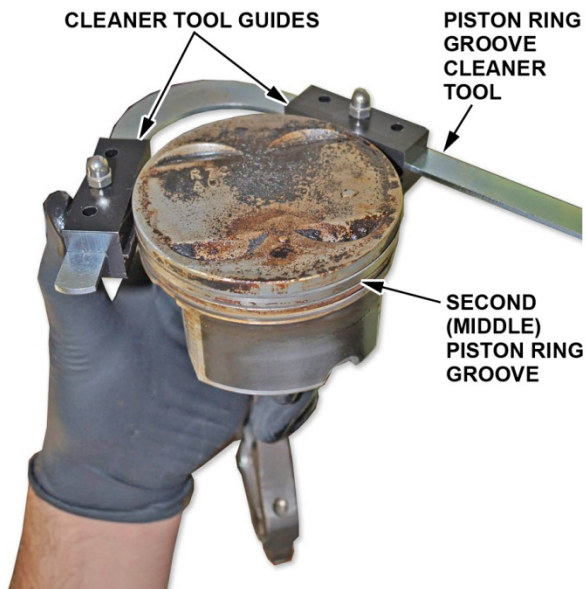
3. While holding the piston upright in your left hand, take the piston ring groove cleaner tool in your right hand and line up the cleaner tool guides with the second (middle) piston ring groove.

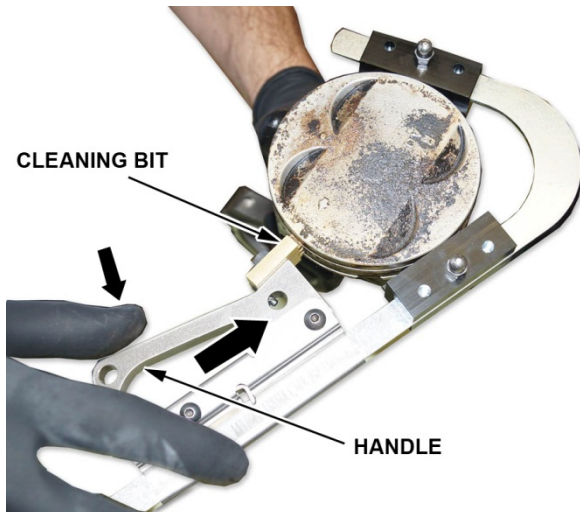
4. Press the handle on the piston ring groove cleaner tool and slide the cleaning bit onto the appropriate piston ring grooves.

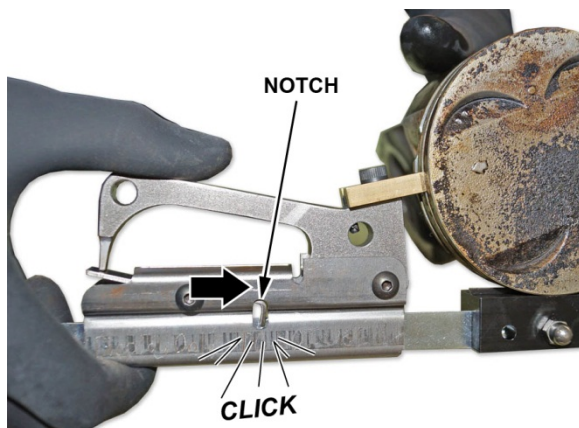
5. Once the cleaning bit is in the appropriate ring grooves of the piston, make sure the tool handle clicks into place.
NOTE: There is only one notch on the tool for the handle to engage.

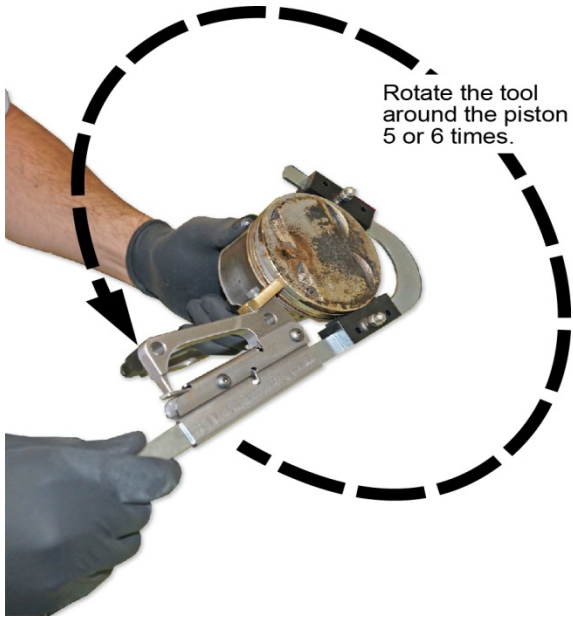
6. Hold the piston steady and rotate the tool counter-clockwise five to six times to remove any carbon deposits in the piston ring grooves. **Do not** rotate the tool clockwise.

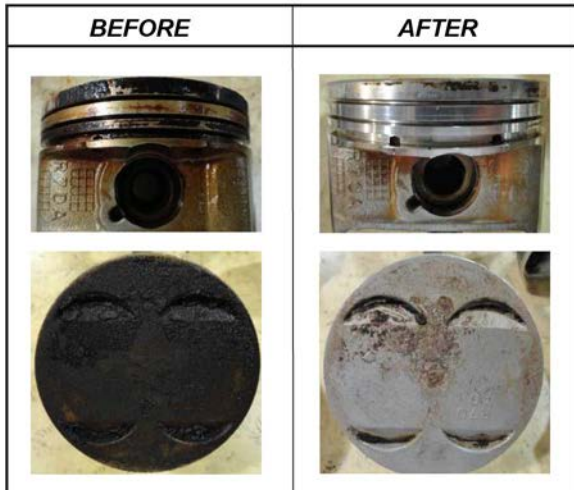
54K PISTON

NOTE: Below are some examples of before and after pictures. Depending on mileage and running conditions, the pistons will achieve different levels of cleanliness.

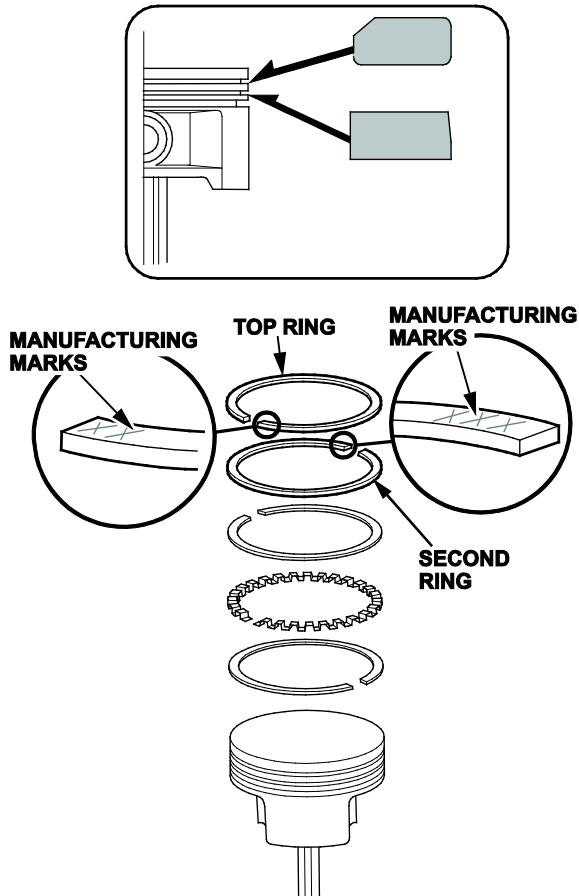
9. Install the piston rings as shown.

NOTE: The first (top) ring has a **1D** manufacturing mark and the second (middle) ring has an **SPR** manufacturing mark. The manufacturing marks must be facing upward.

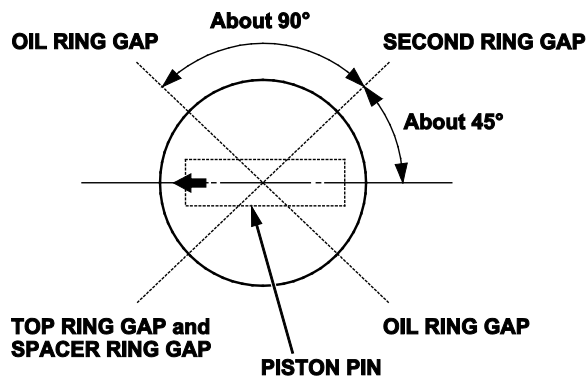
10. Position the ring end gaps as shown.

NOTE: If the ring gaps are not positioned correctly, excessive blowby may occur.

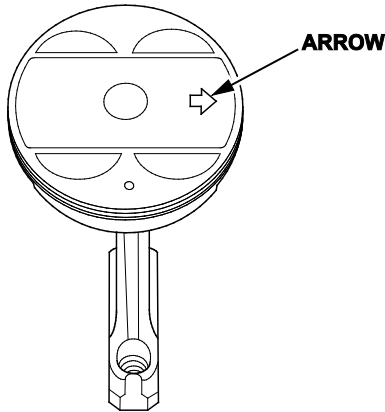
12. Install the piston/connecting rod assembly into the cylinder bore with the arrow on top of the piston facing the timing belt side of the engine.

NOTE: Be careful not to damage the cylinder wall when installing the piston.

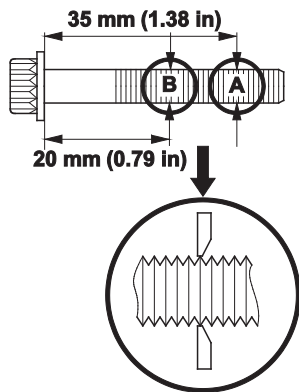
13. Measure the diameter of the connecting rod bolts to determine if they need replacement. Calculate the difference in diameter between point A and point B. It should not be more than **0–0.1 mm (0–0.004 in)**.

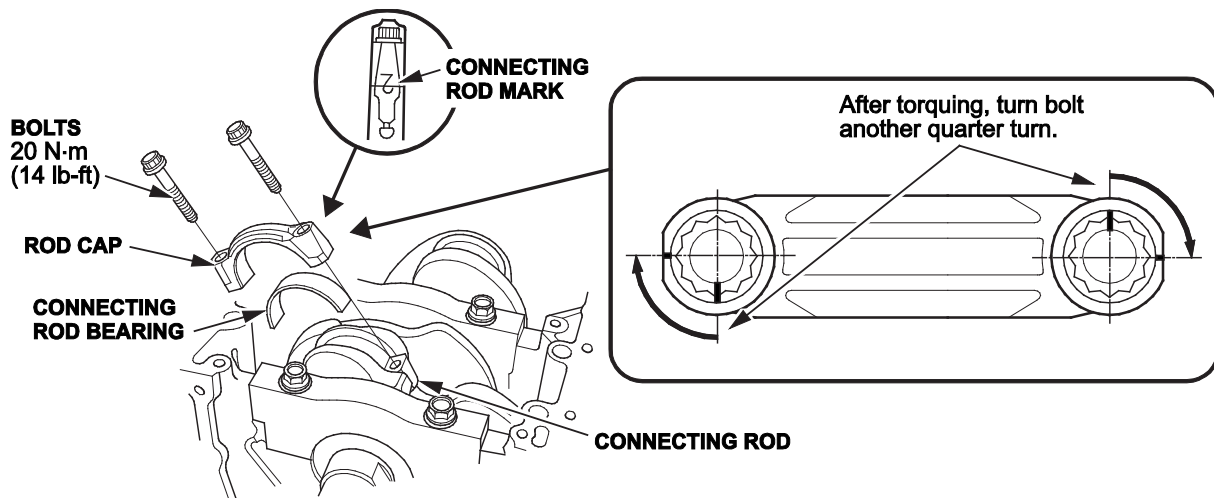
14. Apply new oil to the connecting rod bolt threads and flanges. Torque the bolts to **20 N·m (14 lb-ft)** then tighten the connecting rod bolts an additional **90 degrees**.
