Low Tire Pressure/TPMS Indicator On After Recent Tire Replacement?

2014–16 CR-V

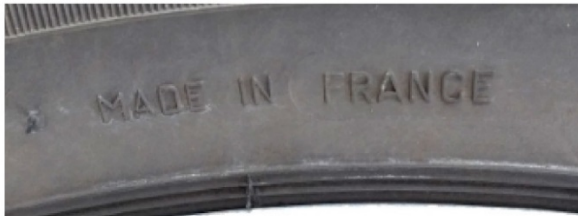
If you get any vehicles coming in because the Low Tire Pressure/TPMS indicator is on after a recent tire replacement, the issue could be a mismatched tire. The original tires (**CN5L**) were made in France and have a **1-ply** sidewall construction. Those tires have been discontinued and are now made in Portugal. The Portugal-made tires (**AF5L**) have a **2-ply** sidewall construction.

The online owner's manual recommends replacing all four tires at the same time. But if that's not practical, the tires should be replaced as a set (right and left front tires, right and left rear tires). If the mismatched tire happens to be a Portugal-made tire, your customer will have to replace the opposite side of the set with another Portugal-made tire since the France-made tires are no longer available.

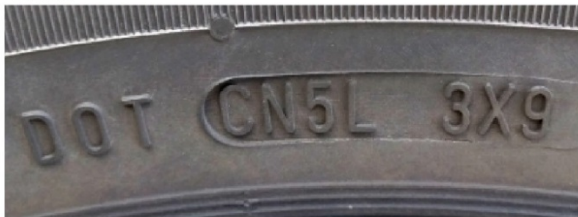
"CN5L"

1 Ply

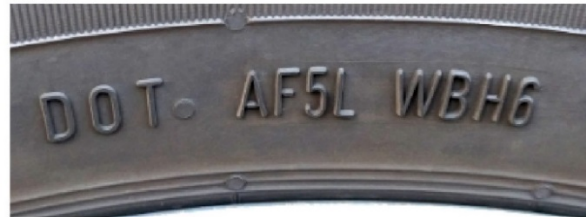
"AF5L"

2 Ply

This difference in sidewall construction means the Portugal-made tire has different rolling characteristics than the one made in France. Because of the way indirect TPMS works, that difference will cause the Low Tire Pressure/TPMS indicator to come on.
