RECREATIONAL VEHICLE SERVICE CAMPAIGN

SERVICE ADVISORY # 17-309

Hideout Furnace Return Vent

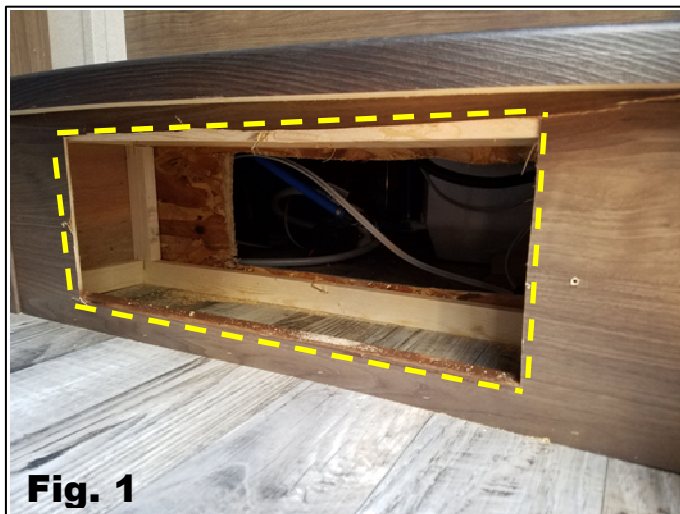
Fig. 1

Cut an opening that measures 17" x 6" below the first step for the return grill as shown in Figure 1. Cut a similar size hole in OSB towards the back of the step, as shown in Figure 2, to reveal the furnace area.

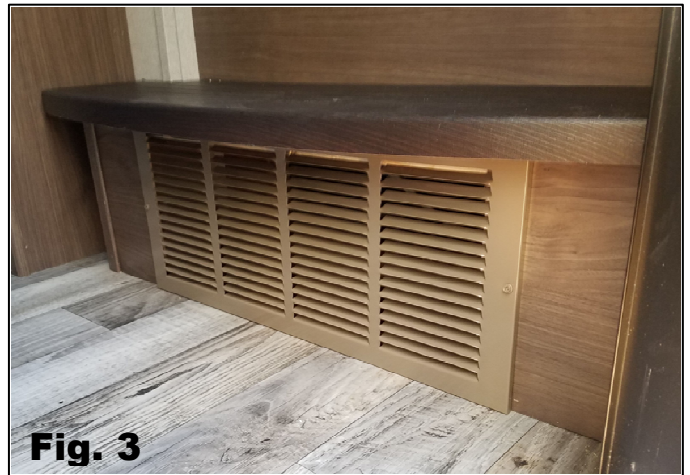
Clean debris from steps and install the return air grill KRV # 103208 - Grill - Return Air - 20" x 8" – Brown, Figure 3.
