MODEL: Karma Revero

TITLE: Seat Squeak Remedy

PURPOSE: To reduce noise concern related to seat use

TB-18-86-01

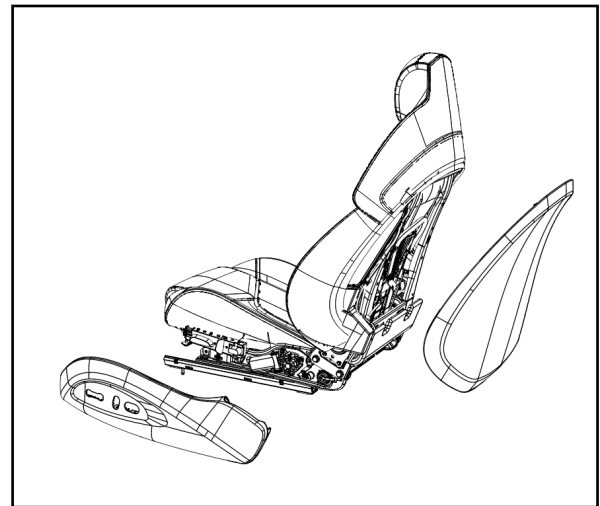
fig.1

For reference the following images are provided.
 Outboard side shield and back panel (fig. 1)

Reassemble side shield and back panel onto seat

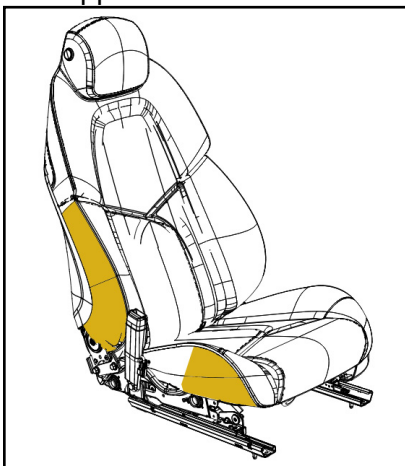
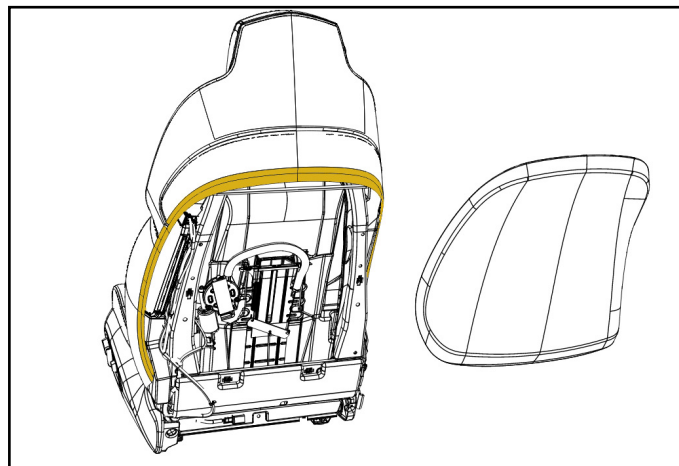
fig.2a

Begin preparation of the front seat:
 Move the driver side front seat to provide exposure to all the highlighted areas. (Fig 2a and 2b)

Kluberafa application areas shown below

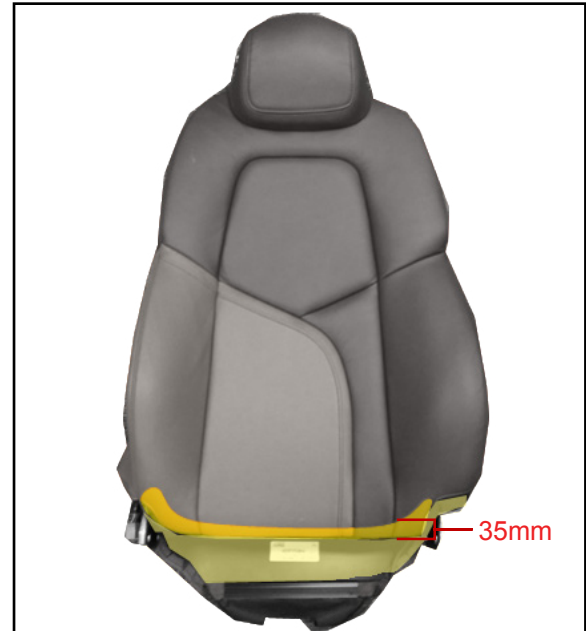
fig.3

Both top (fig.3) and bottom of bite line (fig.4), specifically applying to inboard and outboard corners, 35mm from the suede seam, and all the suede surfaces.

Spray the required lubricant directly onto leather in the indicated areas, applying to one area of the seat at a time:

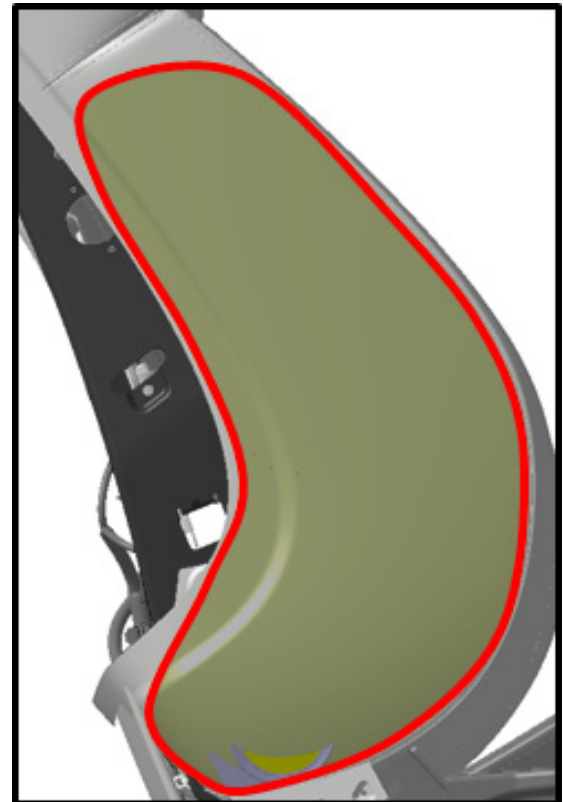
fig.5

Apply lubricant to inboard back panel, including suede and seam (fig.5)

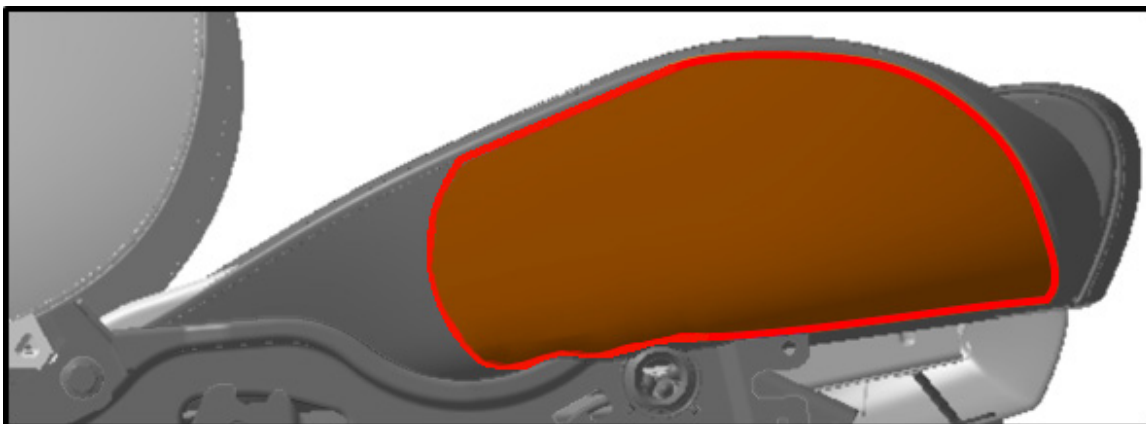
fig.6

As shown apply the inboard side of driver seat where it contacts the tunnel (fig. 6)

Apply 2-3 inches away, 3 times in a sweeping motion

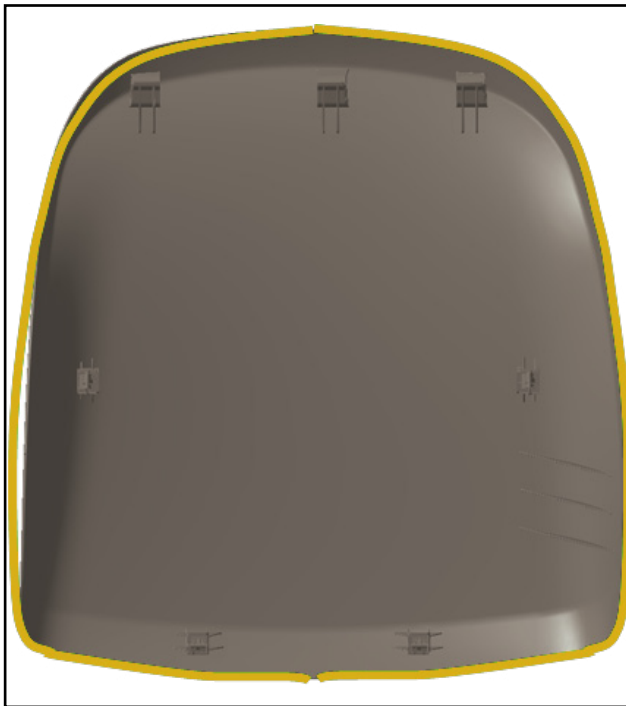
fig.7a

Apply the specified lubricant to entire edge of back panel, a 25mm band following the edge as shown (fig.7a), and the mating surface of the leather on the seat back. (fig 7b)

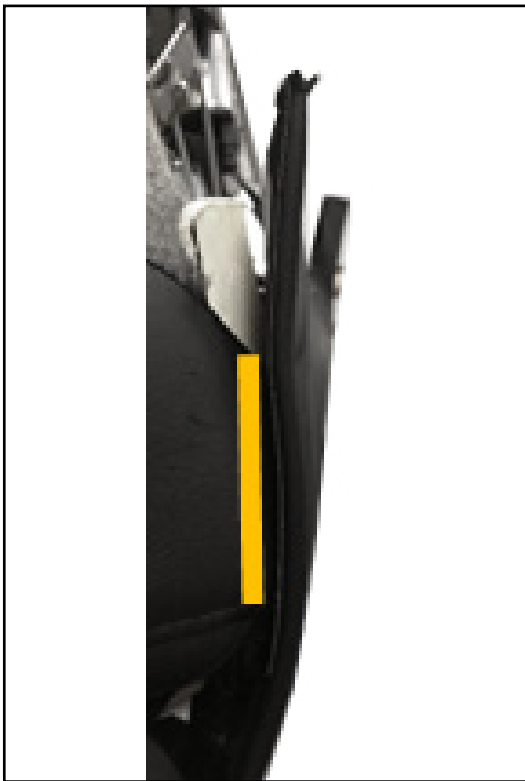
fig.8a

Apply to mating leather on back shield trim (fig.8a)

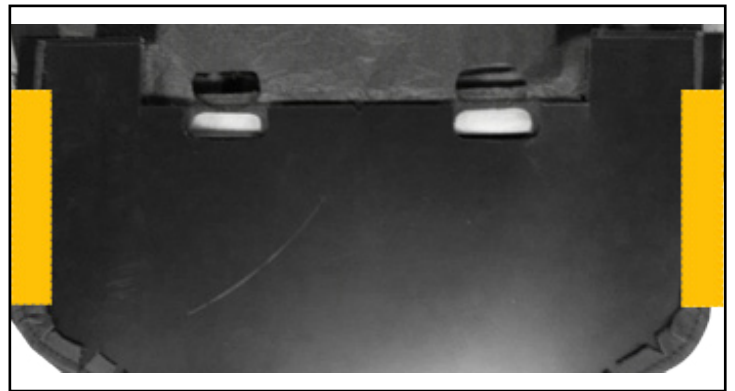
fig.8b

Apply to both inboard and outboard lengths of the toe kick, the rear lower portion of the seat. (fig.8b)
