08043 Version 2

## Tailgate Will Not Open from the Outside Handle in Cold Weather

Year	Model	Trim	VIN range
2012-2016	CR-V	ALL	ALL
2011-2017	Odyssey	ALL	ALL

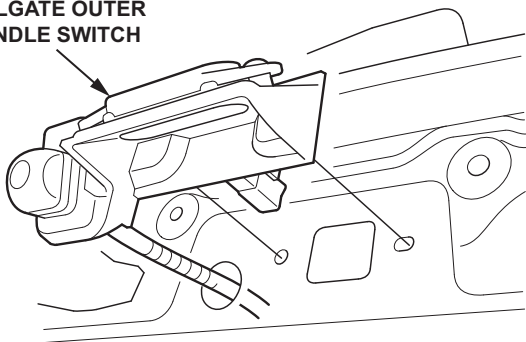
**TAILGATE OUTER  
HANDLE SWITCH**

There is an internal failure of the tailgate outer handle switch.

NOTE: The illustration shows with rearview camera.

8. If equipped, disconnect the rearview camera 6P connector.

9. Remove the tailgate outer handle switch.

10. Install the new switch.
11. Install all remaining parts in the reverse order of removal.
