Audio System Cuts Out When Using Right Turn Signal While Playing FM Radio

2018 Accord

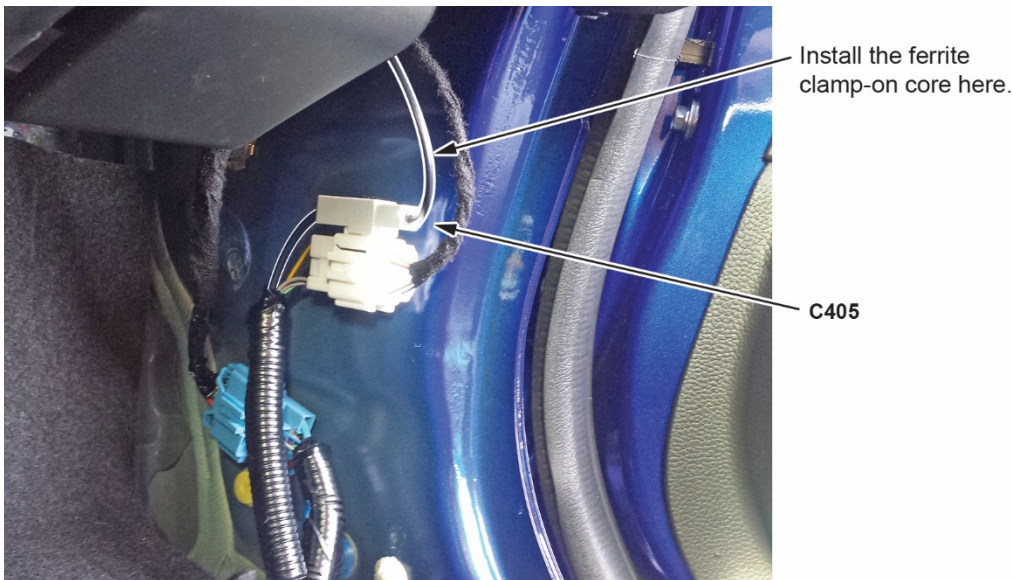
We're currently looking at an issue where the audio system cuts out when using the right turn signal while playing FM radio. Until we come up with a permanent solution, here's a temporary fix that's quick and easy and will prevent cutting out the noise:

1. Remove the passenger side kick panel, and find connector C405.
2. Install a ferrite clamp-on core on the black coax cable leading to the dashboard, near the connector.

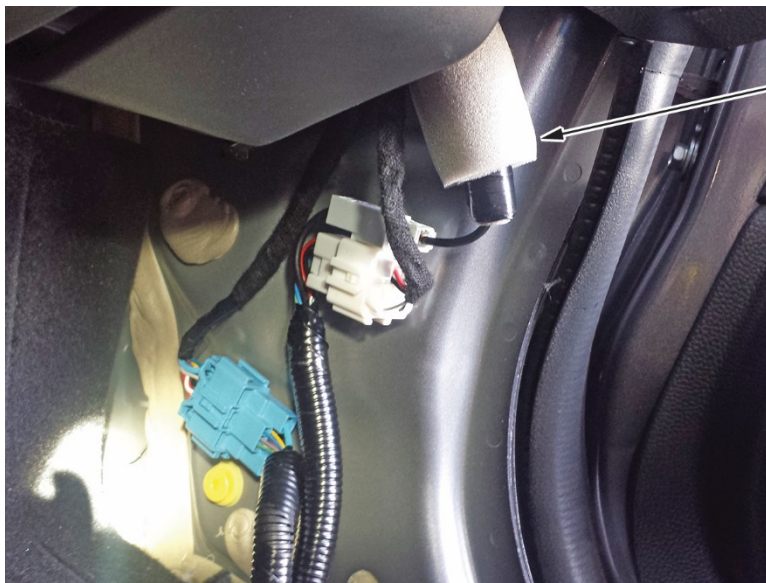
FERRITE CORE
WRAPPED WITH FOAM

3. Wrap the core with foam tape to prevent contact with the surrounding area.
