Service Bulletin

18-014

Capless Fuel Filler (Mis-Fuel Inhibit Device) Leaks When Refueling Vehicle

| Year | Model | Trim | VIN Range |
|---|---|---|---|
| 2016-17 | Civic | 4-door | ALL |

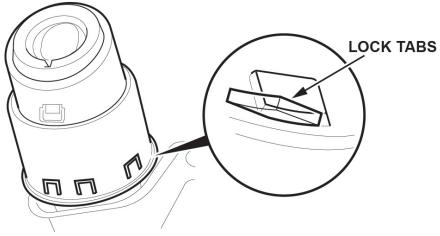
1. Remove the mis-fuel inhibit device by breaking the 6 lock tabs.

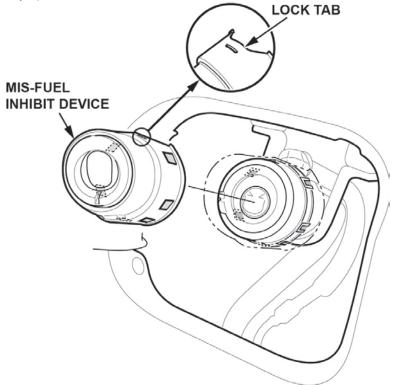
2. Pry up the lock tab and remove the mis-fuel inhibit device.

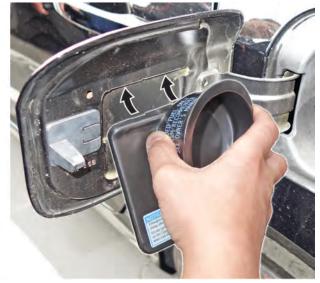
5. Align the hooks on the top edge of the fuel lid cover to the fuel door.

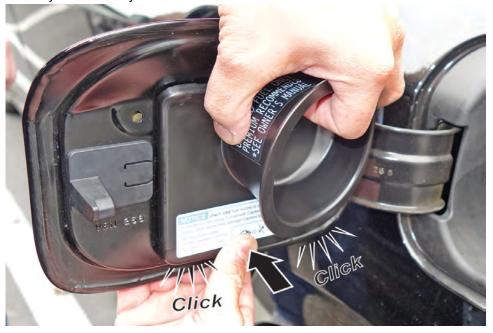
6. Press the bottom of the fuel lid cover to the fuel door until both locking tabs click. This indicates the fuel lid cover is securely and correctly installed.
