Preliminary Information

PIP5395D Ticking Rattle Or Buzz Noise Heard The Best In The Passenger Compartment

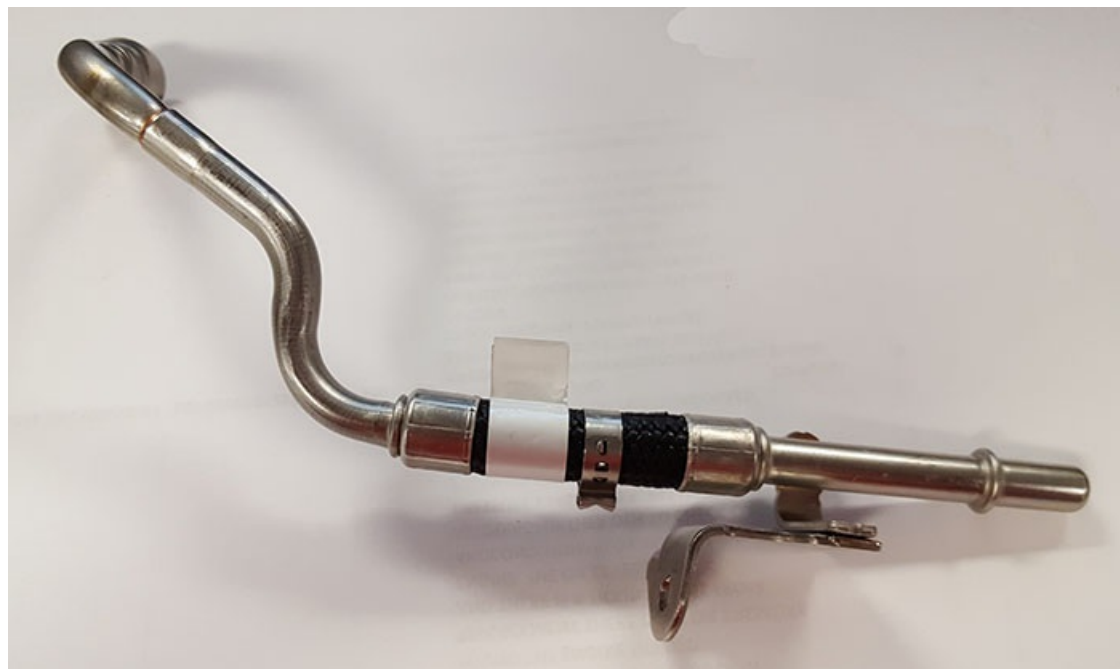
The line above is the fuel feed pipe for Corvette, truck and SUV.

This line connects the chassis fuel line to the high pressure fuel pump.

The fuel feed line between the high pressure fuel pump and chassis fuel line could be the cause allowing high pressure pulsation back to the low side of the fuel system. There is not a good way to test the check valve, the line will need to be replaced.

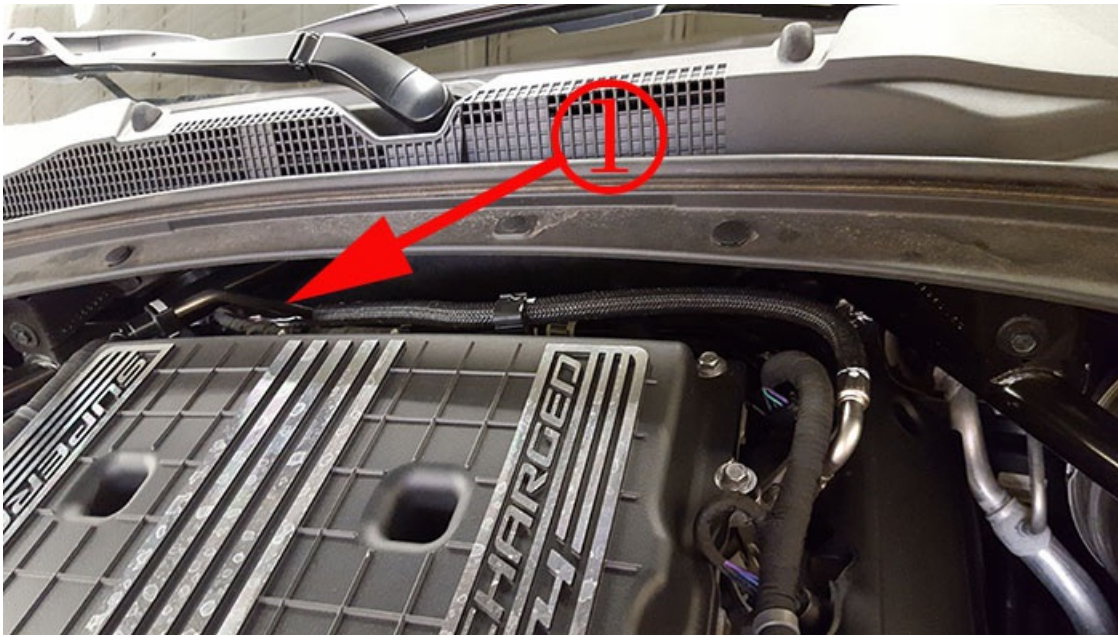
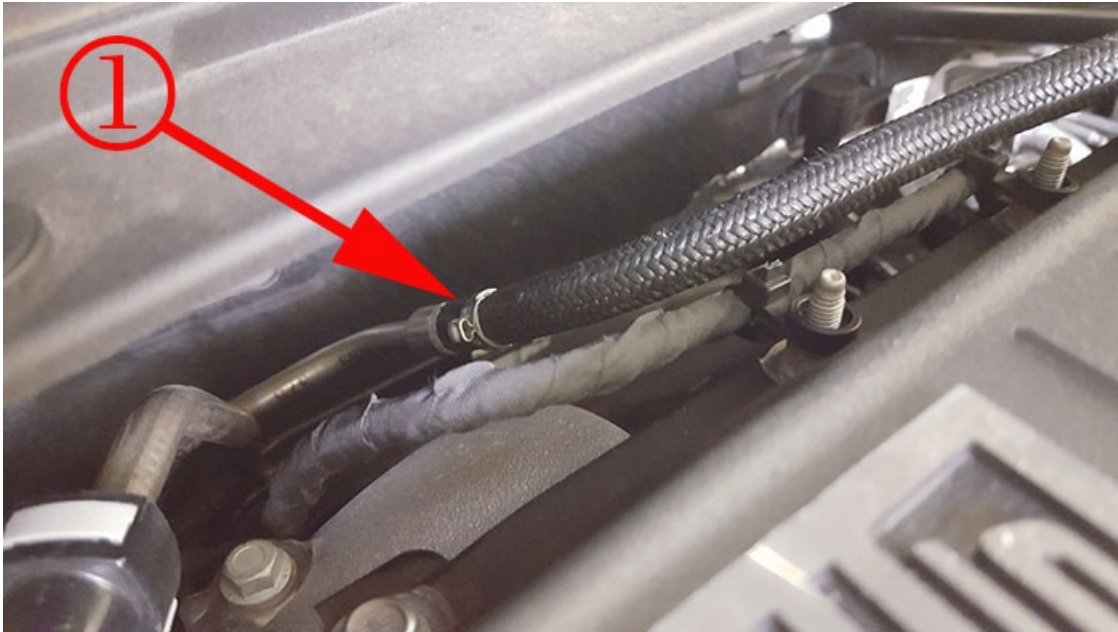
These pictures above shows the chassis fuel feed pipe for the LT4 supercharged ZL1 Camaro. On LT1 Camaro and LT4 CTS-V this line would have a jumper line with quick disconnects at both ends. One end will connect to the chassis line and the other to the high pressure pump feed line.
