| <b>HYUNDAI</b><br><b>Technical Service Bulletin</b> | GROUP<br><b>AUTOMATIC TRANSMISSION</b> | NUMBER<br><b>18-AT-001</b> |
| | DATE<br><b>FEBRUARY, 2018</b> | MODEL<br><b>ELANTRA (AD/ADa) 2.0L,<br/>SANTA FE SPORT (AN) 2.4L</b> |
| <b>SUBJECT:</b> AUTOMATIC TRANSAXLE<br>SHIFT LEVER DIFFICULT TO MOVE | | |

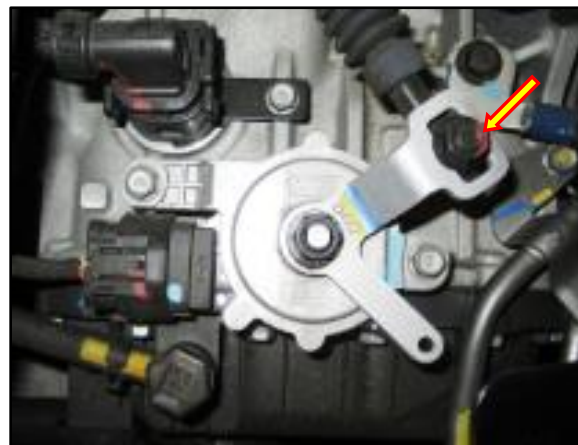
- Disconnect the shift cable at the inhibitor switch.
  - If the shift lever is difficult to move, check and replace the shift lever, if necessary.
  - If the shift lever shifts smoothly, rotate the manual control lever on the inhibitor switch. If the manual control lever is difficult to rotate, go to Step 2.
