Subject		Market
<b>Navigation Head Unit Precautions</b>		USA
Service Category	Section	
Audio/Visual/Telematics	Audio/Video	
Applicability		
2010-2018, Lexus Models with Navigation Head Unit

Subject	Market
<b>Navigation Head Unit Precautions</b>	<b>USA</b>
Applicability	
<b>13 CY 15CY Lexus Navigation Systems</b>

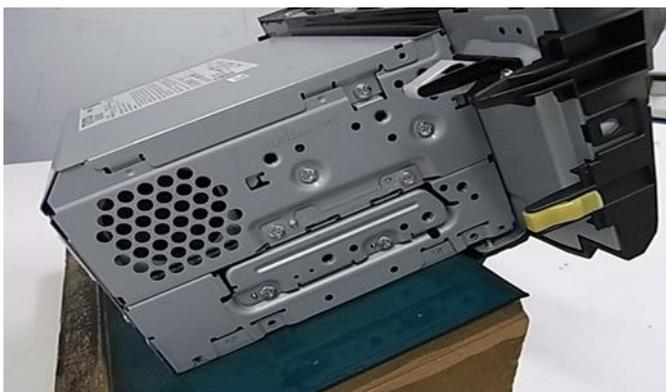
The HDD is inside this cover.  
The HDD needs to be removed when returning the Main Unit to Pioneer.

1. First type is generation 6 or 7 which utilizes HDD (Hard Disc Drive). Pioneer models that begin with **NXH**, have Map Data, Operating System and other Information in the Hard Disc Drive. With this system if a radio is being sent back for an exchange. The original Hard Disc Drive needs to be removed and installed into the newly serviced radio.

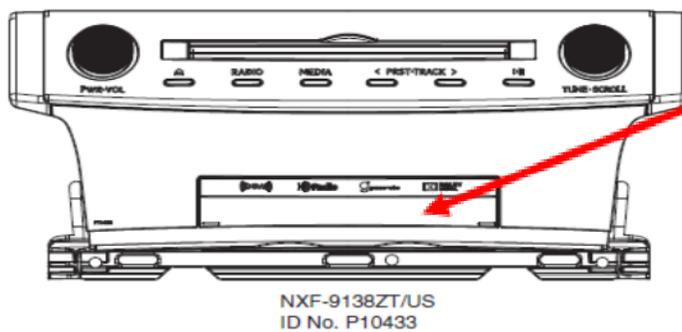
The SD card is behind this flip cover. The Micro SD needs to be removed when returning the Main Unit to Pioneer.

- The Second type is Generation 8 Navigation system which utilizes the Micro SD Card. Pioneer models that begin with **NXF**, have map data in the Micro SD card. This is a customer accessible Micro SD card which can be found behind the front flip cover. The original Micro SD card should be removed and installed into the newly serviced radio.

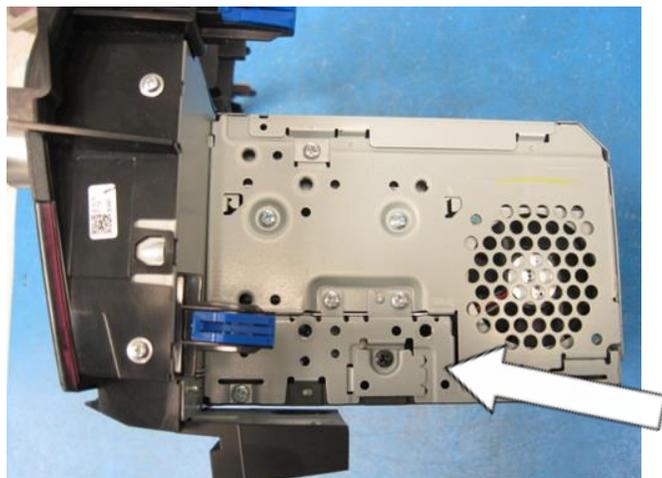
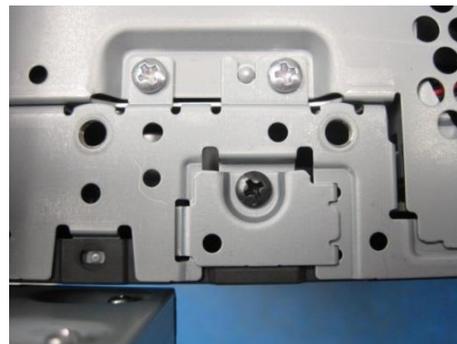
**DO NOT REMOVE**

**This Micro SD card MUST NOT be removed.**

There is another Micro SD card (*Operating System*) inside the Navigation Module. (Similar location to the Hard Disc Drive in the Generation 7 system). This micro SD Card **Should Not** be removed for any reason. Micro SD cards located in this internal slot need to be returned with the original radio.

This will void the Warranty status from Pioneer if removed and dealer will be debited the core credit.
