# Headlamp Durability Enhancement

YEAR(S)	MODEL(S)	ADDITIONAL INFORMATION
2010 - 2012	Prius

Some 2010 – 2012 model year Prius vehicles may exhibit a condition where a halogen low beam headlamp bulb lifetime is shorter than customer expectation. Follow the Repair Procedure in this bulletin to address this condition.

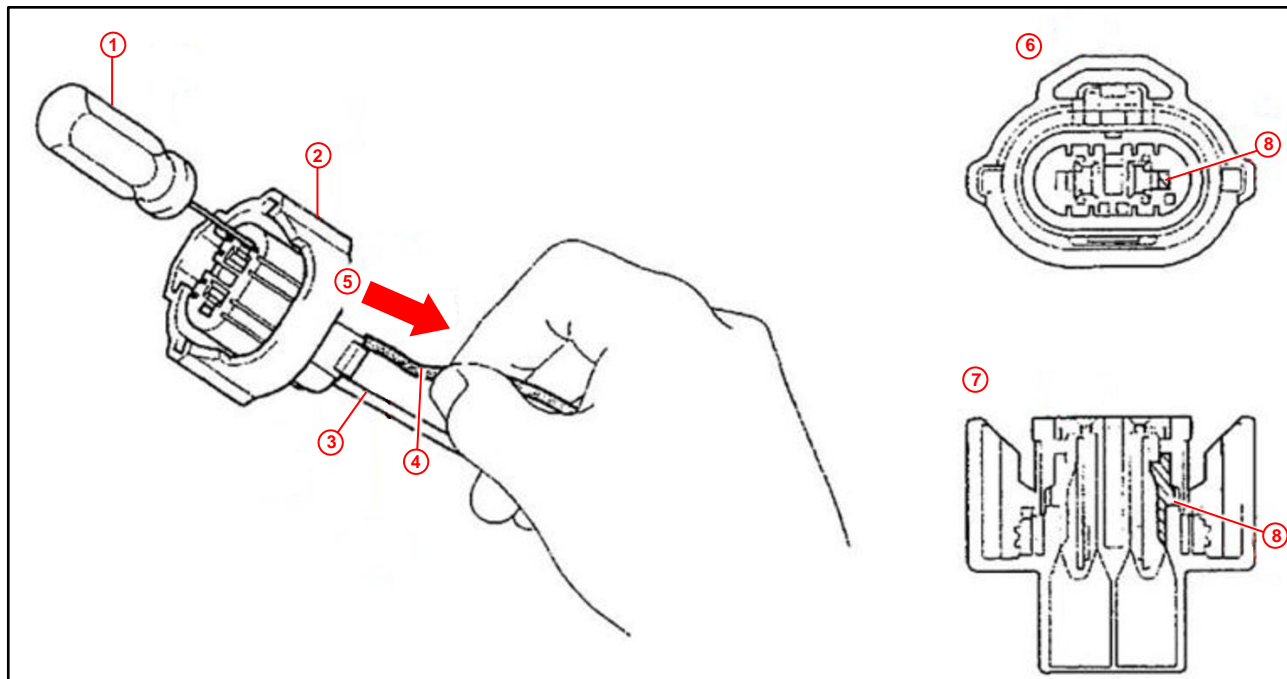
Figure 1.

1	Lance Canceling Tool M
2	Headlamp Bulb No. 2 Connector
3	Engine ROOM Main Wire Harness (White-Black)
4	Engine ROOM Main Wire Harness (Violet)

5	Remove Violet Wire Harness from Connector
6	Front View
7	Cross Section
8	Lock

- (1) AFTER the terminal cap is removed, gently insert lance canceling tool M into the connector between the terminal and the terminal lock (see Figures 1 and 3), then gently push the terminal lock to the outward side of the connector. Do NOT overstress the lock or it will NOT properly hold the terminal when reassembled.

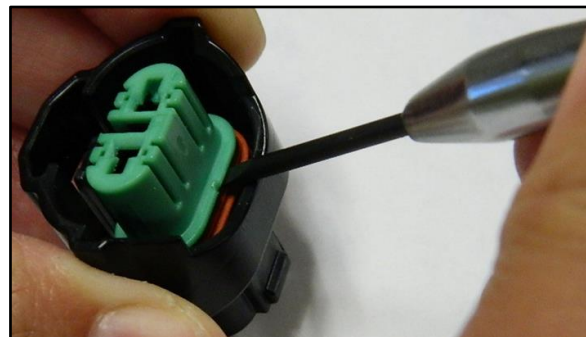
Figure 2.

- A. Remove the green cap from the headlamp connector by carefully using a small screwdriver or pick to detach the cap as shown.

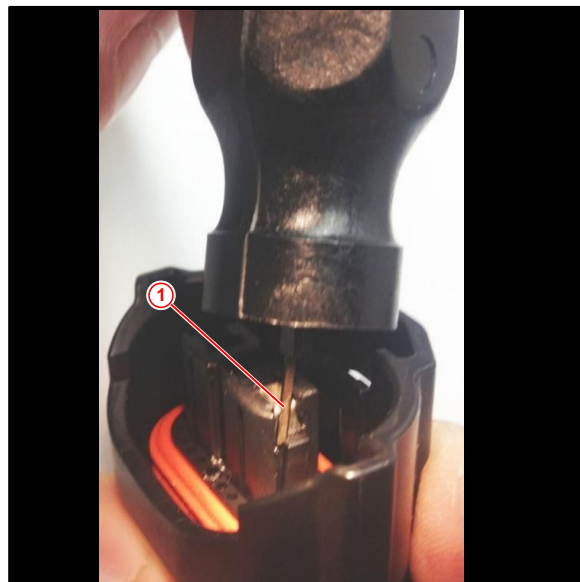
Figure 3.

1 TerminalLock

- (2) As the lock is held outward, gently pull on the violet wire from the back of the connector to remove it.

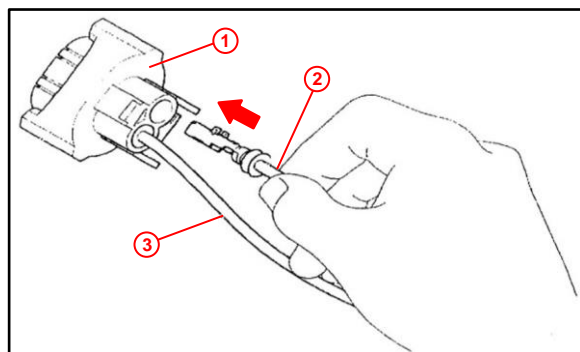
Figure 4.

- C. Insert the terminal of engine wire No. 4 (white-black) into the headlamp bulb No. 2 connector.

1	Headlamp Bulb No. 2 Connector (Low Beam)
2	Insert Engine Wire No. 4 Into Terminal (White-Black)
3	Engine ROOM Main Wire Harness (White-Black)

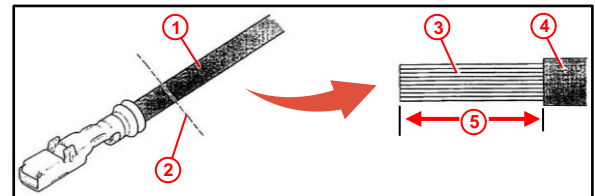
Figure 5.

- D. Cut the violet wire previously removed from the headlamp bulb No. 2 connector near the terminal.
- E. Remove the wire outer coat insulation 10 mm from the edge.

1	Engine ROOM Main Wire Harness (Violet)
2	Cut Here
3	Strip Off 10 mm of Insulation
4	Wire Insulation Coat
5	10 mm

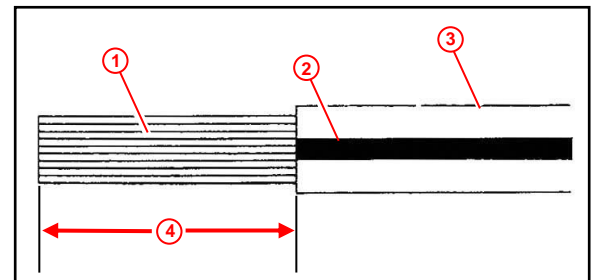
Figure 6.

- F. Remove 10 mm of the wire outer coat insulation from engine wire No. 4 (white-black wire).

1	Strip Off 10 mm of Insulation
2	Wire Insulation Coat
3	Engine ROOM Wire No. 4
4	10 mm

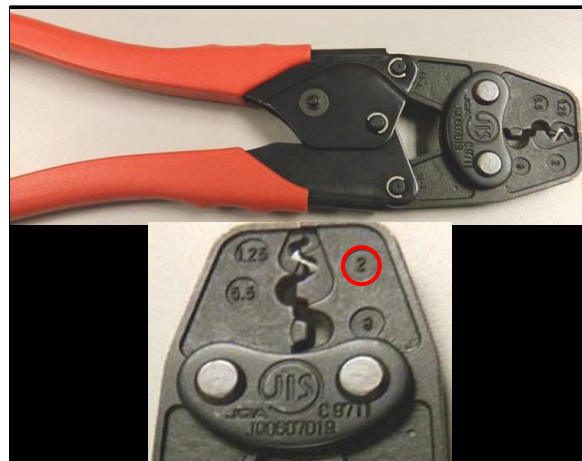
Figure 7.

- I. Using the wire crimper, apply a 2 crimp to the center of the sleeve tube.

The wire crimper tool handles **MUST** be fully depressed for them to release. Verify proper alignment **BEFORE** applying pressure to crimper handles.

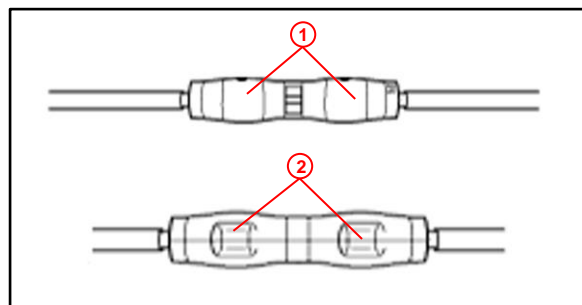
Figure 8.

- J. Apply one additional crimp on both sides of the center crimp as shown.

1	Apply a 2 Crimp Here
2	Crimped Sleeve Tube

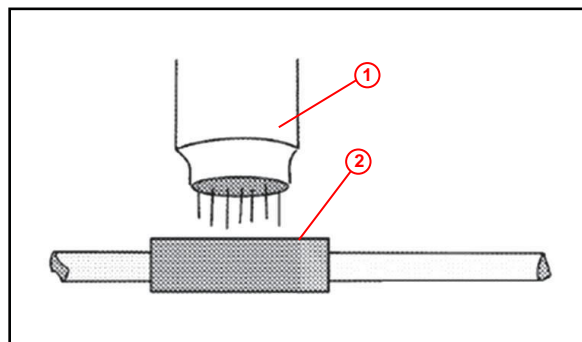
Figure 9.

- K. Slide the heat shrink tubing over the crimp and apply sufficient heat with a heat gun to close the heat shrink around the wire insulation.

1	Heat Gun
2	Shrink Tube

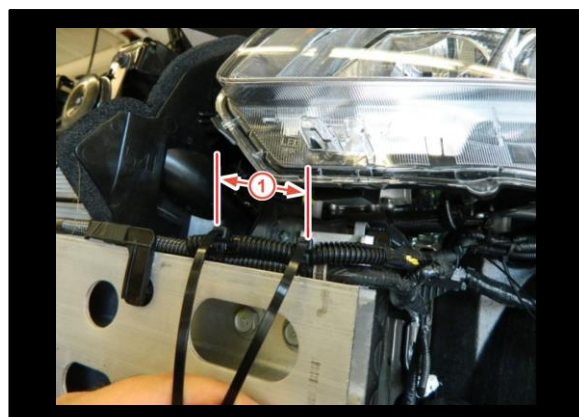
Figure 10.

- Each nylon tie should be located no more than 100 mm from the next one.
- There should be no free play between the factory harness and the engine wire No. 4 wire harness loom.
- The ties should face outside the vehicle.
- Be sure to trim the ties AFTER application.

1	Distance Between Nylon Ties Less Than 100 mm
---	--

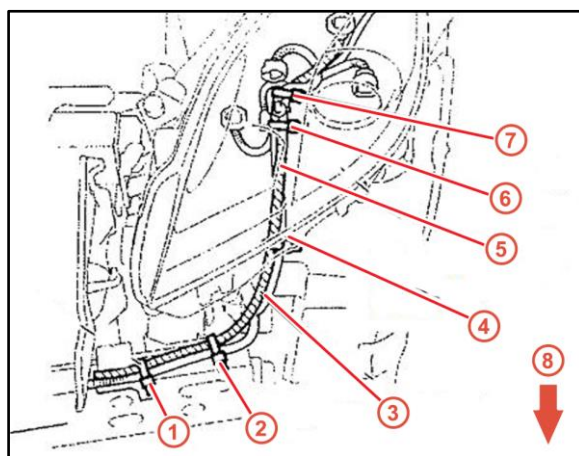
Figure 11.

- (1) Install the engine wire No. 4 harness connector into the headlamp assembly.
- (2) Route the No. 4 harness at the inner bumper reinforcement area following the contours of the factory harness. (Test first routing as necessary to ensure fit.)
- (3) Apply the nylon ties less than 100 mm from each other, facing outward.

Seven tie wraps are needed for the left side. Ties number 6 and 7 are located closer together than other ties. Exact distance depends on routing.

1 – 7	Nylon Ties
8	Front of Vehicle

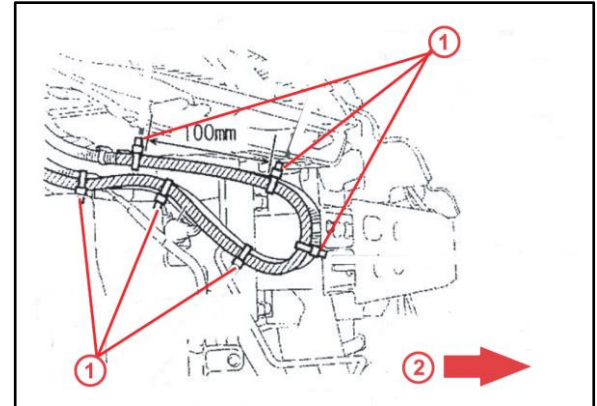
**Figure 12.**

- (1) Plug the engine wire No. 4 harness connector into the headlamp assembly.
- (2) Test fit routing the No. 4 harness by following the contours, starting at the upper part of the factory wire harness area.
- (3) Apply the nylon ties less than 100 mm from each other, facing outward.

1	Nylon Ties
2	Front of Vehicle

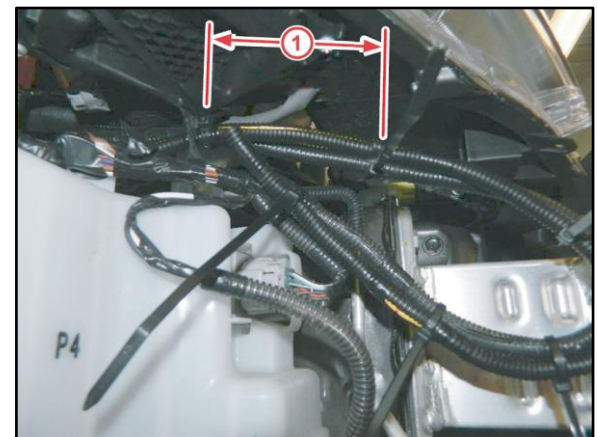
**Figure 13.**

1	Distance Between Nylon Ties Less Than 100 mm
---	--
