QUARANTINE NOTICE

Reference number:	QN-01-1029	Issued: 15 February, 2018
Subject:	Replace Bonnet Meshes with Bonnet Blades	
Model(s):	DB11	
VIN Range:	Refer to the attached list of Vehicle Identification Numbers (VINs)	
Applicable to:	All Dealers	
Distribute to:	After Sales Manager Executive Manager Service Manager Sales Manager	Warranty Staff Technician(s) Parts Staff

Aston Martin has found that some DB11 vehicles had bonnet meshes installed in error. Do the procedure that follows to install the correct black bonnet blades on all applicable vehicles.

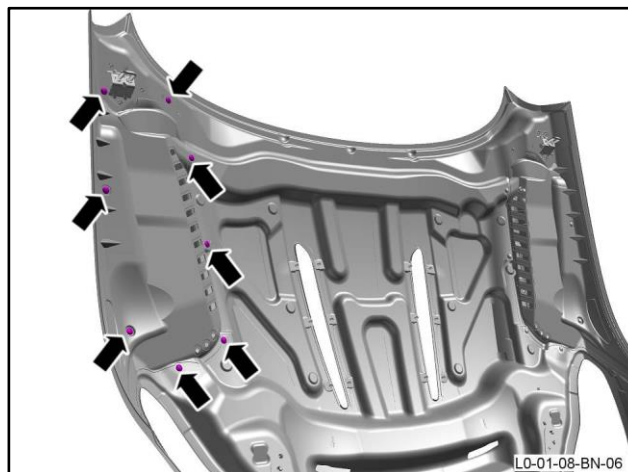
Figure 1

2. Remove the eight push clips that attach the left-side centre wheel-arch liner to the bonnet (refer to Figure 1).

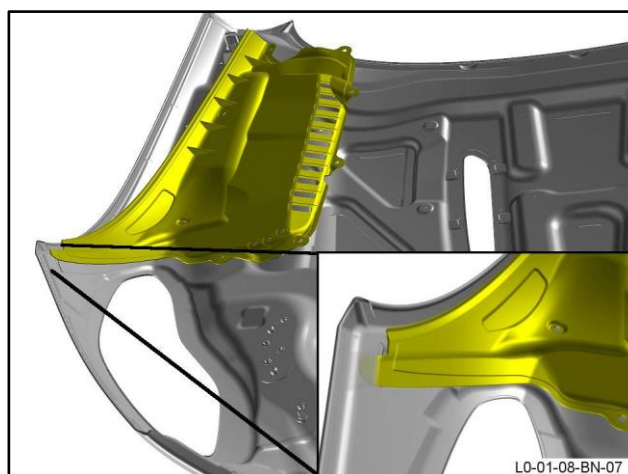
Figure 2

3. Release the left-side centre wheel-arch liner from the bonnet (refer to Figure 2).

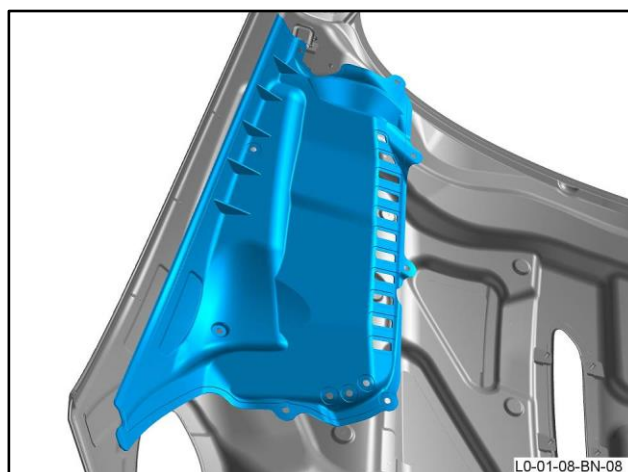
Figure 3

4. Remove the left-side centre wheel-arch liner from the bonnet (refer to Figure 3).

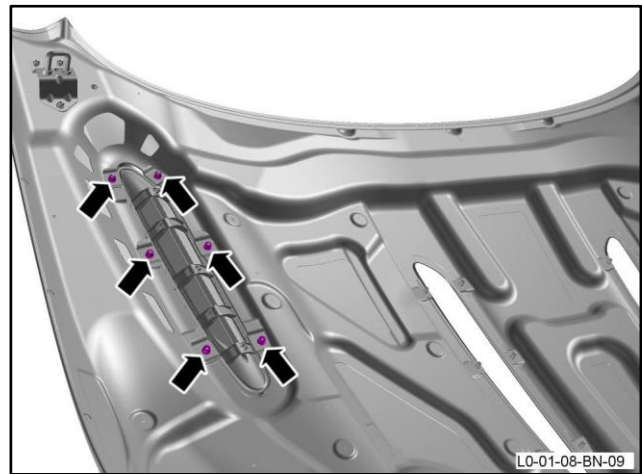
Figure 4

5. Remove the six nuts that attach the left-side outboard bonnet mesh to the bonnet (refer to Figure 4).

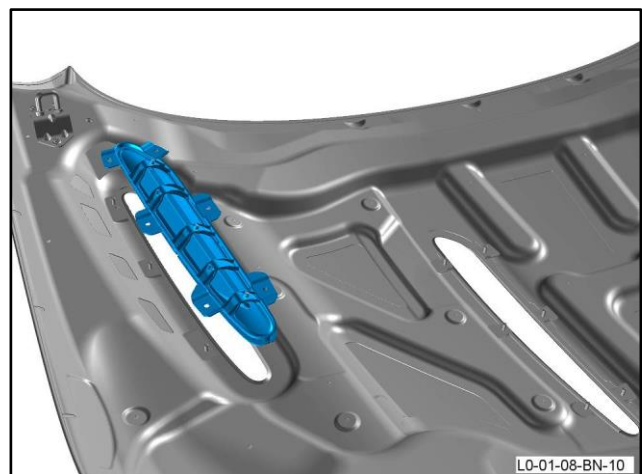
Figure 5

6. Remove the left-side outboard bonnet mesh from the bonnet (refer to Figure 5).
